RAWFILL WP I1

I1.4.2 As-built document, works report

Date: October, 2020

SUBJECT: WP I1 - I1.4.2 As-built document, works report

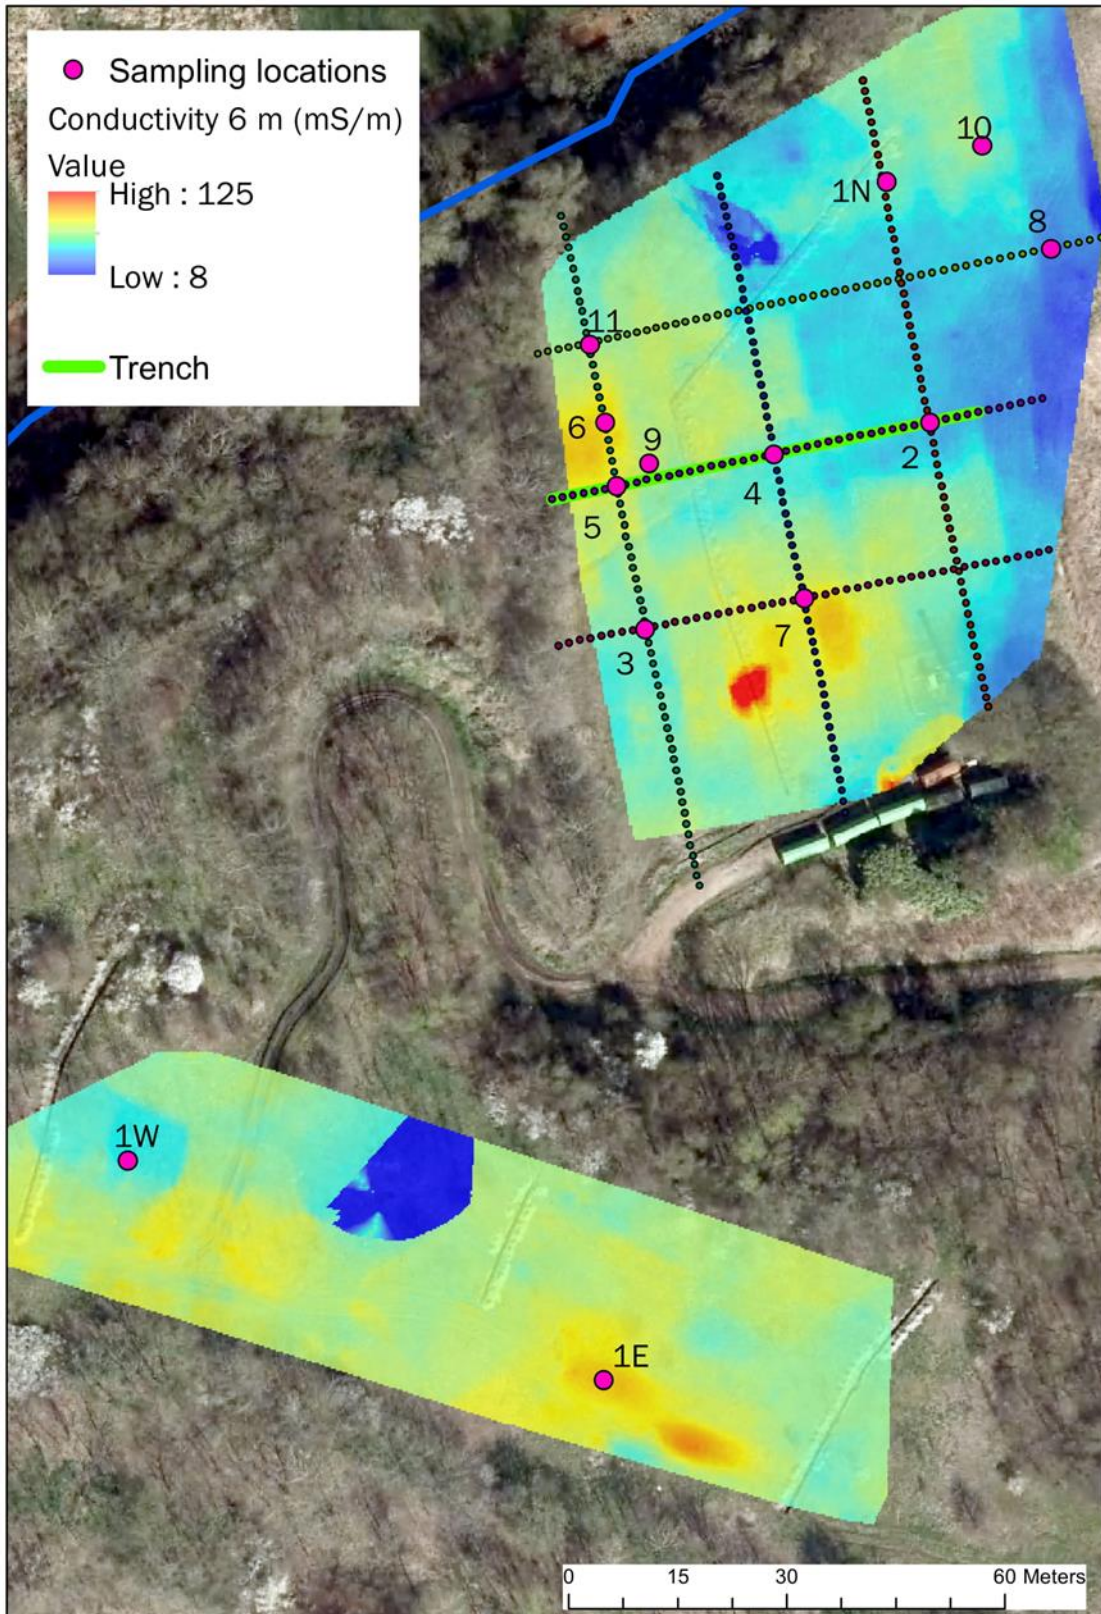
The geomembrane was restored at the location of two boreholes (1W and 1E) by Benvitec nv (**Fig. 1**). The exact coordinates are listed in **Table 2**.

Figure 1: Location of the boreholes performed in November 2018. Capping restoration was only performed in the southern part (1W and 1E) .

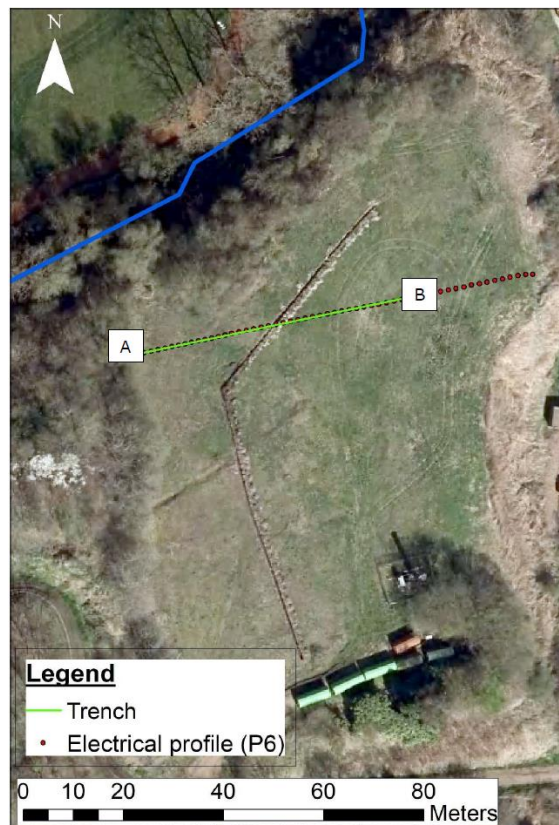
Seven trenches were performed along a profile (A → B in Fig. 2) in the upper part of the landfill in order to investigate the waste composition. The profile started at the point A in **Figure 2** (coordinate x: 197712.626; y: 199516.3403) and ended at the point B in **Figure 2** (coordinate x: 197771.5366; y: 199528.4963). The exact coordinates of the seven trenches as well as their sizes are listed in **Table 3**.

Figure 2: Location of the profile AB where seven trenches were performed (northeastern part of the landfill).
