# **Caen Hill Pumping Station**

PUMP AUDIT SUMMARY REPORT NICK TAYLOR March 2020

**Report No:** 10031024-00516

**Date:** March 2020

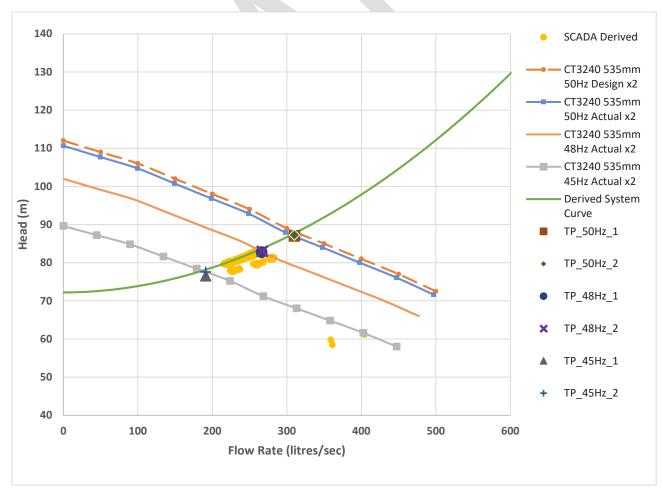
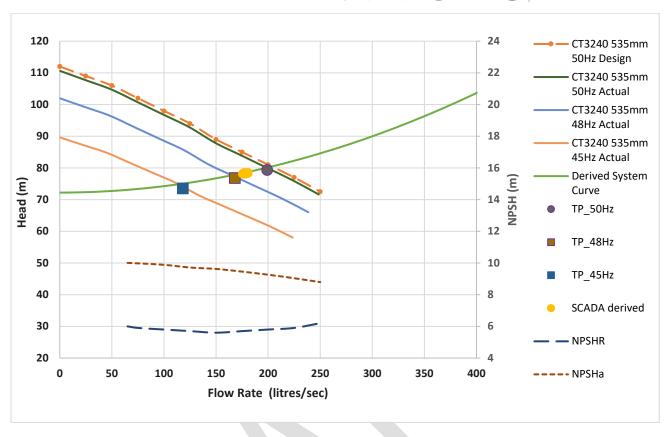
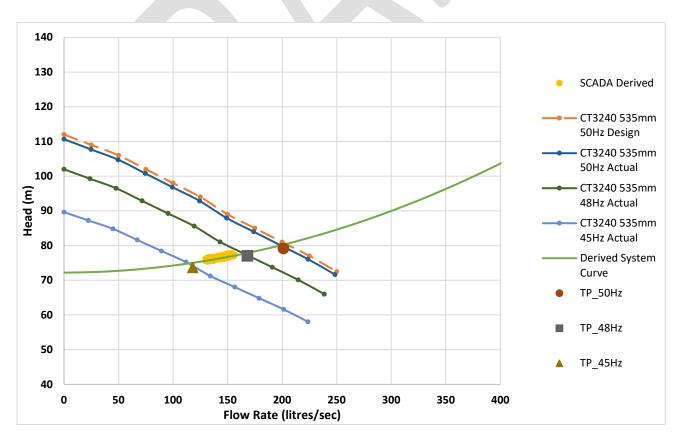
- a) The site test results backed up by the SCADA data raised a concern with the rising main losses. For a relatively new pipeline main of less than 25 years' service, an additional head loss coefficient of 120 was necessary for the calculations to obtain an equivalent head loss performance. This creates an additional 6m at 300l/s. To put this into a physical context, a restriction equivalent to an orifice of 224mm create the same loss within the system.

- b) From the 2018 SCADA data, Pump 2 experienced some hydraulic issues and performance below its curve. This was explained by AMCOs recent maintenance and removal of blockage items, after which the pump delivery performance was reported to have improved from 121l/s to 169l/s once returned to operation. This performance improvement was confirmed at the site test.

- c) The performance of the pump curves were adjusted down from the manufacturers published performance curves in order to align with site results. The reduction being an equivalent of 0.3 Hz on a VSD. It is noted that impeller impact damage is present on Pump 2 as discovered from the recent AMCO maintenance visit, which may have had an impact. It is also noted that this curve is still within "as new" manufacturers tolerances<sup>1</sup>.

- d) The best efficiency point (BEP) of the installed CT3240 pump is just to right hand side of the pump curve extents as shown in the system curves i.e., 262I/s @ 70m for 1-pump and 524I/s @ 70m for 2-pump operation.

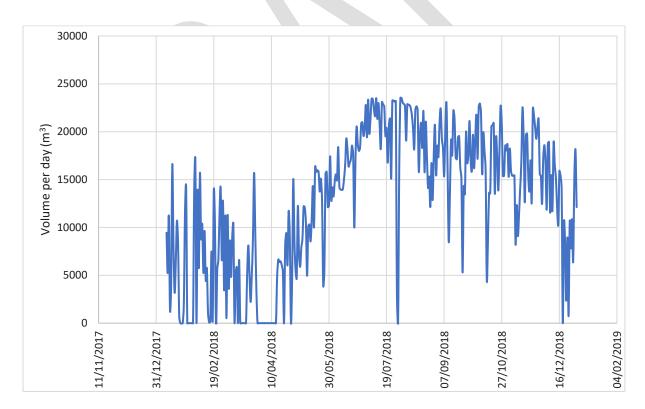
Figure 7 – Daily Volume Pumped during 2018 (Estimated from SCADA data)

The daily output volumes taken from the 2018 SCADA data in Figure 7 suggest that opportunities may exist for optimising control.

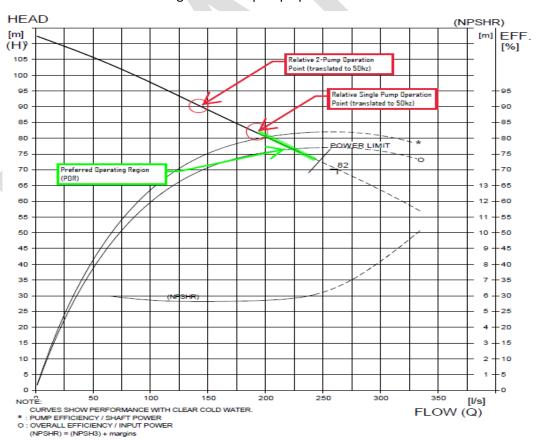
Figure 8 – Manufacturer's Pump Curve and Relative Operating Points at Caen Hill

The pump curve has a preferred operating region (POR), defined by being 70% to 120% of flow rate at the best efficiency point (BEP), where vibration should be lowest. This is highlighted in green in

Figure 8 and shows that single pump operation is within the POR but falls to the left of POR under 2-pump operation, which may be an indicator of higher vibration.

High vibration levels may be a symptom of adverse hydraulic pumping conditions, either from any intake flow instability or pumping duty outside the preferred operating region, as axial thrusts increase further from the BEP. At Caen Hill they may be secondary contributors, given that under 2 pump operation the pumps operate outside the 70% to 120% BEP range.

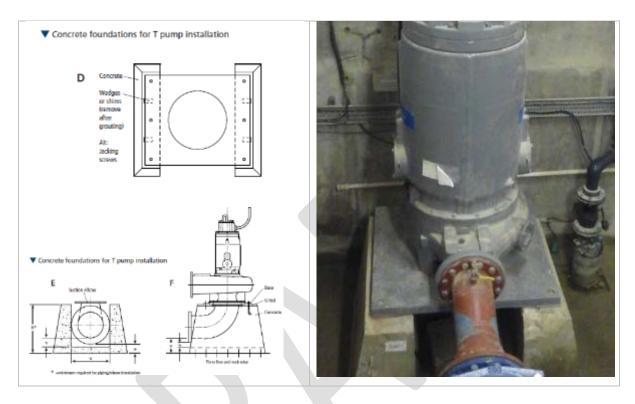
Figure 9 – Pump Installation Recommendations and Photo of As Built Installation

The vibration levels on the mounting plate were also measured and indicated comparable levels of excessive vibration to the pump. This suggests that the concrete supporting plinths are not providing a firm anchored foundation. The evidence of cracking and groundwater/clay seepage at the plinth- floor joint suggests that the plinths are not adequately secured to the PS floor structure.

The spalling of concrete and further cracking within the concrete plinths is of concern and should be investigated as a priority.

Visually the pump baseplate and plinth appear in keeping with Xylem's recommendations (Figure 9). The interfacing of the plinths to the PS floor could not be seen, but it was noted that the floor itself near the plinths had a noticeable reduction in vibration from the plinths to the touch.

In summary, the most likely cause is considered to be poorly anchored pumping installation. The level of degradation suggest that remedial works should be a high priority.

At this time the preferred solution would be to replace the plinths under Pump 1 and Pump 2, but this would be subject to a structural survey of the floor/building to inform on the required plinth design and it would be advisable to include Xylem within these discussions to benefit from their expertise and experience on anchoring this model of pump.

- It is recommended that the vibration issues and the pump plinths are looked into as a
  matter of priority, including a structural assessment. Resolving this issue would have the
  potential benefit of increasing the bearing life of the pumps, leading to increased reliability
  and efficiency. Depending on the existing structural design, the new plinths should be
  integrated into the existing foundations.

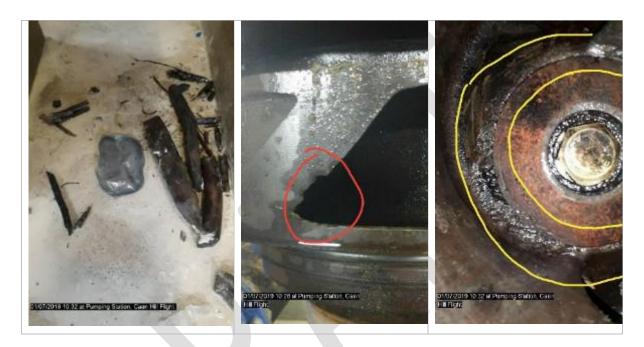
Figure 10 - Photos following Pump No.2 Inspection - July 2019

Based on the AMCO's maintenance records since 2017, there were two other occasions since November 2017 when significant debris was found in the pumps and necessitated reactive maintenance removal.

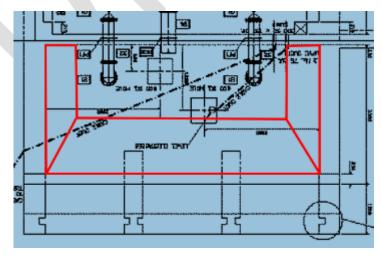
Figure 12 - Potential benching possibility in wet well

The option introducing benching as per Figure 12 would reduce the volume of the wet well and silt deposition and maintain the existing access points. It is unlikely that the improvements would result in avoidance of silt build up, but it would result in lower amounts of debris being removed in a single visit.

In summary, the action of increasing the benching needs to be balanced against the risk of higher frequency of blockages / desilting operations based upon an assumption that the rate of debris ingress remains consistent.

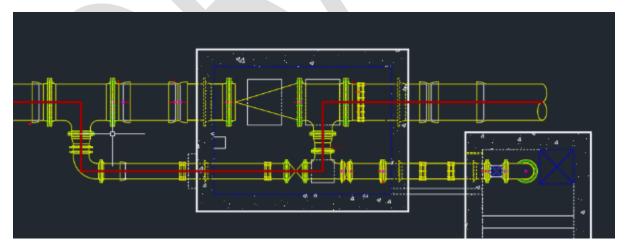
Figure 13 -Intermediate NRV schematic with suspected flow path in red

From the calculations, based on the provided SCADA and pump audit data, an unknown head loss is present within the rising main, equating to an additional 6m of pumping head at 300l/s. The condition and operability of the intermediate NRVs is questionable and requires further investigation to understand if they are a contributing factor to the high dynamic losses.

During the investigation it was noted that there is DN250 return bypass pipework around the intermediate NRV that connects the 600 mm DI upstream and downstream (Figure 13) complete with a 250 mm gate valve for isolation. If the intermediate NRV was damaged and unable to open and the 250 mm gate valve was open the flow would pass through the bypass, which would account for the additional head loss found from the site data.

It is suggested that CRT investigate the 2no. Intermediate NRVs – it is possible that at least one of these valves are in poor condition and causing a restriction to flow path in the main or are shut with flows passing via the NRV bypass pipework.

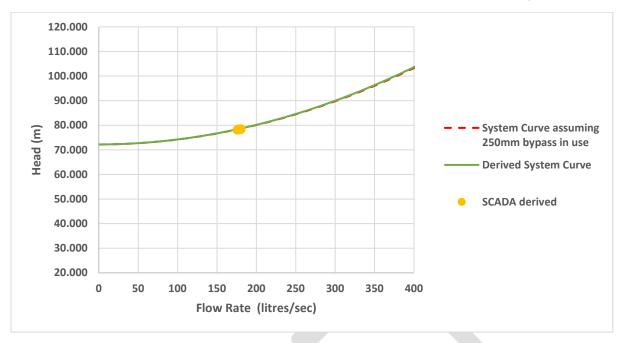
Figure 14 – System curves showing estimated system curve based on site data and system curve if flows pass around the 600 mm NRV and through the 250 mm bypass line

The overlaid system curves for this scenario and the estimated system curve from the site data can be seen in Figure 14 and it would seem to suggest that this is a possibility that should be explored further as correlation between the system curves is evident.

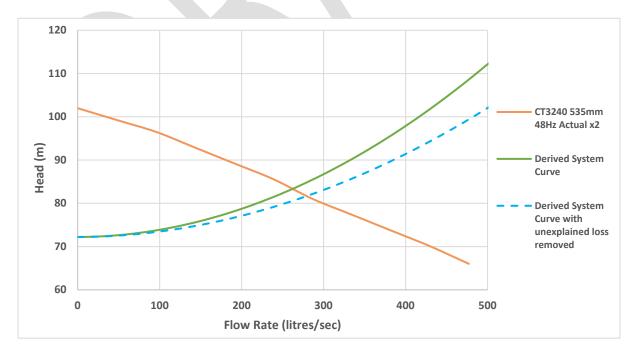
Figure 15 – System curves showing impact of removing the perceived restriction when 2 pumps are operating at 48Hz

If this head loss can be located and potentially eliminated, the pumps would produce an approximate 15-20l/s increase when operating 2 pumps at 48Hz. This could raise the capacity of the 2 pump operation from 266l/s to 280l/s which would give an approximate 5-7% increase in capacity. (Figure 15)
