# Tinsley Pumping Station

## PUMP AUDIT SUMMARY REPORT

**Report No:** 10031024-00519

**Date:** March 2020

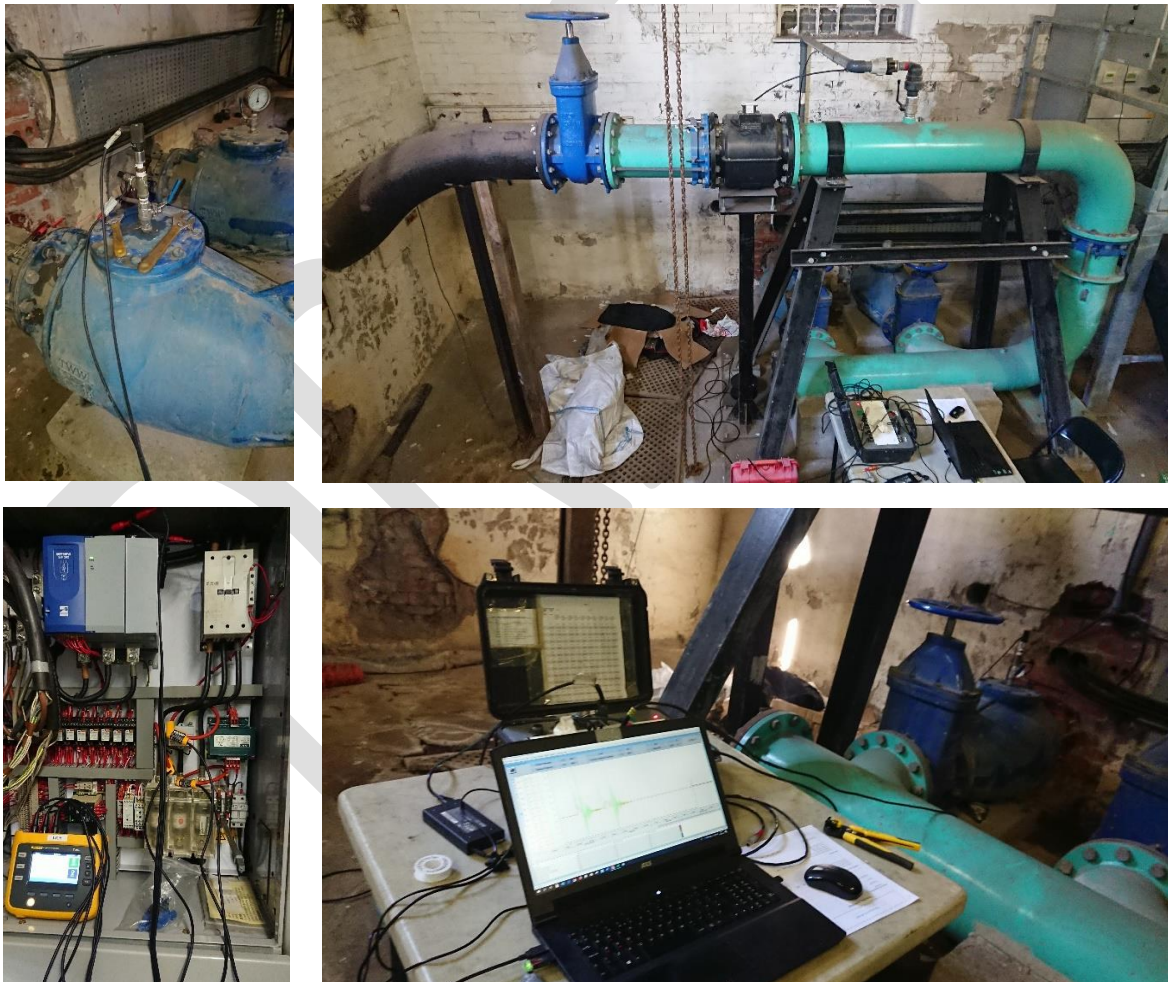
*Figure 1 – Photographs taken during site audit (Top left: pressure transducer connected to top of check valve, Top right: Common discharge pipework and flow meter arrangement, Bottom left: 'Fluke' meter connected to terminals inside MCC; Bottom right: Data recorder and laptop)*

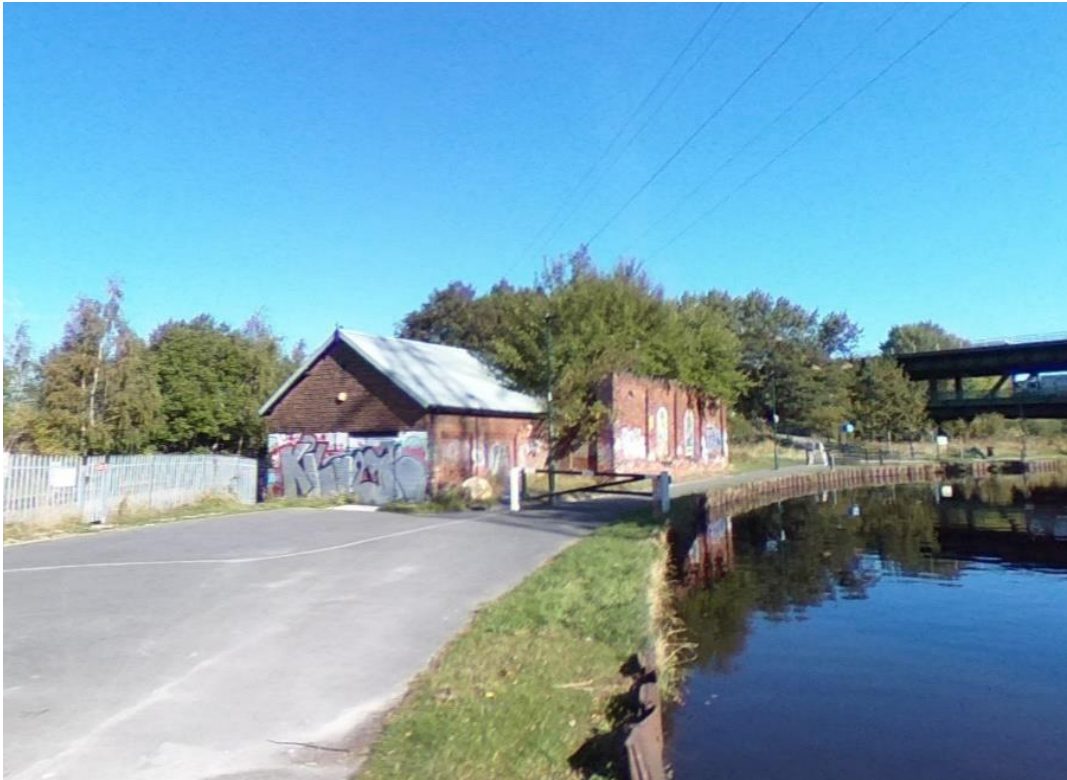
*Figure 3 – Tinsley Pump Station building*

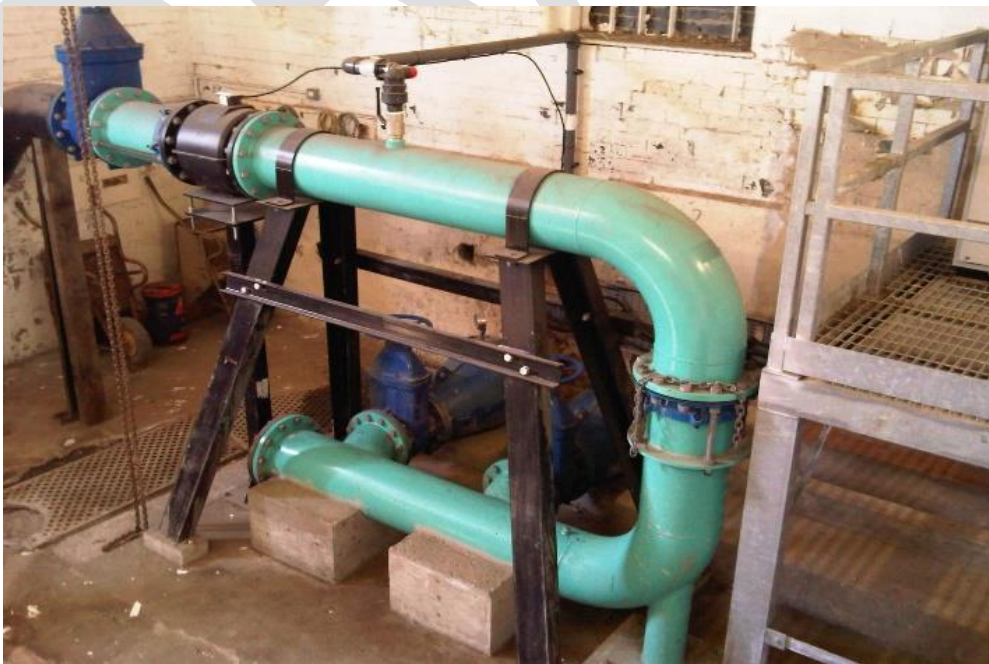
*Figure 4 – Tinsley Pump Station basement area pipework*

DN250 pump discharge pipework is located within the basement / lower level of the existing pumping station building. Each pump has a recoil swing check valve with pressure gauge and an isolation gate valve.

The discharge pipework from each pump combine into a DN300 common header pipe. There is also an air valve, with discharge piped back to the wet well, a flow meter and isolation valve on the common header pipework within the building.

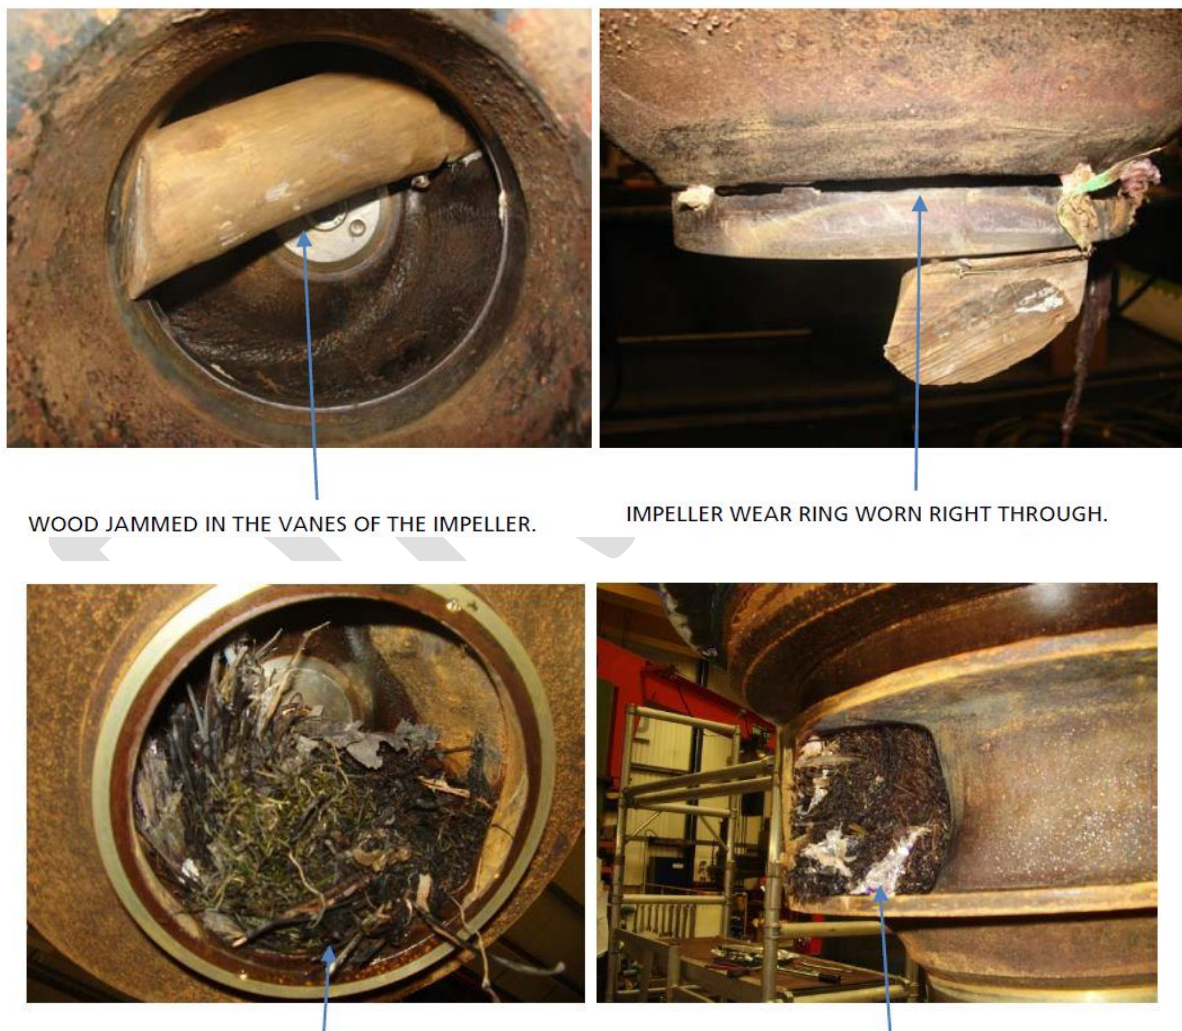
There have been numerous reported instances of pump failures and blockages, mainly due to debris and rubbish entering the wet well, resulting in high maintenance costs from the associated pump damage/wear (Figure 6).

*Figure 6 – Examples of pump blockages and damage associated with previous KSB installation*

Provision of new pumps with a 'non-clog', hardened impeller is expected to reduce the frequency of issues with pump blockages and wear caused by silt and debris that may enter the wet well.

Pending the improvement outcome of the pump impeller change, an alternative solution may be required in lieu of the bar screen, which is manually raked, in order to minimise these occurrences and associated operator intervention.

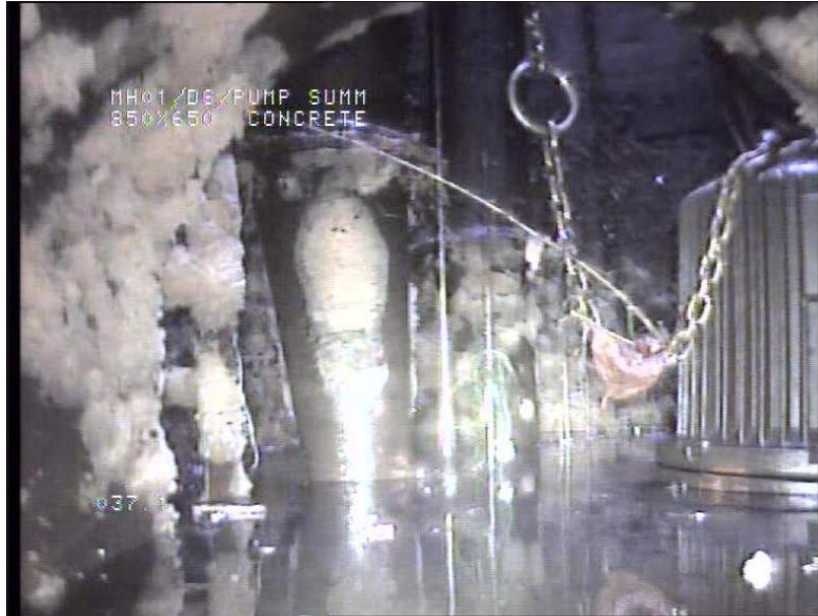
Photo: 2\_15a  
37.2m, General Observation, Remark: Pumps at Pump Sump Chamber

As shown in Figure 7, the orientation of the pumps is not aligned with the inlet, so it could be possible that the hydraulic presentation to each pump differs. The recommendation position of the inlet for Flygt pumps is with a 120° sector opposite the discharge pipes (Figure 8).

Figure 7 – CCTV survey photo showing view of pumps from culvert at wet well inlet

The orientation of the inlet culvert into the pump sump results in flows entering the pumps from the side, in addition it appears that the culvert may be offset from the centreline of the wet well. The operation of the far-side pump is more impeded by the near-side pump and this potentially could affect the pump performance.

Since the pumps do not normally operate in parallel, the effect on the hydraulics should be minimal. However, the far side pump could be encountering a degree of swirl or poorer flow presentation at the pump intake (possibly in the same direction of rotation as that of the pump impeller). Swirl can cause a change in the operating conditions of the pumps with a tendency for the flow capacity and efficiency to decrease.

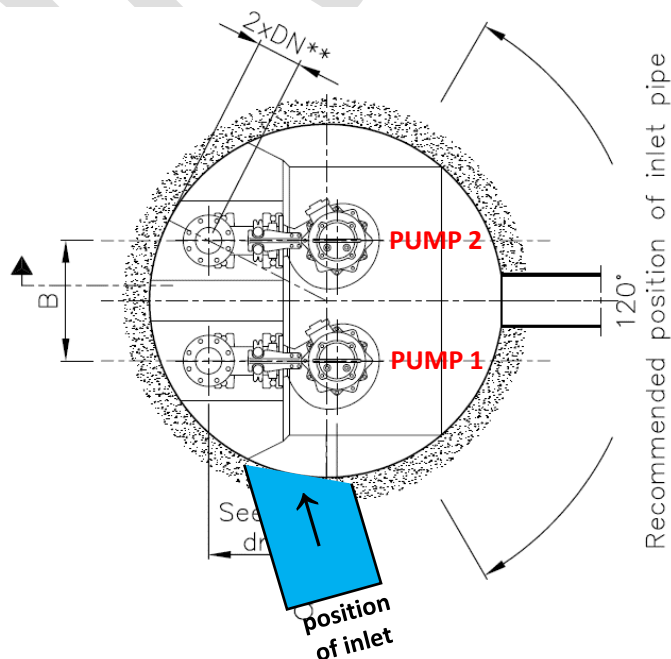
Figure 8 – Recommended pumping station intake positioning and approximate orientation of culvert

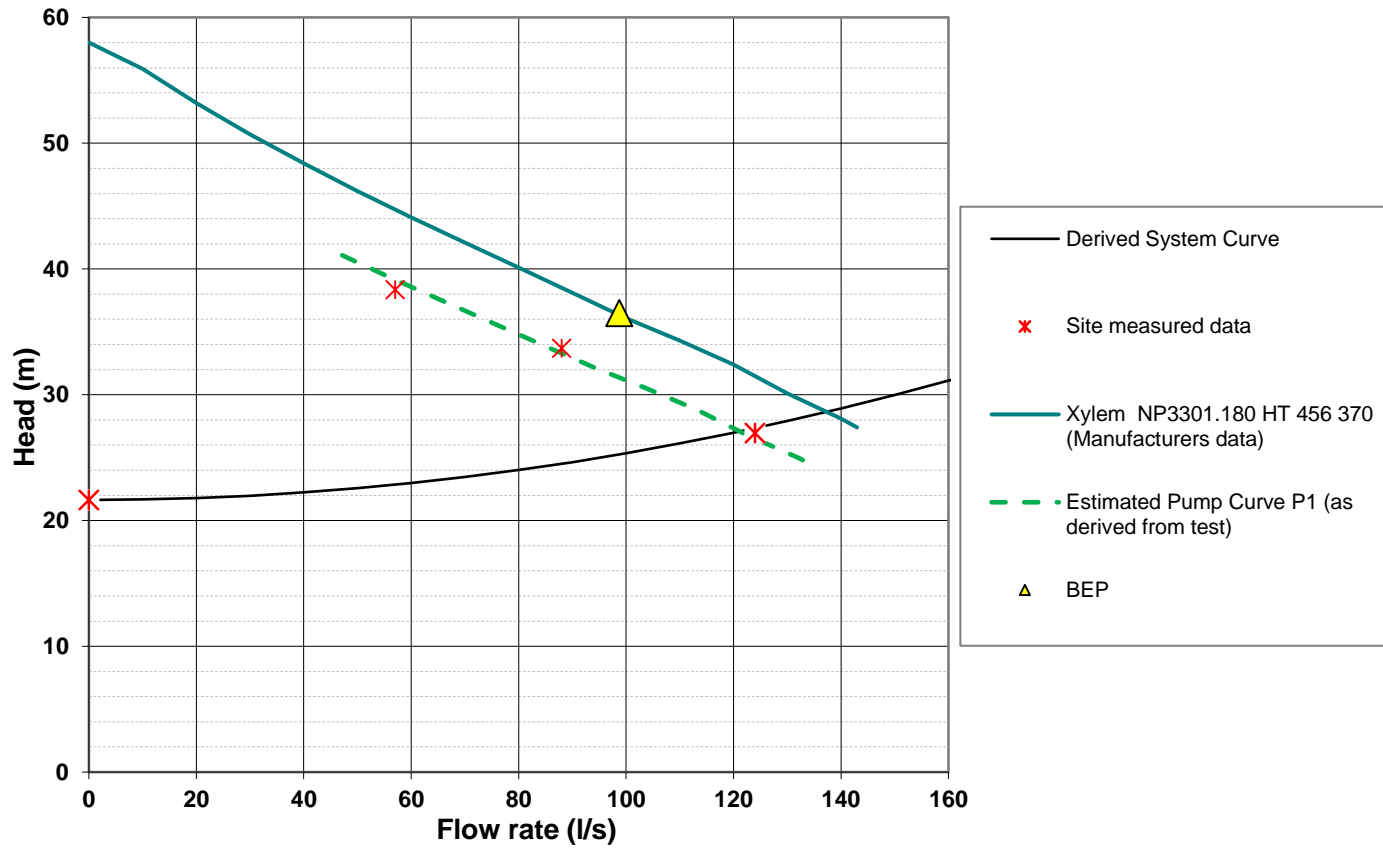
Excessive pump wear could also be a cause of the difference and, or reduction in the expected pump capacity. Based on a 370 mm impeller, the measured pump flow rates would equate to approximately 5.7% wear for pump 1 and 10.2% wear for pump 2.

Given the significant variance in flows, the actual pump performance curves are suspected to be different, possibly same models with different impellers (or possibly different units altogether). Subsequent research into various other manufacturer pump curves was carried out, and it is thought that both units are Flygt NP3301 180 HT model pumps, and that pump 1 has a 456 370 mm impeller but that pump 2 may be fitted with a 458 350 mm impeller. The performance curves for these two impellers are compared to the actual measured pump performance in Figure 9 and Figure 10.

Figure 9 – Derived system curve and pump curves (Site data vs Xylem pump curve) for Tinsley PS, Pump 1

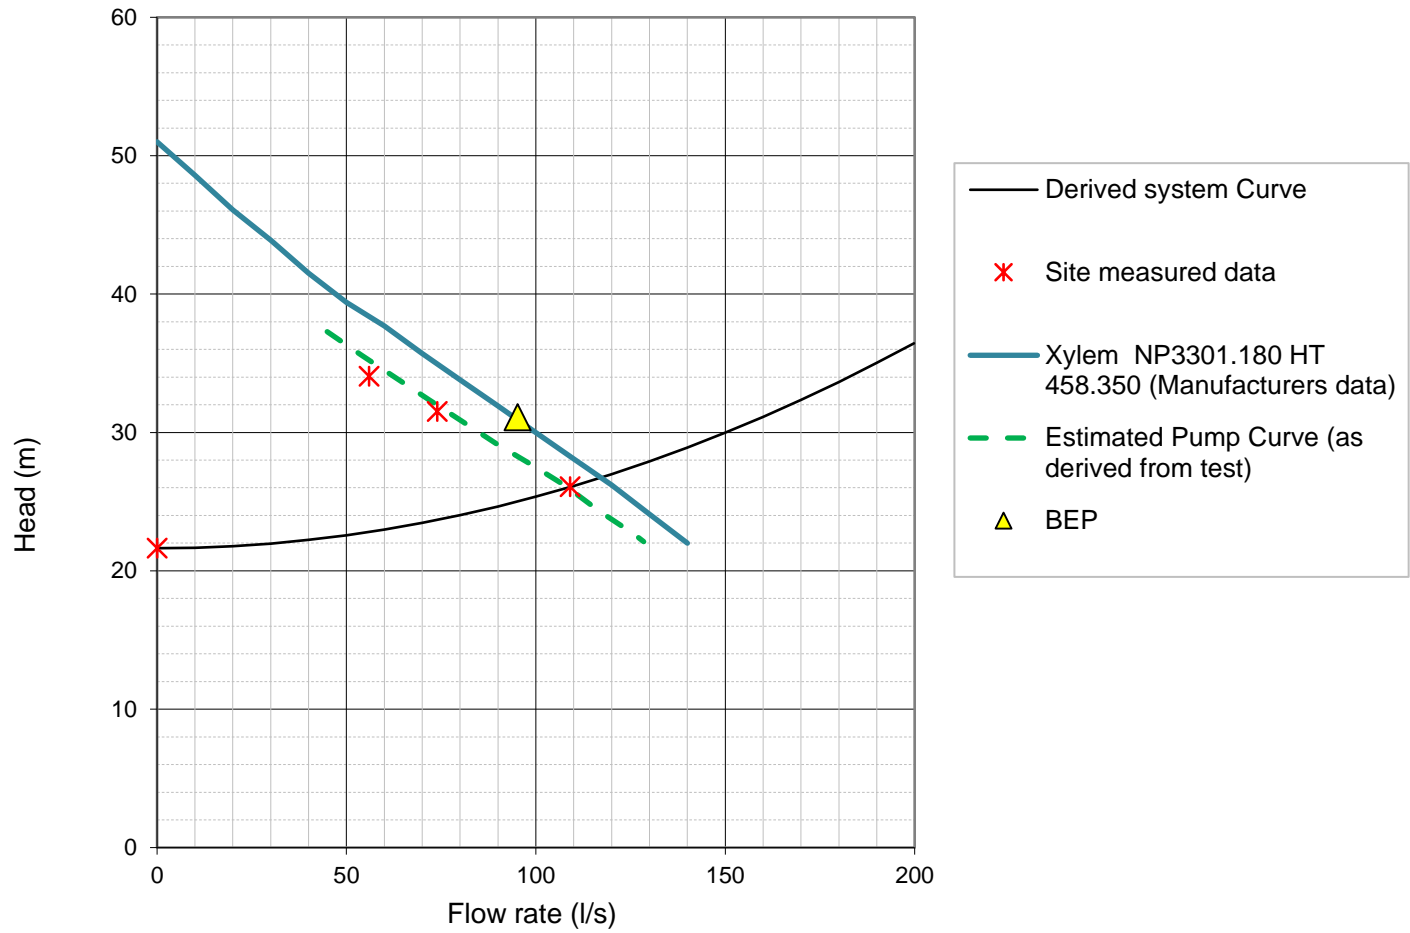
Figure 10 – Derived system curve and pump curves (Site data vs Xylem pump curve) for Tinsley PS, Pump 2

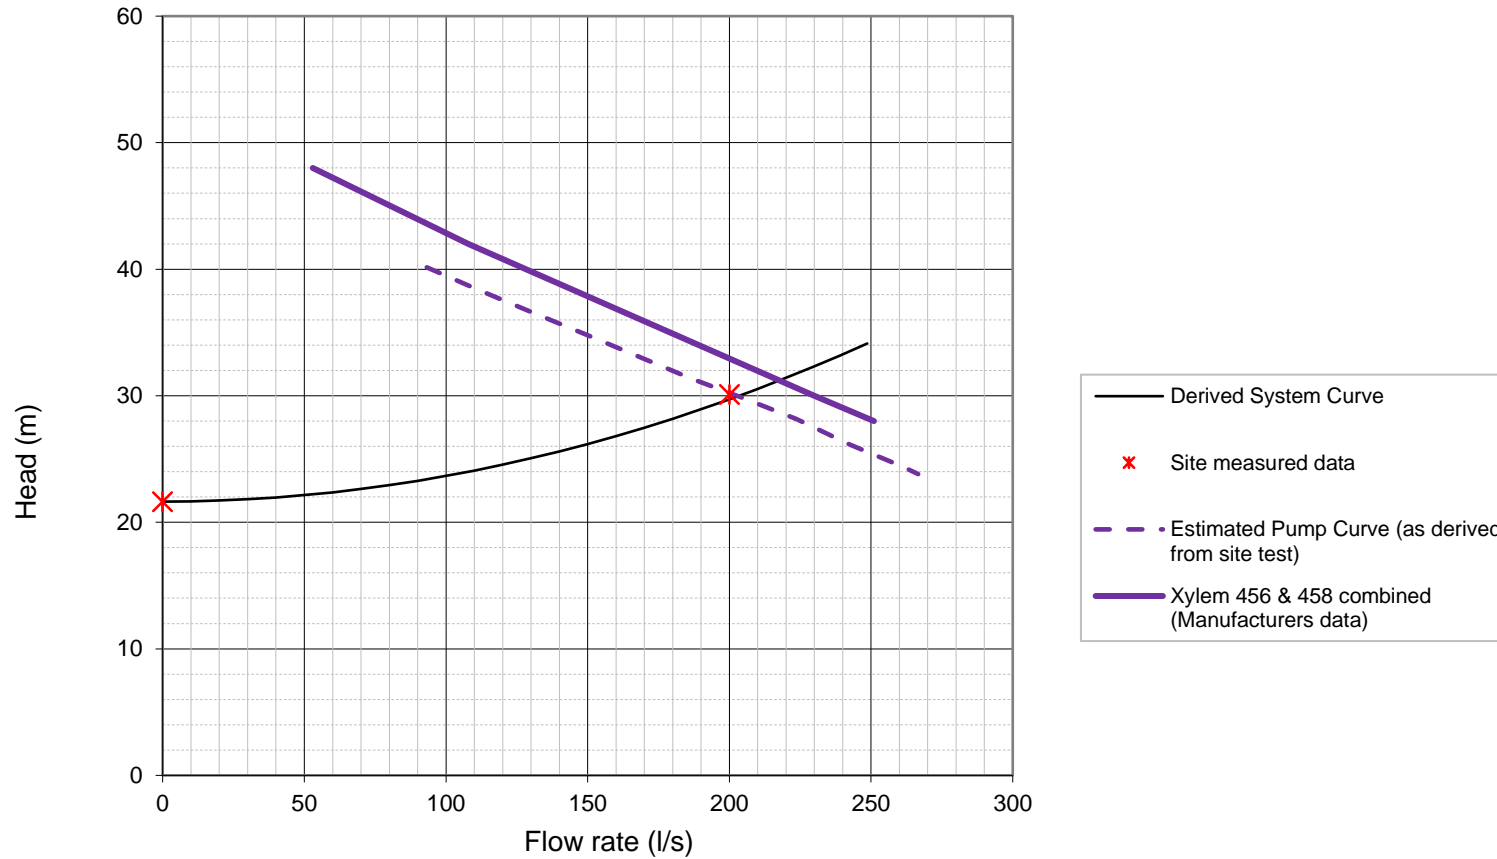
Figure 11 – Derived system curve and pump curves (Site data vs Xylem pump curve) for Tinsley PS, Two pumps in operating parallel

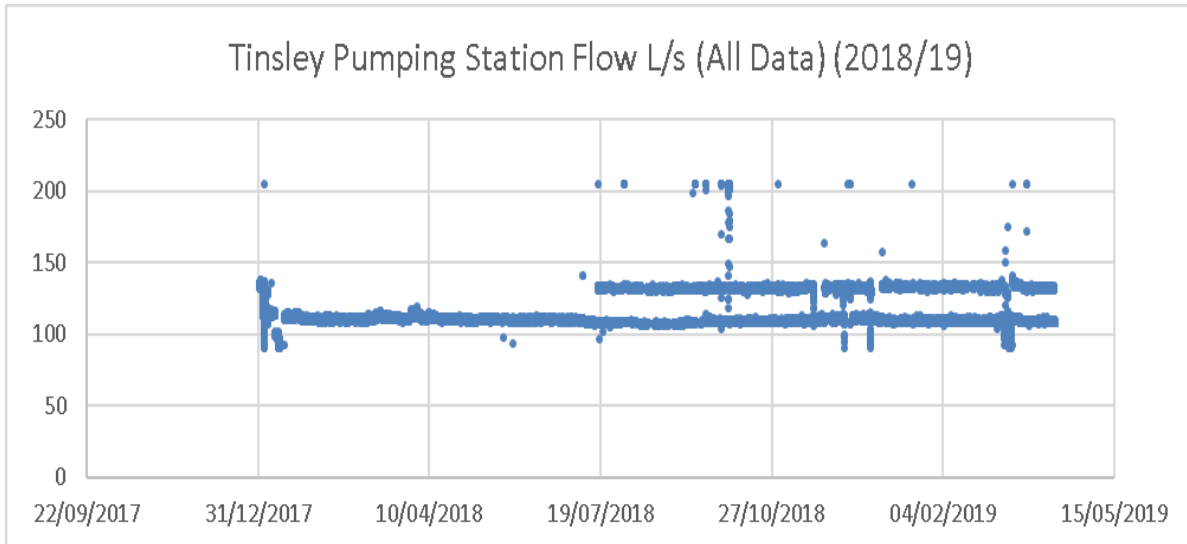
Figure 12 – Tinsley PS SCADA flow rate data 2018/19

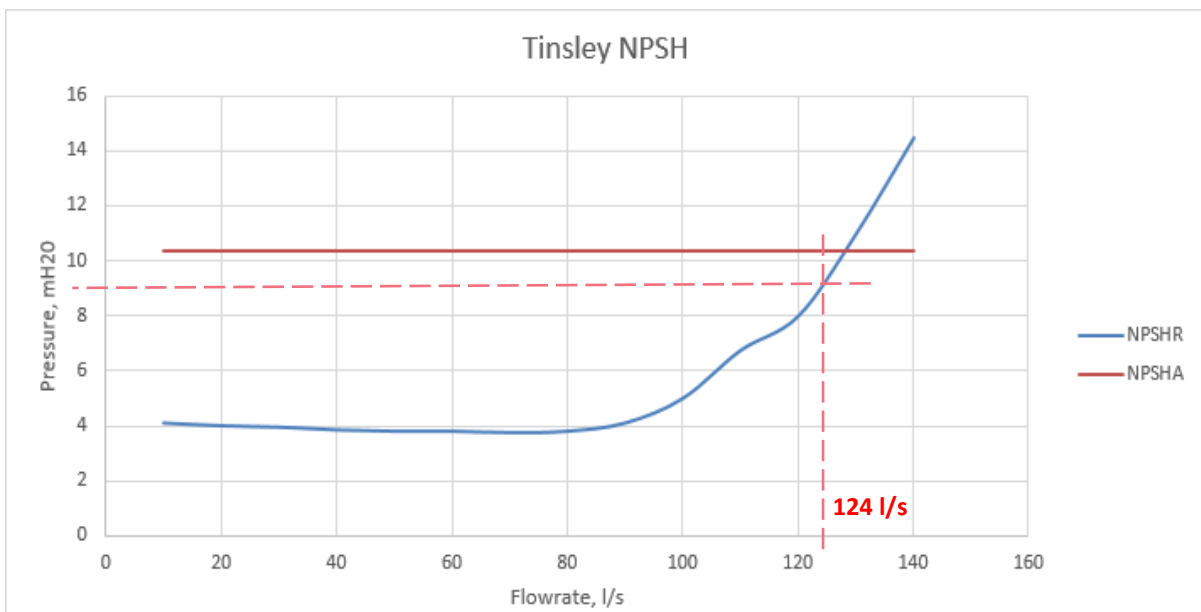
A relative safety margin for NPSH of 30% or 2m is the WIMES<sup>1</sup> default requirement for submersible pumps. NPSH calculations have been undertaken and the results suggest that there is approximately a 1.2 m margin at the worst-case bottom water level (BWL), between NPSH required (NPSHr) and NPSH available (NPSHa) – see Figure 13. This BWL has been based on the recommended minimum 430 mm submergence depth for a NP3301.180 HT submersible pump at 29.221 mAOD and is 1.3 m below Minimum River Level (Appendix F).

Figure 13 – Comparison of NPSHr curve for a NP3301.180 HT pump and NPSHa at Tinsley PS

The result is unsurprising given that the pump units are operating to the right side of their performance curve region and BEP. However, it is not known if any evidence of cavitation currently exists as none of the previous pump repair reports or photographs provided suggest this.

At present this does not appear to be causing any issues, but it should be noted that the difference between NSPHr (c.9.2 m) and NPSHa (c.10.4 m) of 1.2m does not meet design best practice when running at 124 l/s with the above BWL. This has the potential to cause issues with long-term operation and functionality, bearing in mind that 124 l/s is an average flow rate, particularly on occasions when the incoming flow is impeded as there is no low level/dry-run protection in the wet well.

The NPSHr at the operating duty point is much lower than the existing pump installation – 3.6 m and 4 m for the Xylem pump selection and the Hidrostal pump selection respectively – and thus provides more than adequate margin. The existing pump NPSHr most likely would exceed the NPSHa at BWL if running at 130 l/s (Figure 13) resulting in cavitation issues.

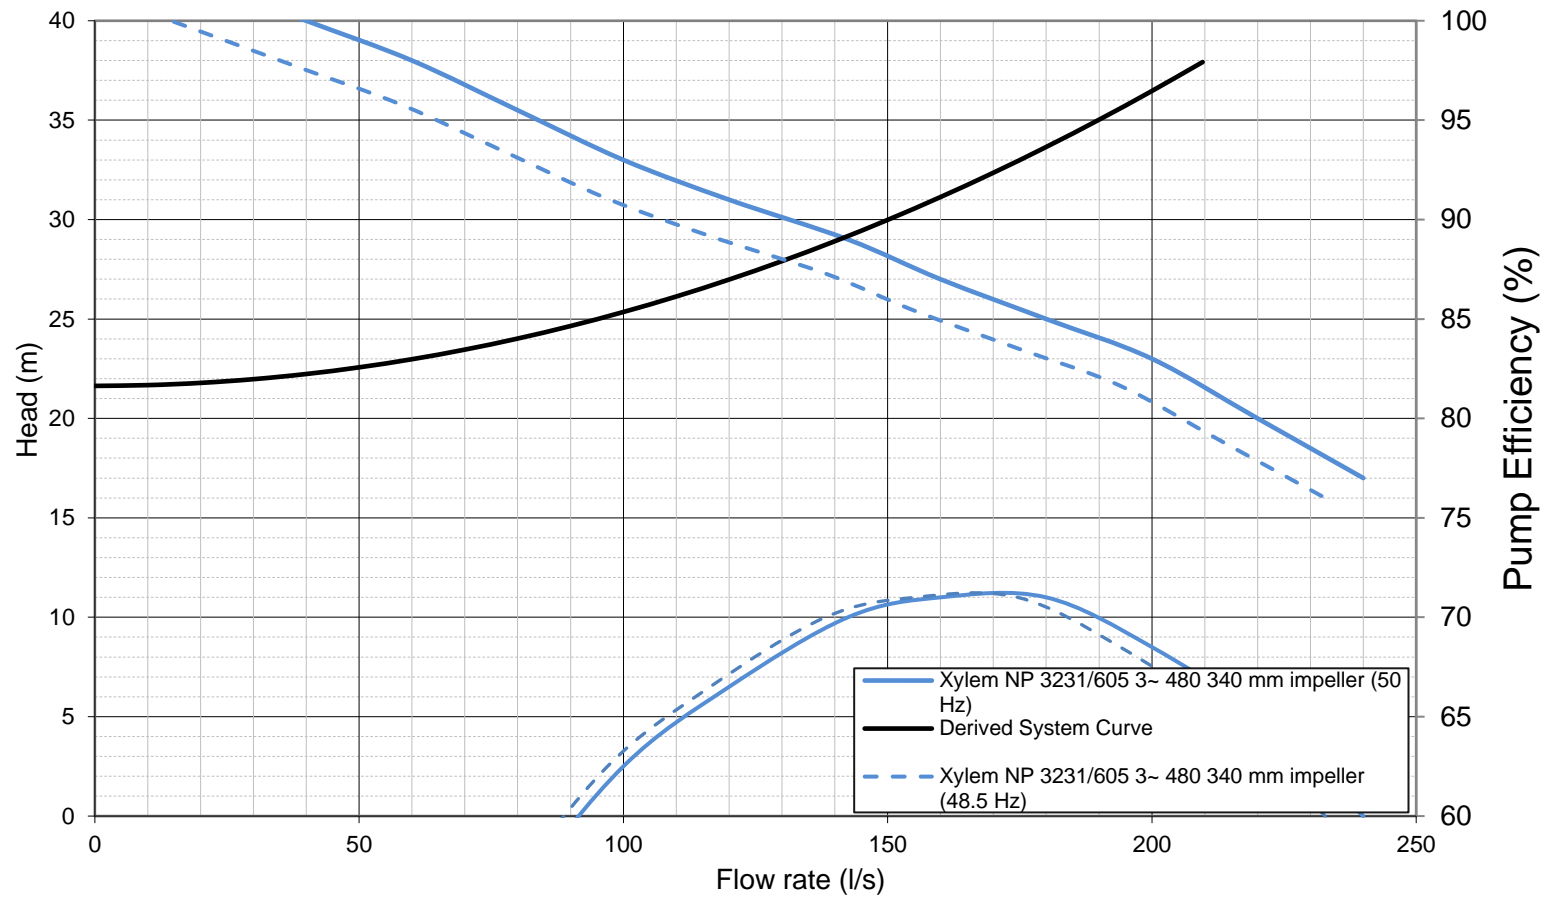
Arcadis investigated potential pumps to replace the existing units based on the required flow rate of 130-140 l/s and the derived system curve, the results of which are indicated in Figure 14 and Figure 15, and Table 4 and Table 5.

Figure 14 – Derived system curve with suggested Xylem replacement pump selection for Tinsley PS showing Full speed operation pump curve (at maximum capacity) and Reduced speed operation pump curve (to achieve minimum target flow rate)

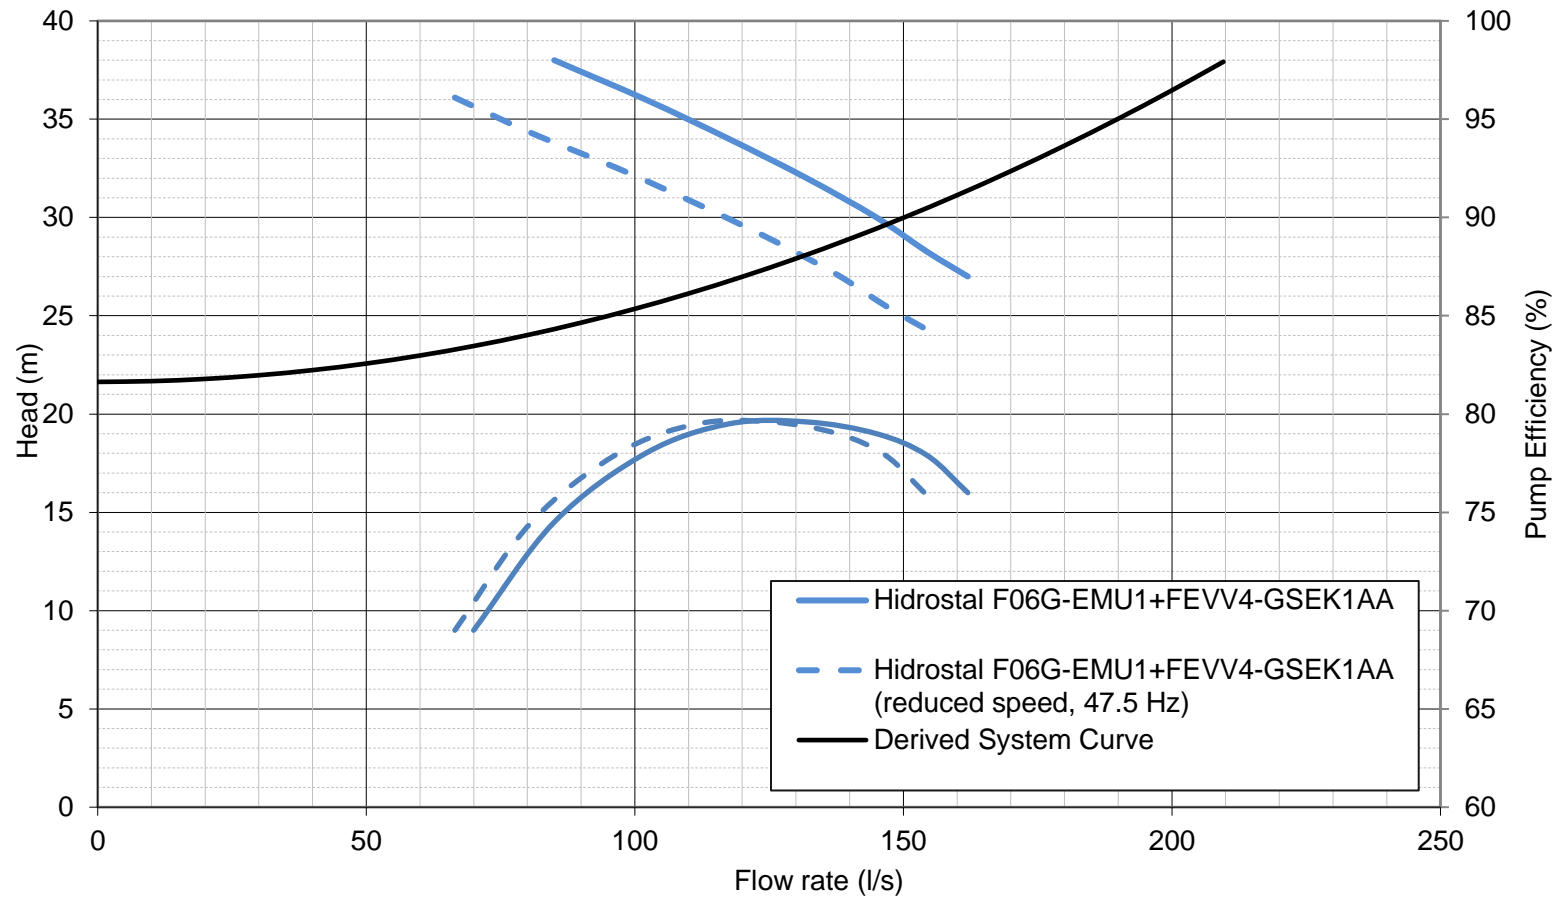
Figure 15 – Derived system curve with suggested Hidrostral replacement pump selection for Tinsley PS showing Full speed operation pump curve (at maximum capacity) and Reduced speed operation pump curve (to achieve minimum target flow rate)

Therefore, the Hidrostal pump units are deemed to be the optimum pump selection for Tinsley PS and are recommended for installation.

1. Purchase Hidrostal F06G-EMU1+FEVV4-GSEK1AA pumps and retrofit into the well, modifying the existing pipework to accommodate as required.
2. Produce "As Built" General Arrangement Drawings following installation, including consideration of point cloud survey.
3. Provide VSDs for optimum pump control.
4. Develop control algorithms/function blocks to monitor performance and automatically run at maximum efficiency / lowest specific energy.
5. Investigate the water losses at the summit pound

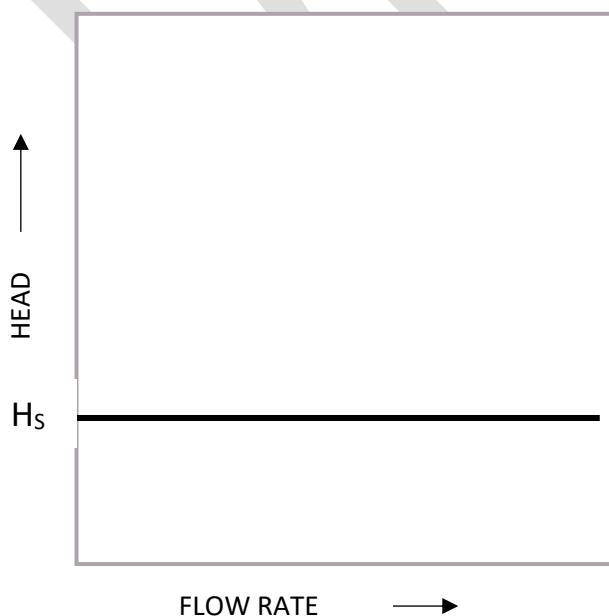
The calculated static head can be represented on a chart with head on the y-axis and flow rate on the x-axis, as follows:

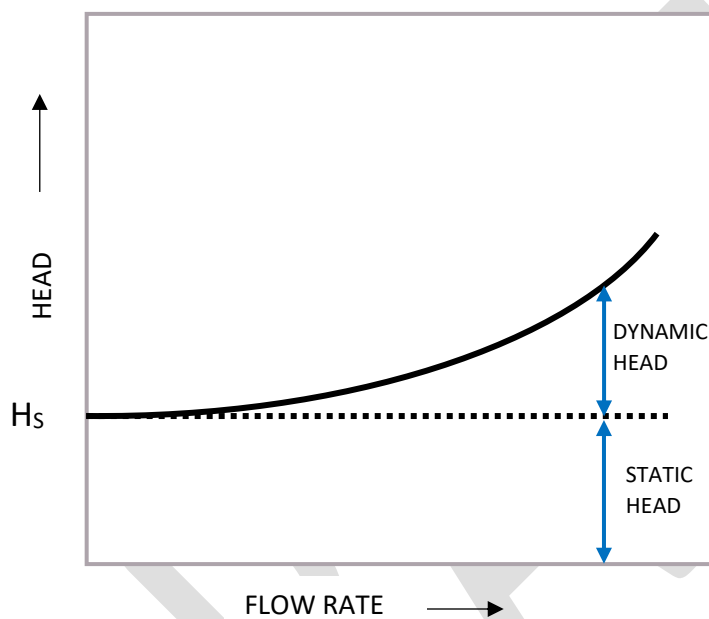
Using established equations and loss coefficients the head unique to the pipe system can be calculated at various flow rates and its curve plotted as shown below. This is known as the “SYSTEM CURVE” or “SYSTEM CHARACTERISTIC”.

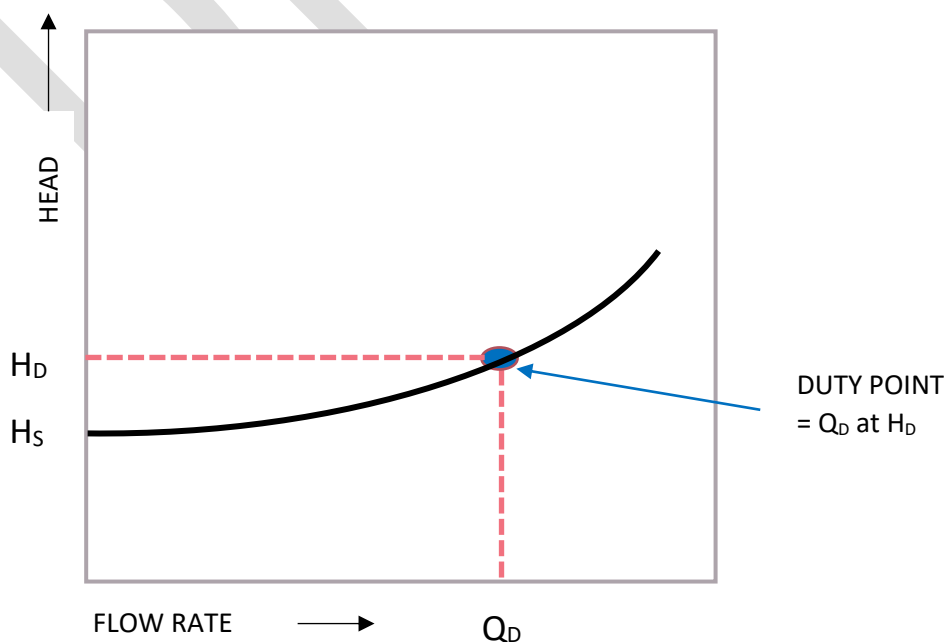
To select a pump for the desired flow rate,  $Q_D$ , the intersection point at  $H_D$ , is translated from the system curve. This is known as the desired “Duty Point”.

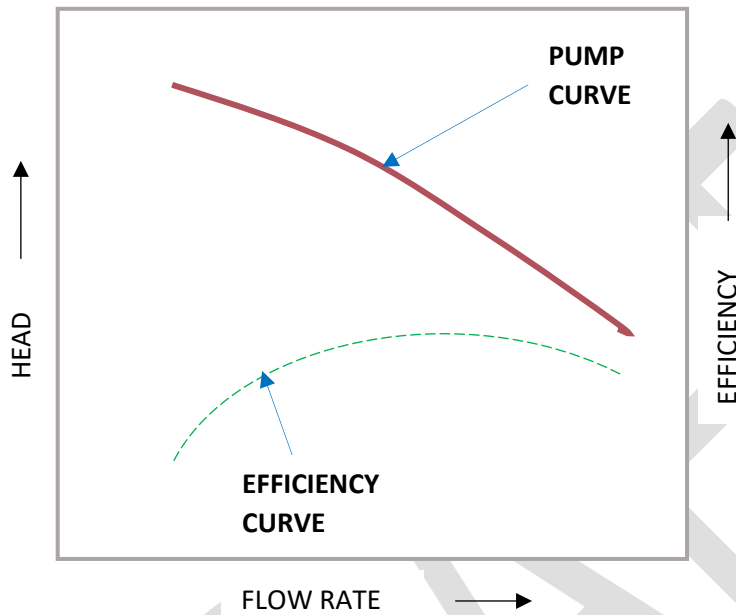
Centrifugal pumps have a flow-head characteristic known as the “PUMP PERFORMANCE CURVE” or “PUMP CURVE”. This shows the flow rate that can be generated by the pump for a given head. The pump curve will typically fall as flow rate increases. The pump efficiency will typically vary with flow rate, initially rising to a peak and then falling away at higher flow rates. These can be represented by curves against flow rate as shown below.

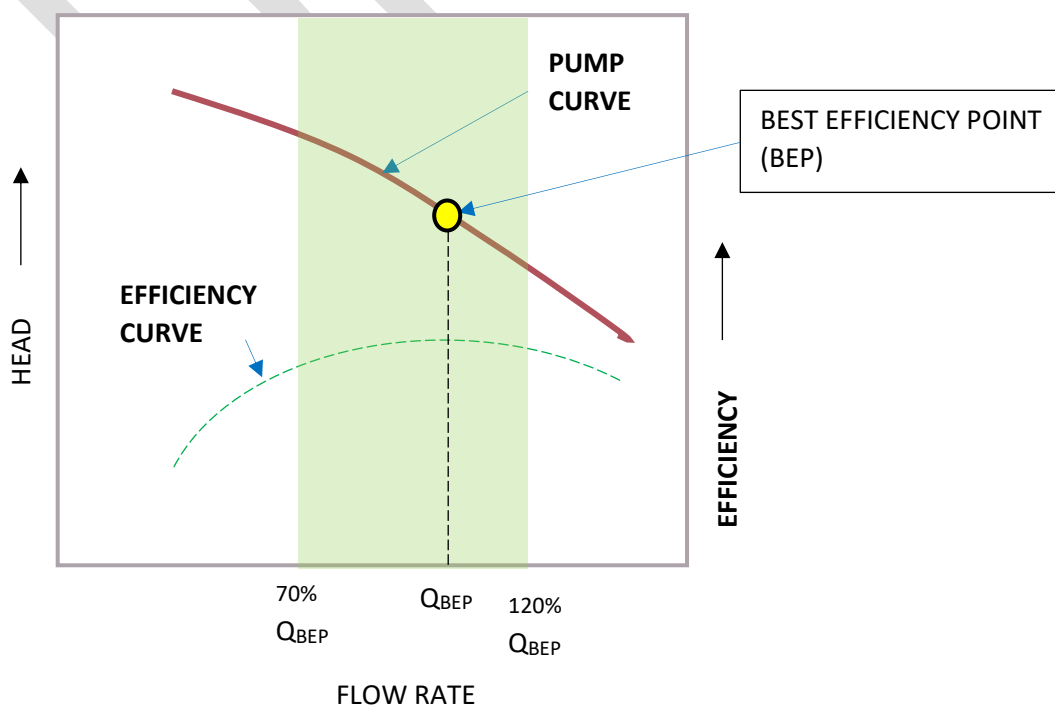
Well selected pumps generally perform at flow rates within  $70\% < Q_{BEP} < 120\%$ , in what is known as the “PREFERRED OPERATING REGION” as highlighted below.

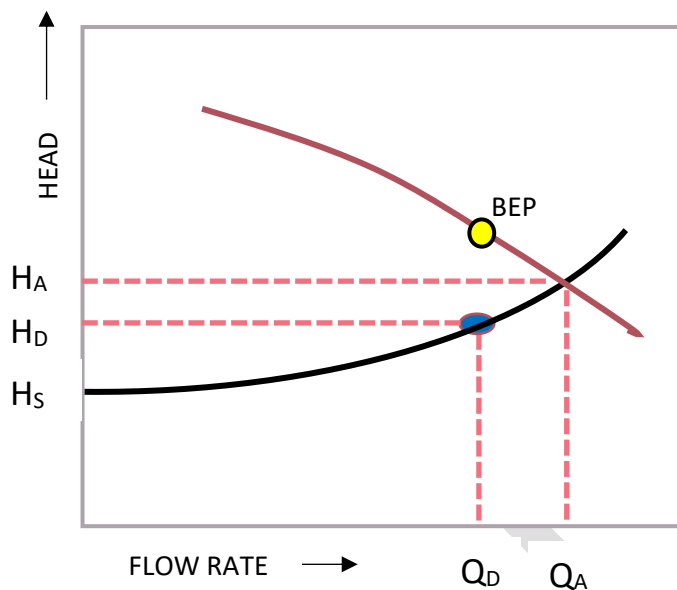
The performance curve for a pump can be overlaid on the system curve. The expected flow rate for a particular pump is indicated where the pump curve intersects the system curve.

In the above example, the pump will pass forward a flow rate,  $Q_A$  at a head of  $H_A$  (Actual Duty Point) which is higher than the desired duty flow rate,  $Q_D$  and higher than (to the right) of its best efficiency flow rate,  $Q_{BEP}$ .

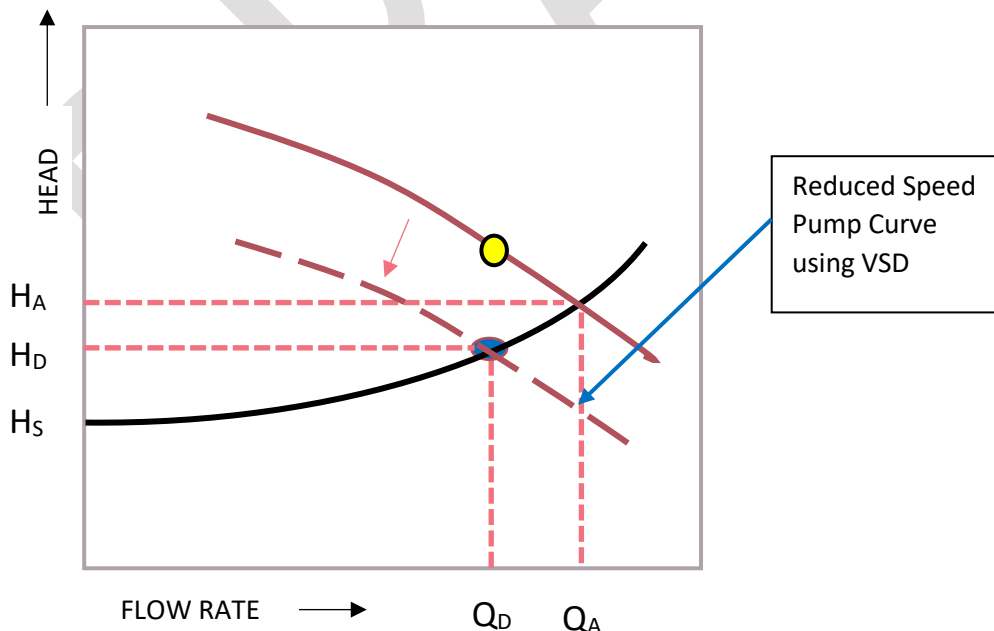
Pump Manufacturers can provide a pump curve reflective of a particular model of pump “as new”. Sites tests can provide an actual pump performance curve through varying pump speed or adjusting valves and measuring flow rate and pressure.

Using variable speed drives it is possible to change the pump speed by changing the frequency of input power to the pump motor. This varies its performance curve meaning that it can meet a desired flow rate. In this example the speed is reduced to meet the desired duty flow rate,  $Q_D$ .

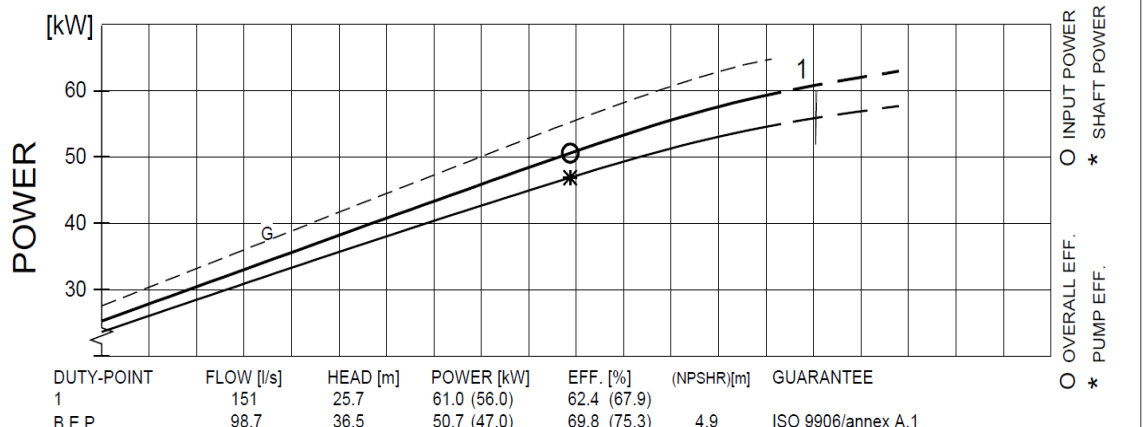
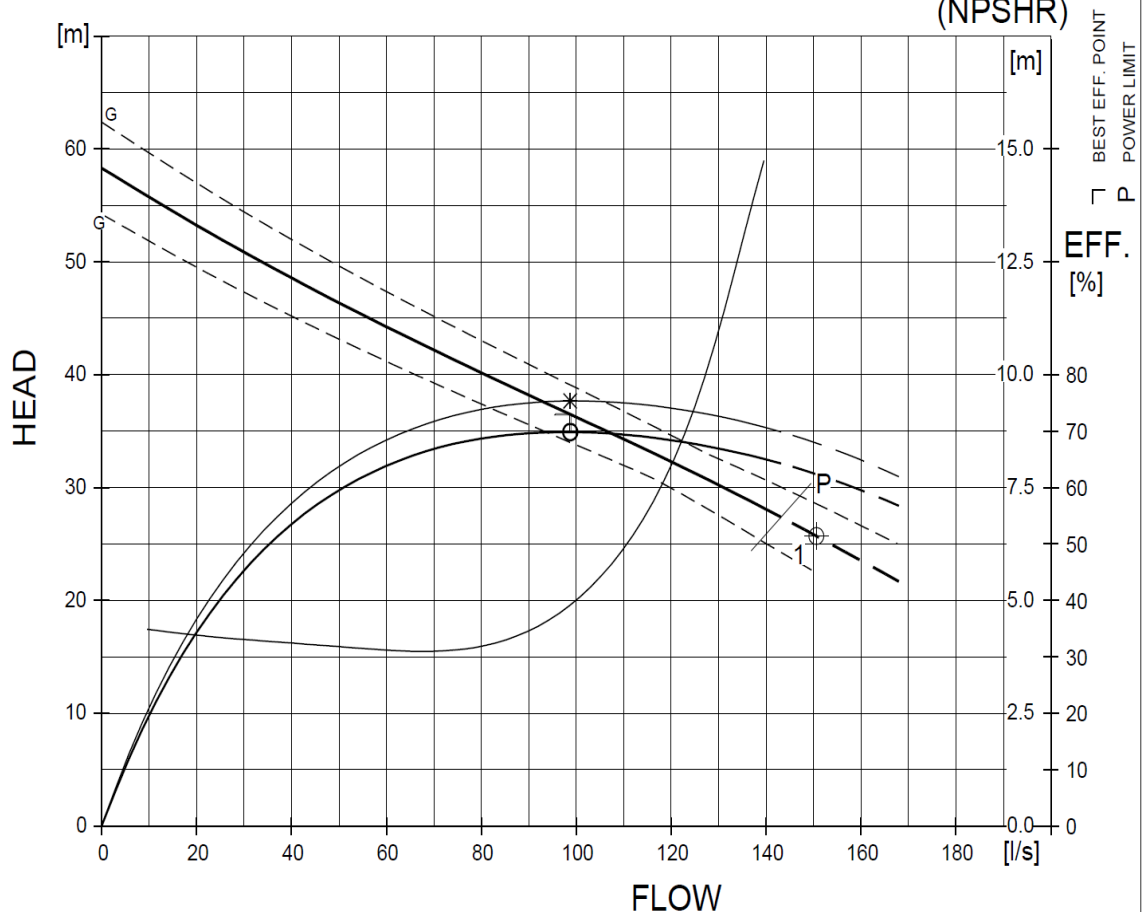
<b>FLYGT</b>		<b>PERFORMANCE CURVE</b>			PRODUCT <b>NP3301.180</b>	TYPE <b>HT</b>
DATE <b>2015-11-17</b>	PROJECT			CURVE NO <b>53-456-00-0150</b>	ISSUE <b>2</b>	
POWER FACTOR	1/1-LOAD 0.84	3/4-LOAD 0.81	1/2-LOAD 0.73	RATED POWER ..... 55 kW	IMPELLER DIAMETER 370 mm	
EFFICIENCY	92.0 %	93.0 %	93.5 %	STARTING CURRENT ... 435 A	MOTOR # 35-25-4AA	STATOR REV 01D
MOTOR DATA	---	---	---	RATED CURRENT ... 103 A	FREQ. 50 Hz	VOLTAGE 400 V
COMMENTS	INLET/OUTLET -150 mm		RATED SPEED ..... 1475 rpm	TOT.MOM.OF INERTIA ... 0.81 kgm2	PHASES 3	POLES 4
	IMP. THROUGHLET ---				GEARTYPE ---	RATIO ---

(NPSHR) = (NPSH3) + margins  
Performance with clear water and ambient temp 40 °C
