## **Drumleague PS**

PUMP AUDT SUMMARY REPORT NICK TAYLOR March 2020

**Report No:** 10031024-00528

**Date:** March 2020

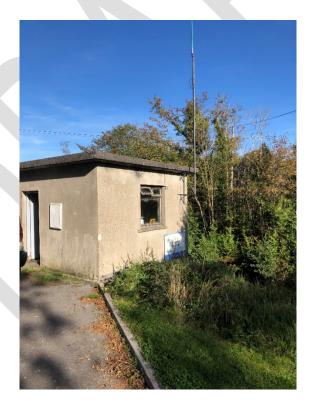
Figure 1- Drumleague Pump Station

Drumleague PS comprises of 1 no. Xylem N3171.181 15 kW, fixed-speed, submersible pump. The pump is situated at the bottom of a circa 3.5 m deep wet well. No record drawings could be

The wet well is reported to have a low-level contact probe, but this could not be confirmed at the time of the audit visit. A stilling tube was found within the outfall chamber but it could not be confirmed whether any instrumentation was present.

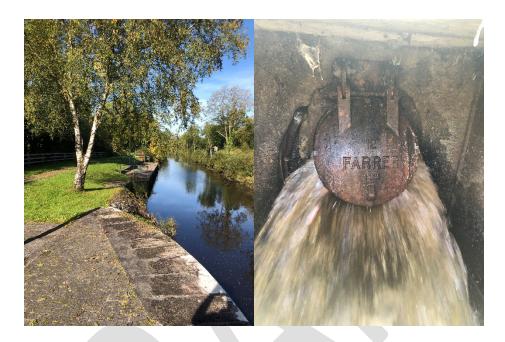
Figure 2 -Drumleague PS Outfall viewed from the Lock (left); Rising Main outfall Farrer 12" flap valve on outlet (right)

The pump discharge pipework is DN250 ductile iron up to the pump house and connects into a 355 mm OD brown PVCu rising main. The rising main discharges via a 12" Farrer flap valve into a concrete outfall chamber upstream of the lower Lough Allen Lock. No other isolation valves or check valves could be validated at the time of audit, but reportedly there are none on the system. There are no reports of bursts on this rising main.

Given the presence of an unknown head loss in the system, it is recommended that the rising main at Drumleague be inspected/surveyed to check for any potential issues, such as blockage, collapse or partially closed valves. It is also recommended that the Ferrer flap valve is inspected to ensure free movement over the full range of opening.
