# Leinster Aqueduct

### PUMP AUDIT SUMMARY REPORT

**Report No:** 10031024-00524

Date: March 2020

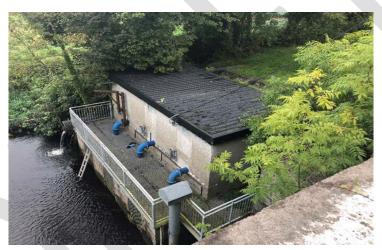
Figure 1- Leinster Pump Station (viewed from Grand Canal)

Leinster Aqueduct PS is situated on the River Liffey, approx. 2 km north east of Donore, Co. Kildare. The pumping station lifts water from the River Liffey into the Grand Canal Lock system to replenish the system during the summer months.

Leinster Aqueduct pump station comprises of 3 no. KSB Amarex KRT K200-401/266 UG-S, fixed-speed, submersible pumps each located within individual pump bays. Each pump bay contains an Endress & Hauser level probe which operate for low level protection. The pumps are protected by a 50 mm bar screen.

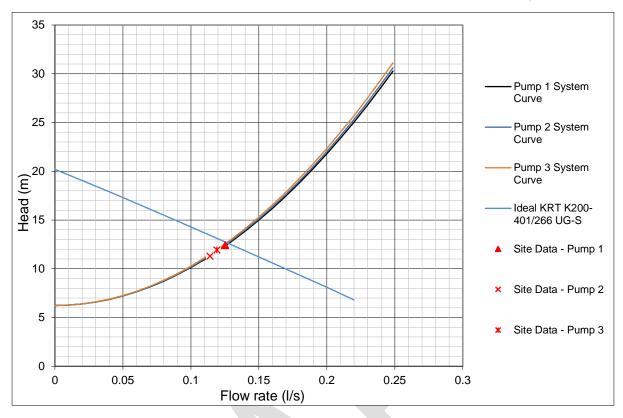
Figure 3 - Derived System Curve - All Pumps

System curves have been derived for the single pump operation as there is no common main within this system.

It should be noted that the 3 no. separate rising mains have marginally different lengths (maximum difference approximated at 2.4 m between Pump 1 main and Pump 3 main) and marginally different flowrates, hence the variation in system curves that can be seen in Figure 3.

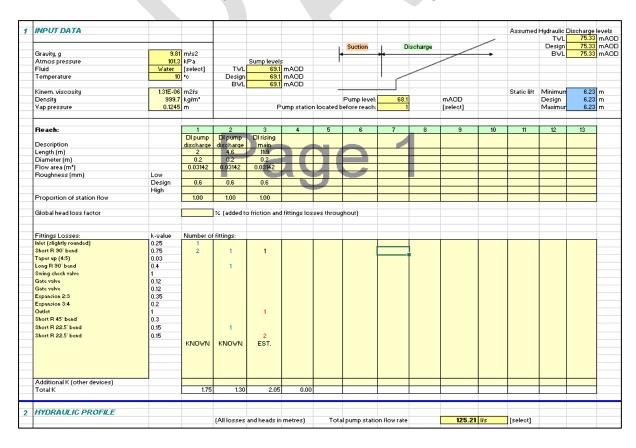
Figure 4 - Hydraulic Calculation Input Data for Pump 1

The suction and delivery elevations, pipe roughness values have been based on the site recorded measurements as there is no SCADA data for Leinster Aqueduct pump station.

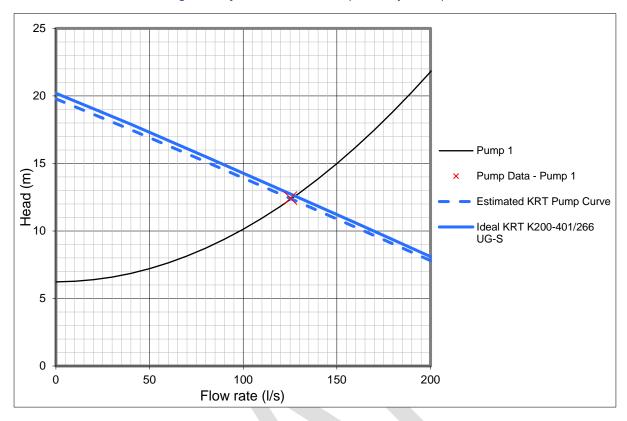
Figure 5 - Derived System Curve - Pump 1

- b) In order to align the site results with the information obtained on the pump curve from KSB, the performance of the pump curves has been lowered from their ideal published performance curves. The dashed line on the individual pump system curve (Figure 5, Figure 7 & Figure 9) represents how an ideal pump is required to be reduced in output using the affinity laws, to indicate wear or smaller impeller trim dia.

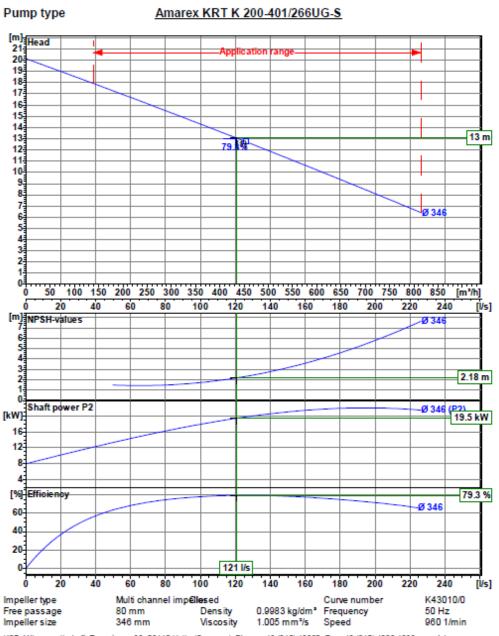
#### Performance curve

### **APPENDIX A KSB AMAREX K200-401/266 PUMP**

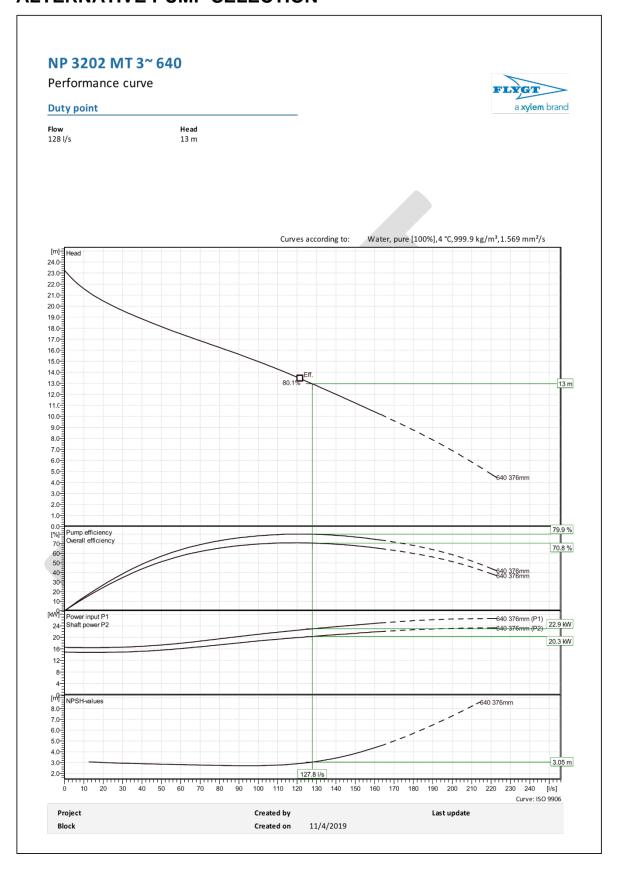
#### **ALTERNATIVE PUMP SELECTION**

On initial findings, KSB Amarex K200 pumps, as installed, are suitably matched for the system. The closest Xylem alternative that could be found was a 22 kW NP3202 with a 376mm impeller and these pumps operate a slightly better as new efficiency than the KSB pumps, although not considered sufficient to warrant pump replacement.
