DIGITAL DECONSTRUCTION (DDC)
Advanced Digital Solutions Supporting Reuse
and High-Quality Recycling of Building Materials

DT 3.1.6
**PREPARATION OF PILOT
SITES FOR DECONSTRUCTION**

HOF TER LAKEN (BELGIUM)
STICHTING KEMPENS LANDSCHAP

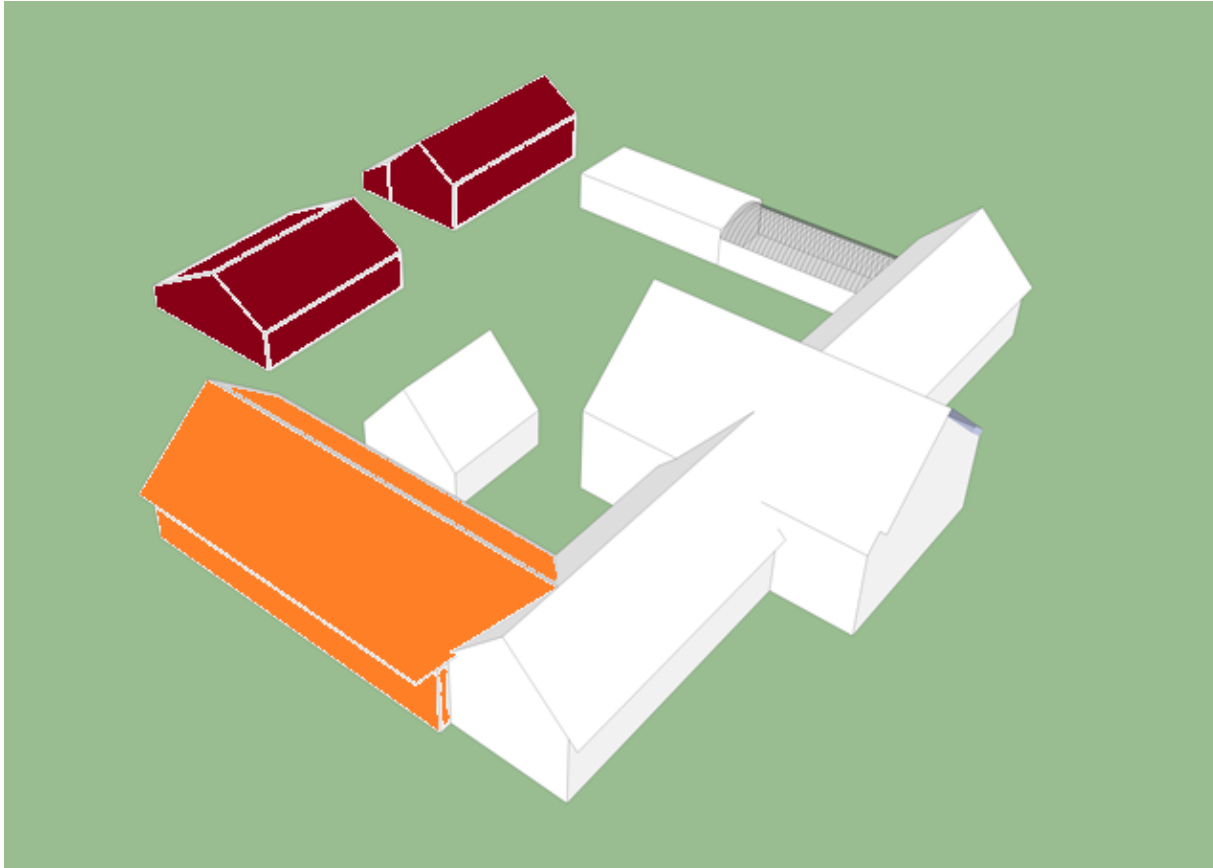
Figure 1: The outbuilding of Hof Ter Laken. Red: the two barns that are deconstructed. Orange: the northern wing of which the interior is deconstructed in DDC

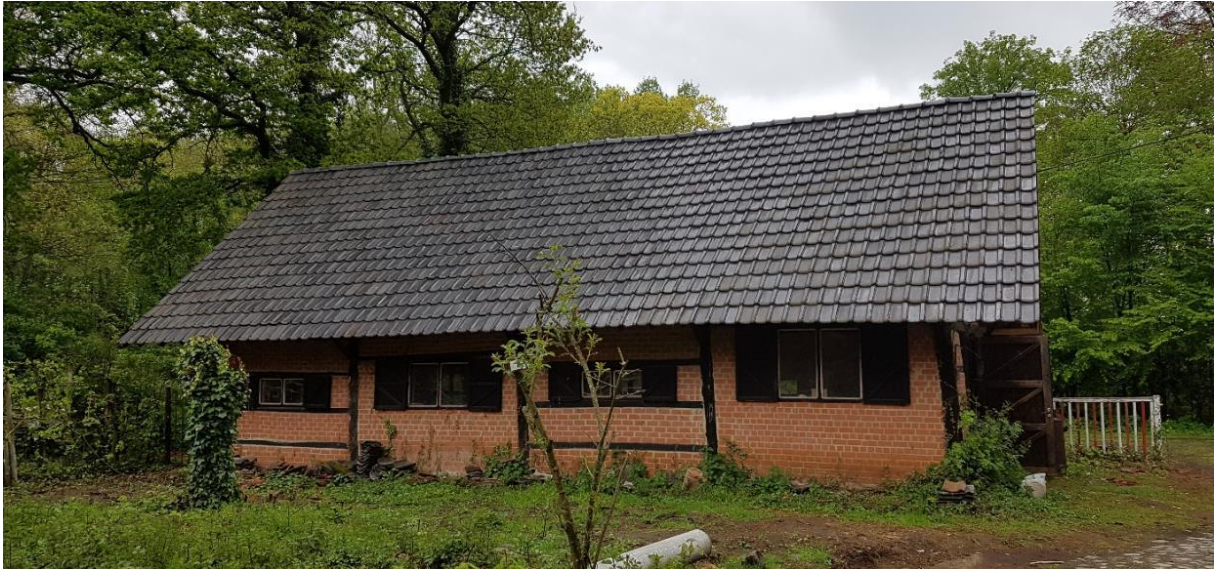
Picture 3: the exterior of the northern barn, situated behind the former stables and residential wings

Then they started with the interior of the northern barn, followed by the exterior. Since there were almost no valuable materials to be recovered here, the execution of this was done fairly quickly and roughly, with larger machines instead of manual operations.

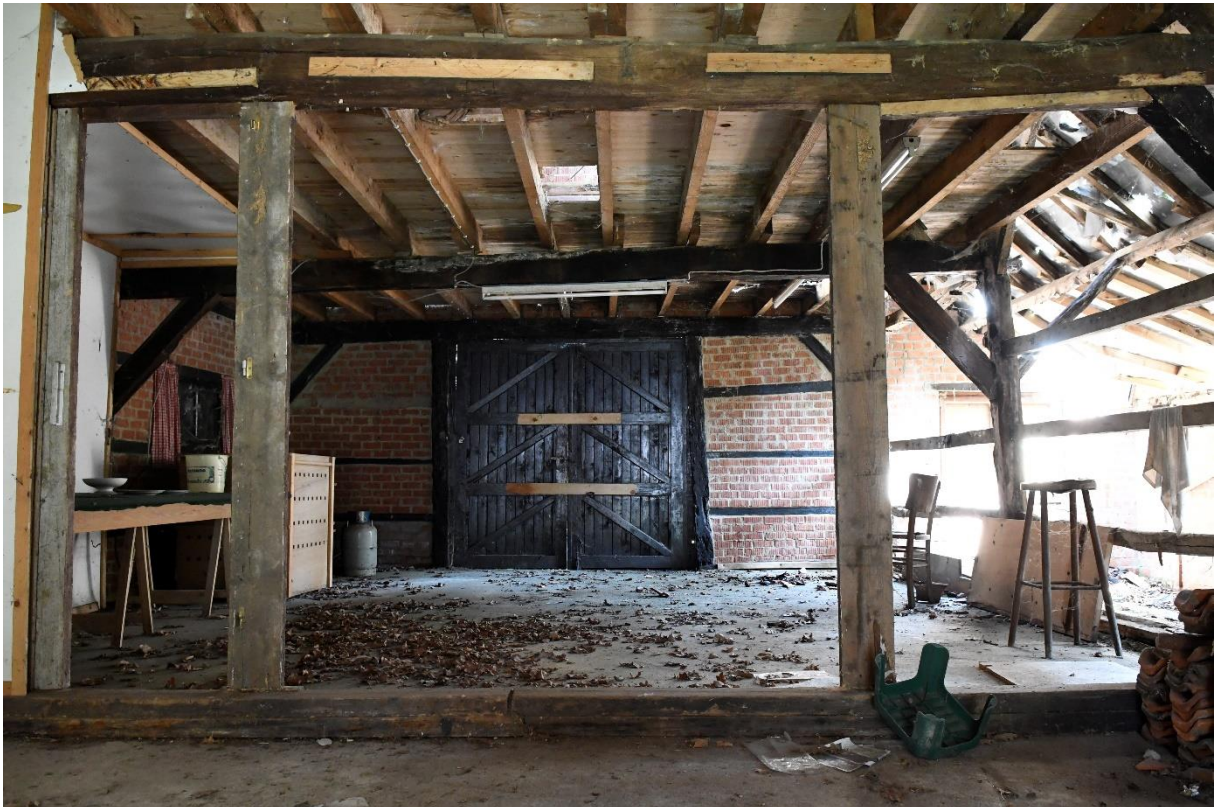
Picture 4: the interior of the northern barn

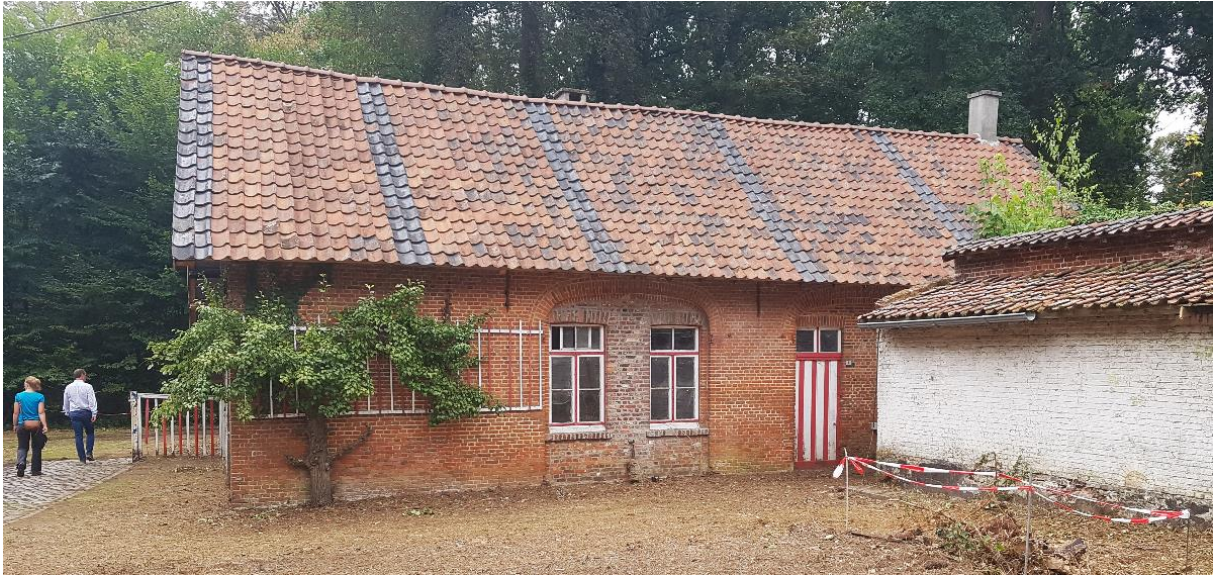
Picture 5: the exterior of the southern barn, next to the northern one

The last building to be deconstructed was the south barn. It contained the most valuable materials, and was therefore carefully dismantled step by step.

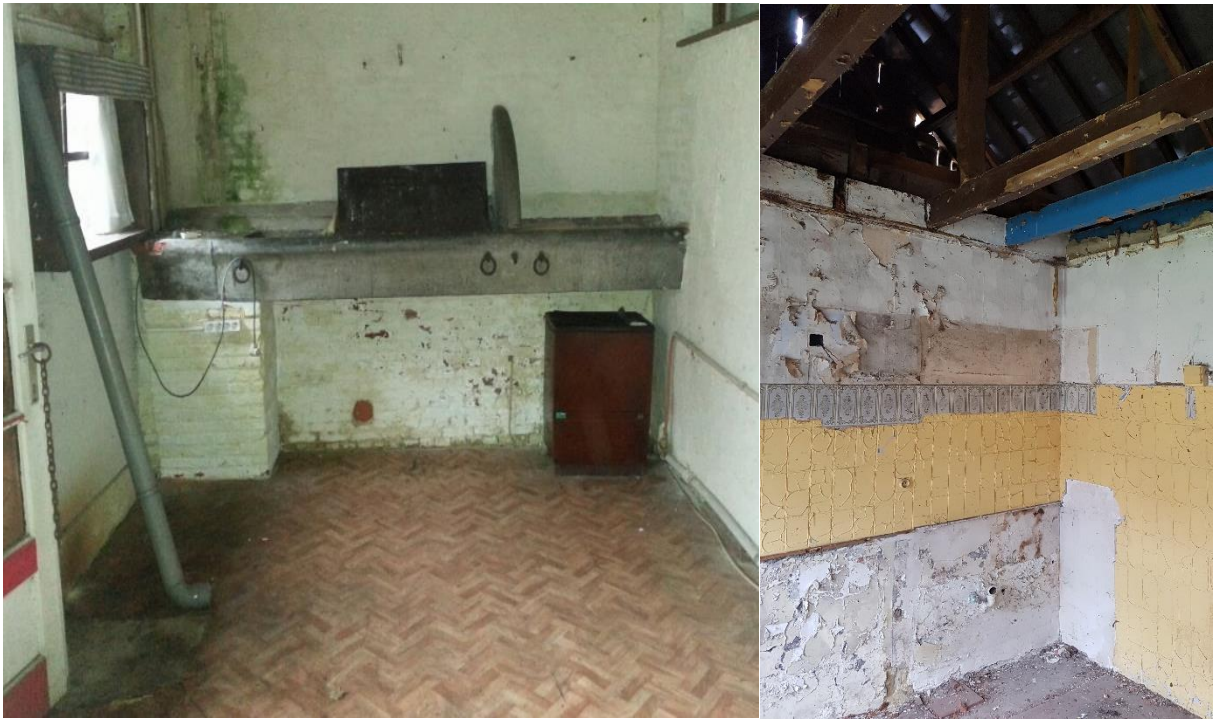
Picture 6: the interior of the southern barn

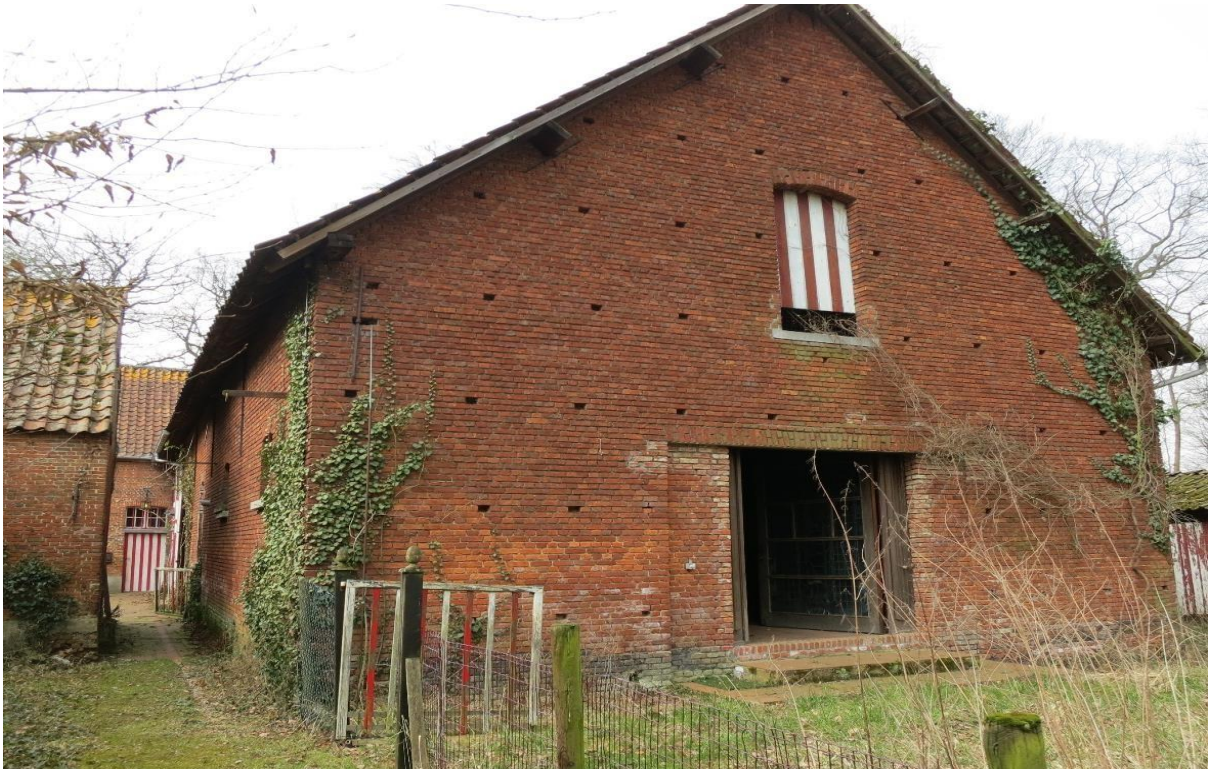
Picture 7: the exterior of northern wing of the outbuildings, of which only the interior has to be deconstructed

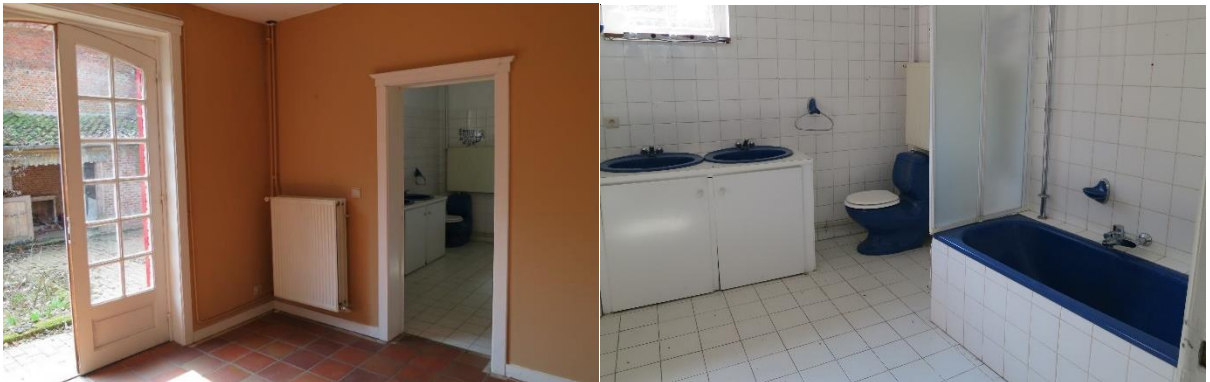
Picture 8: the interior of the northern wing of the outbuildings

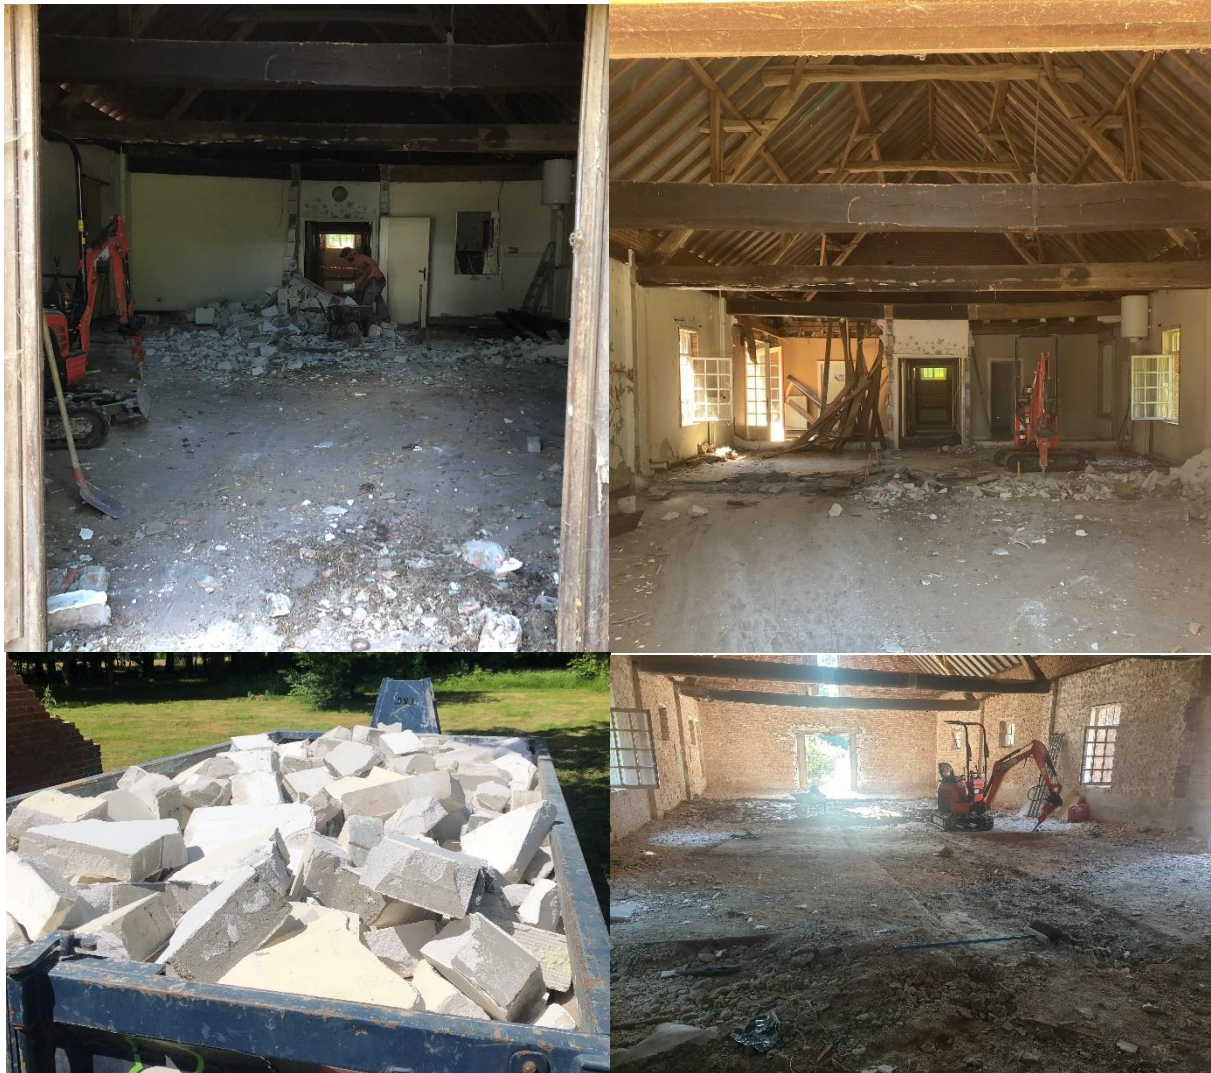
Picture 9: Deconstruction works in the interior of the northern wing

Since the materials to be reused would be stored in the northern wing, of which the interior had to be deconstructed as well, PIT started its work there. The false ceiling was removed, sanitary appliances broken out, heating removed, the walls broken out, and the floor removed.

The materials were sorted by type. Some were removed if this was necessary or if this was determined within the established reuse strategy. Other materials, such as the wooden beams of the false ceiling, were carefully removed, cleaned and preserved.

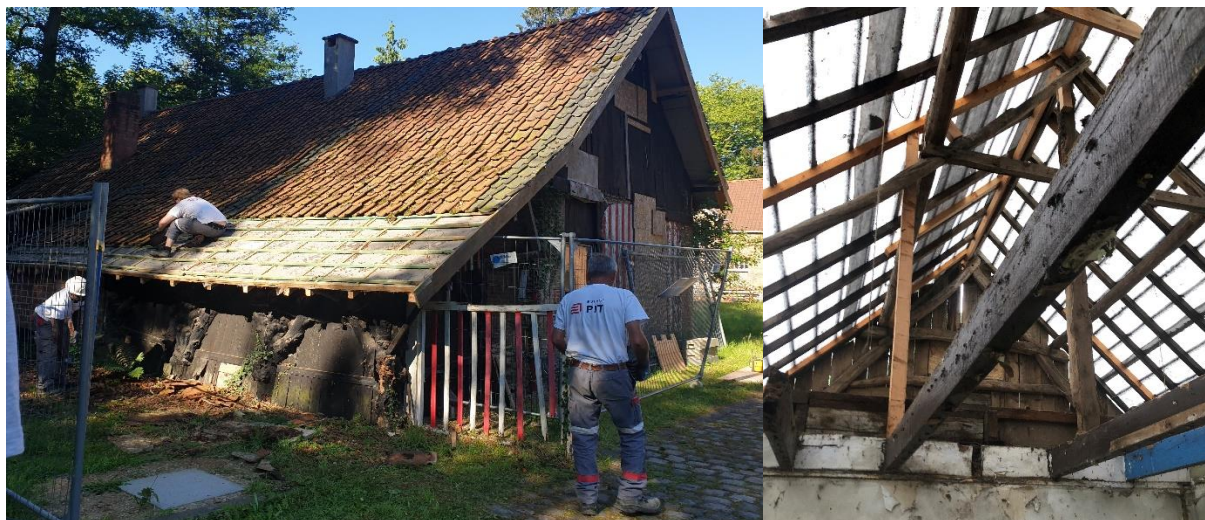
Picture 10: Dismantling of the roofs

After the works had been carried out in the north wing, the deconstruction of the barns was started. PIT started with the dismantling of the roofs, of which the roof tiles and wooden beams were recovered.

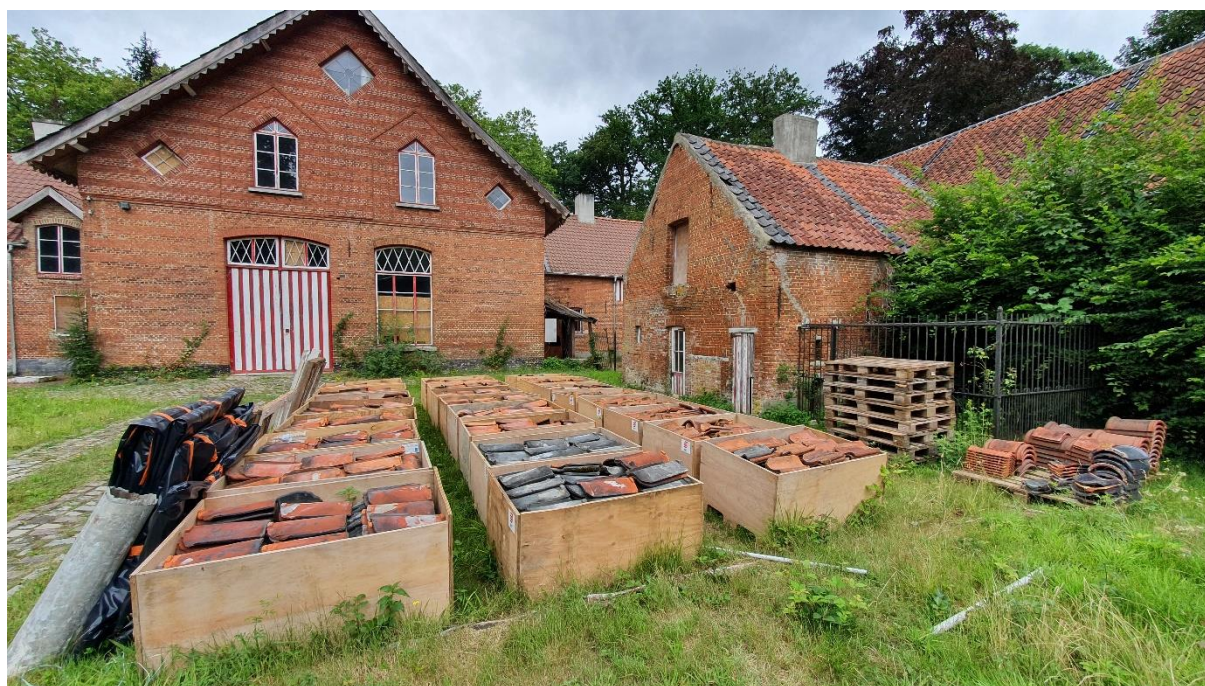
Picture 11: Storage of the roof tiles

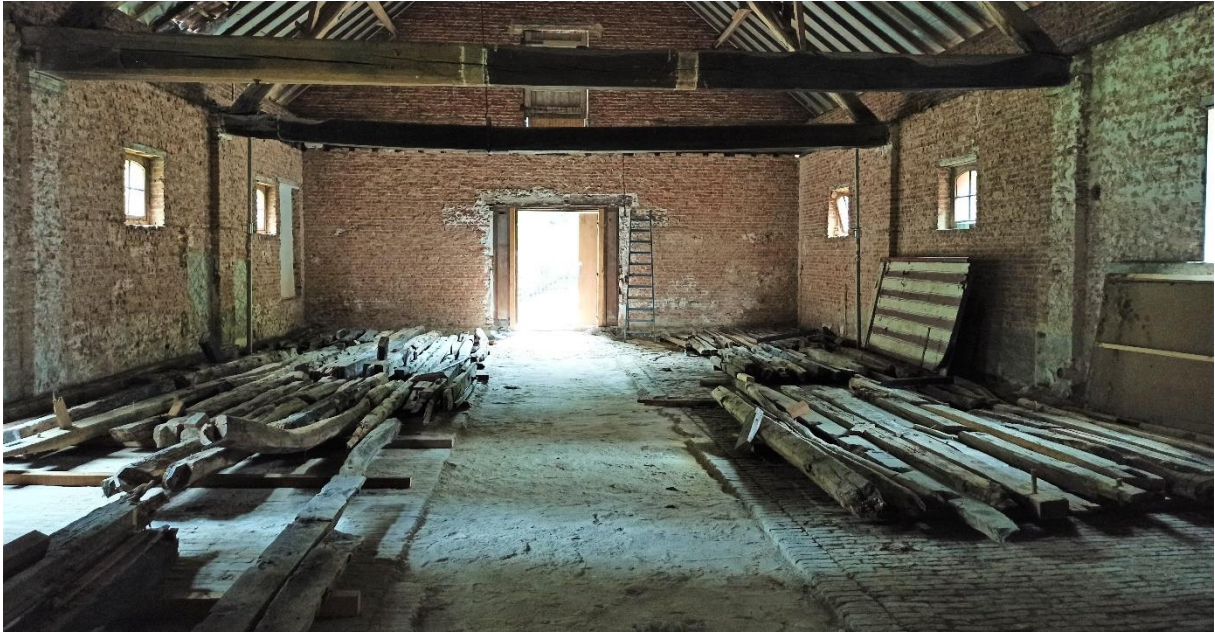
Picture 12: Storage of the wooden beams

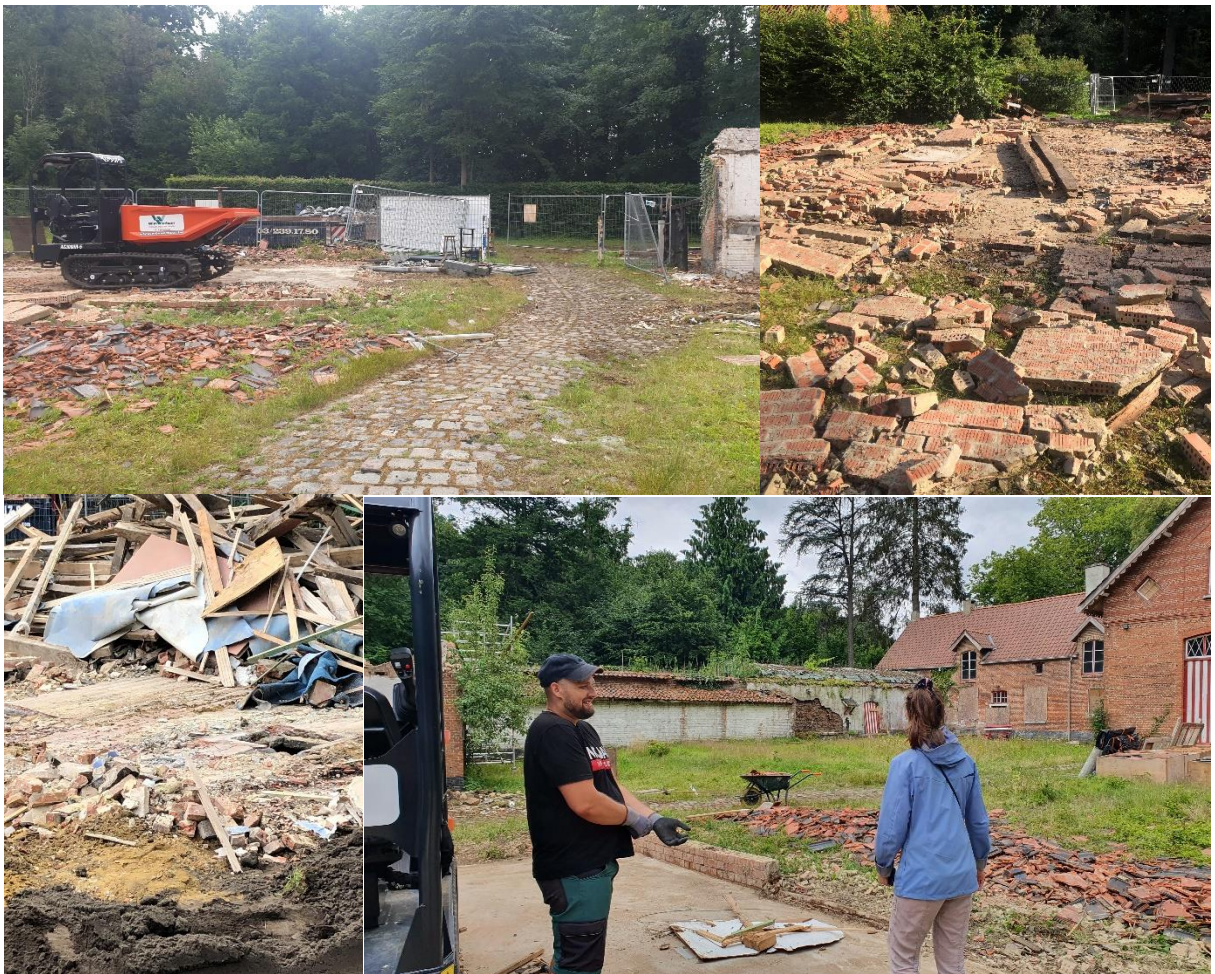
Picture 13: Demolishing of the northern barn

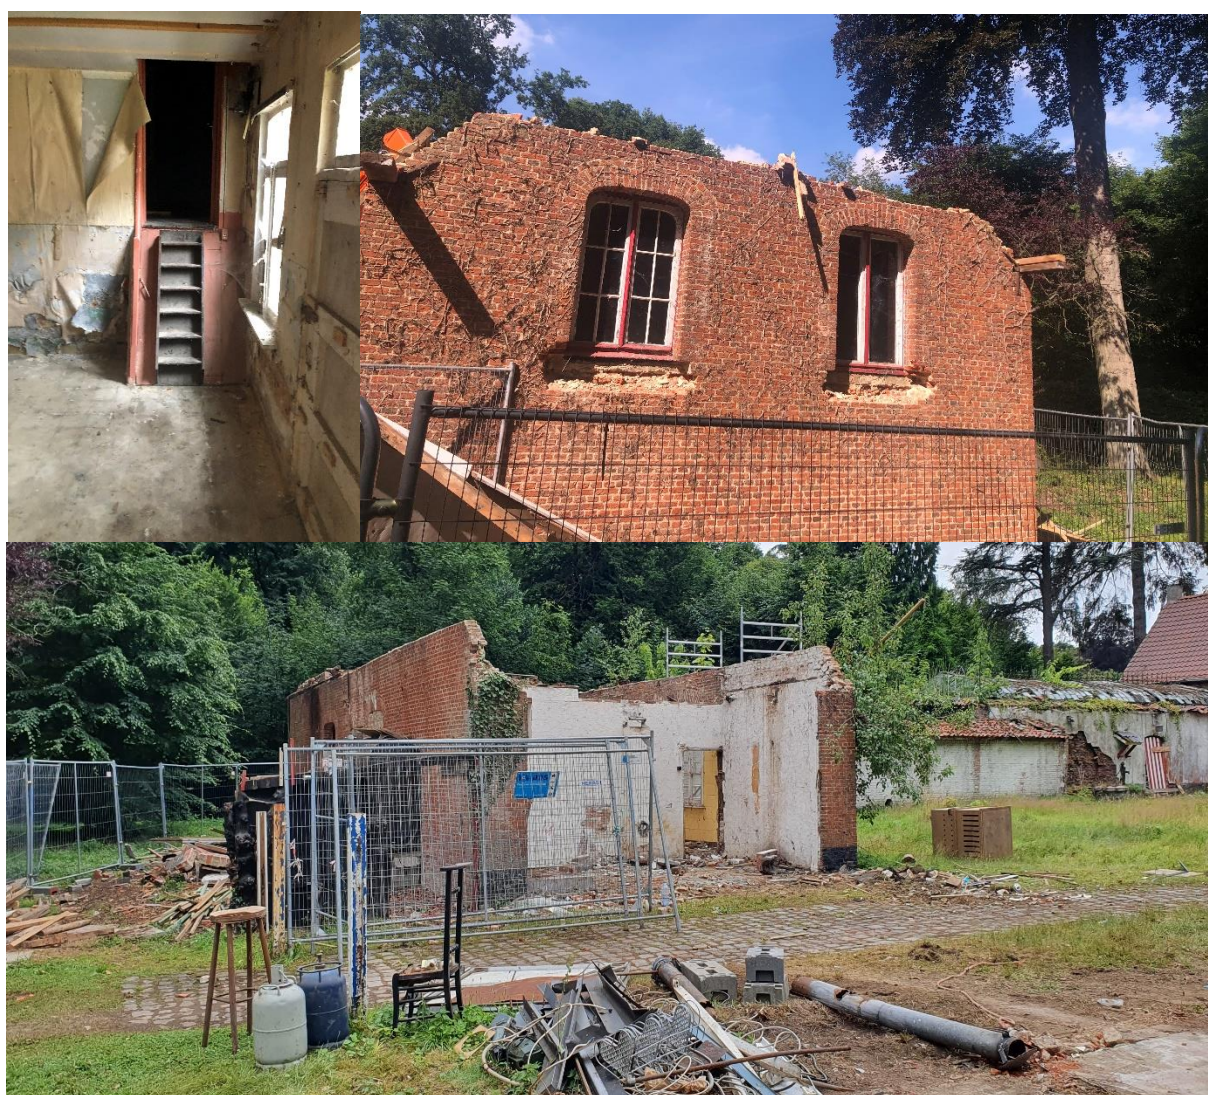
Picture 15: Ongoing deconstruction works of the southern, most valuable barn

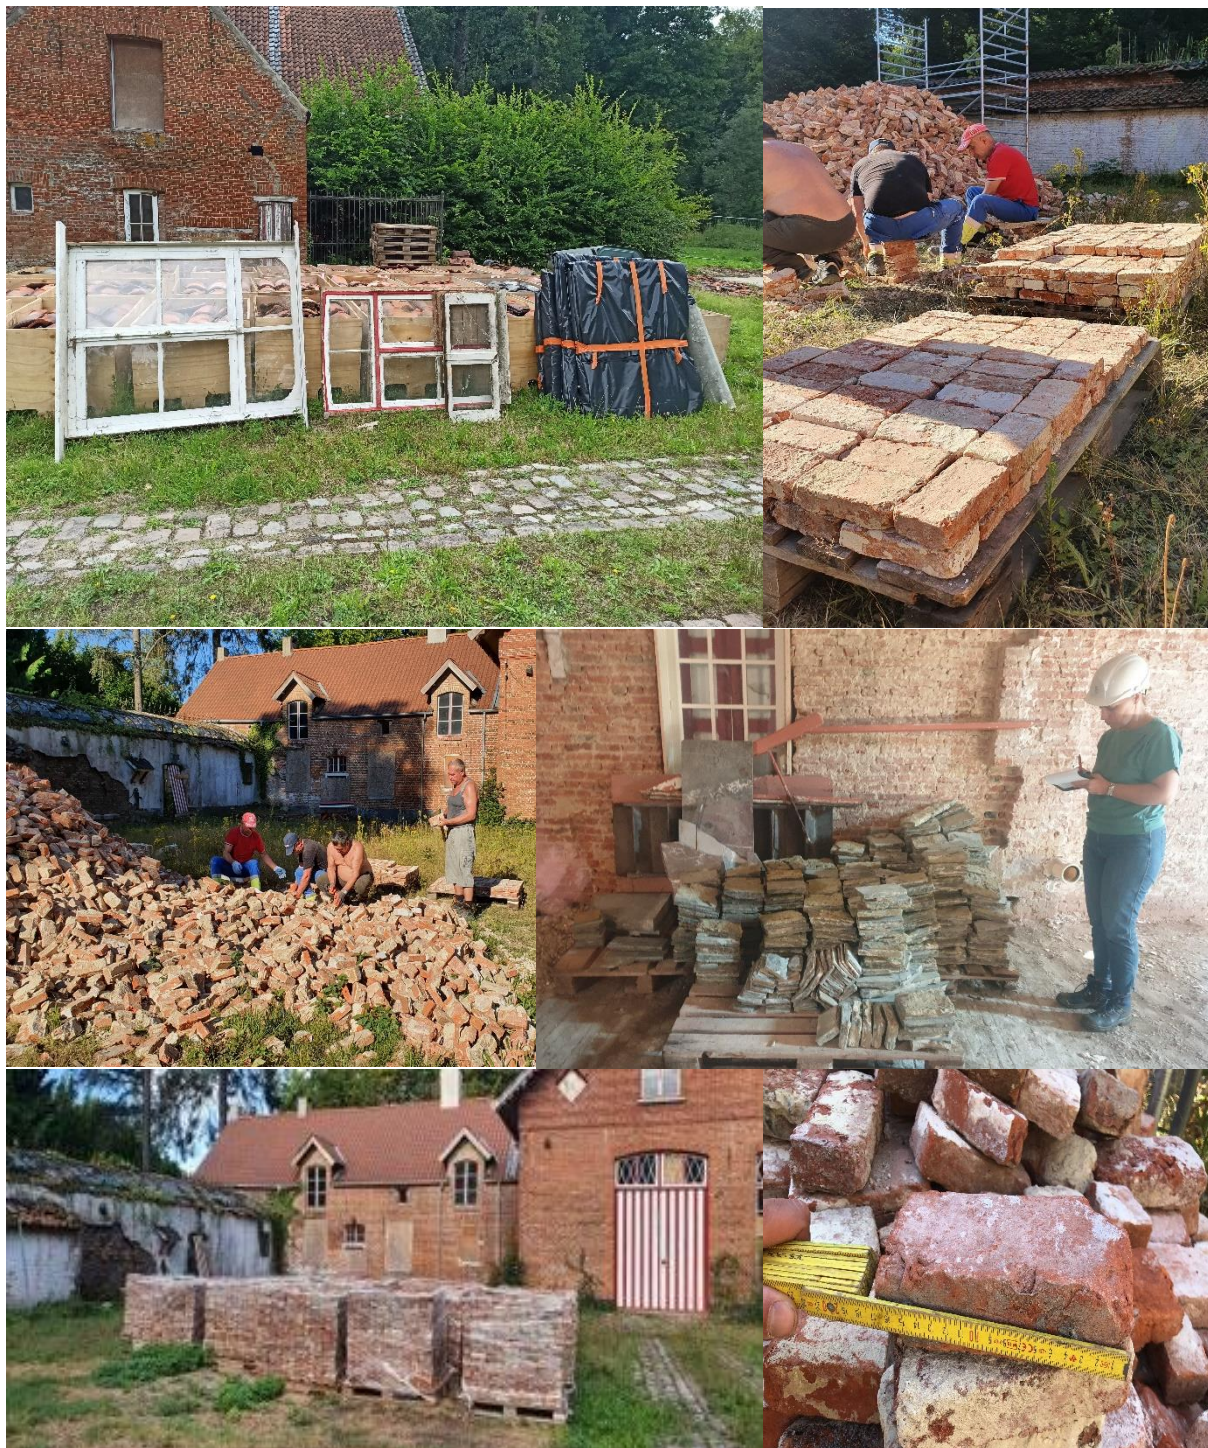
Picture 16: Cleaning, measuring and storing of the materials to be reused

All materials were sorted. The non-valuable (e.g. metal pipes) were removed, the valuable materials, such as the bricks in the walls, old floor tiles or reusable windows, were carefully cleaned, counted, measured if necessary and safely stored on site.

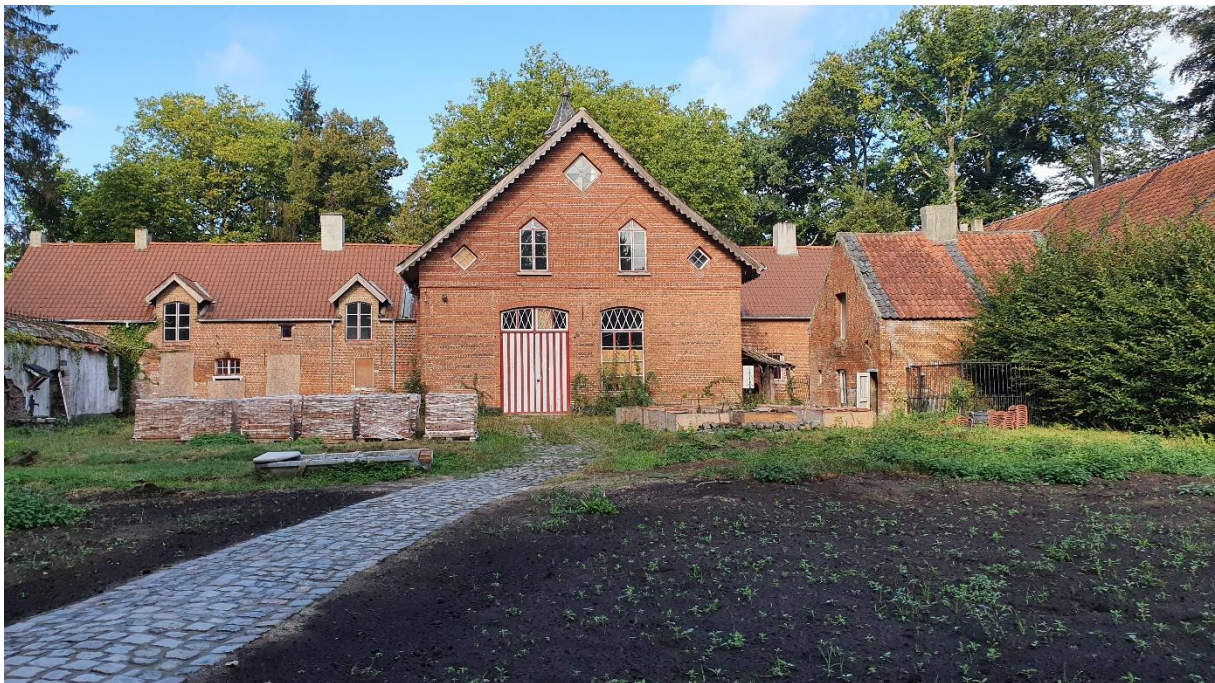
Picture 17: Result of the deconstruction works

Instead of using large machines, roof tiles were removed one by one, wooden roof trusses were dismantled beam by beam and the valuable brick walls were carefully demolished. In this way, the historical and/or economic valuable materials were preserved as much as possible. Contractor PIT Eiffage from Kapellen was hired to carry this out. They emerged as the best bidder from the tender that ran in March-April and were able to start work from June. These progressed well, so that all demolition work has already been done today and the reusable materials are now neatly stacked in the north wing and outside on the site. These will come in handy during the restoration work on the buildings in the coming years.

It can be estimated that 55% of the released materials will be reused on site and 44% will be recycled elsewhere.
