## Test the reuse of equipment and structural elements via the creation of a reuse batch

## Refurbishment of the Grande Halle de Colombelles

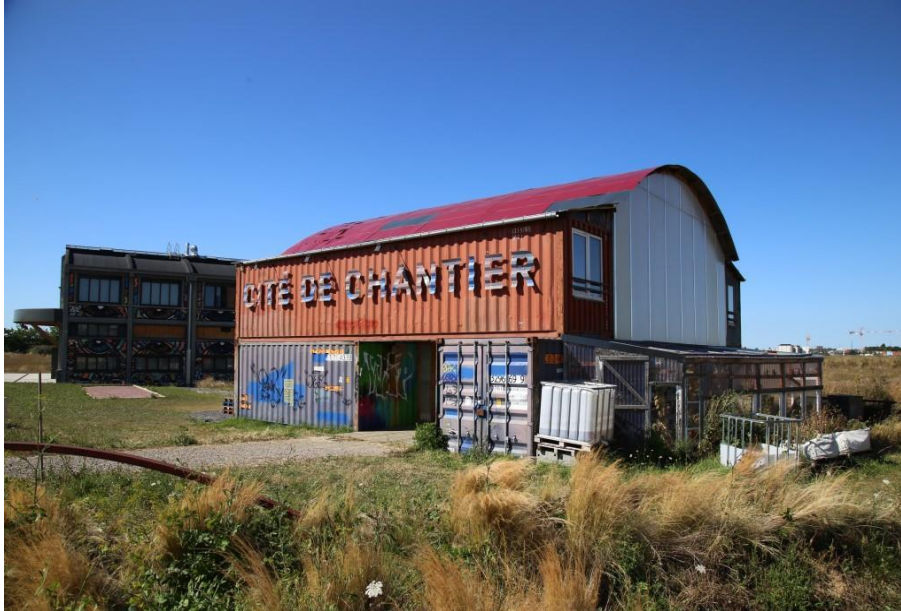
La Cité de chantier, the place where the architects explain reuse methods to the construction companies that were discovering this practice.

**The architect** initiated the creation of the reuse batch. He guided the companies by organising a « permanent architectural space". This space aims to explain the specificities of reuse to the companies, show them which materials would be reused and guide them to see how their usual practices would be modified. Finally, they had to exhibit great flexibility in revising their project and adapting it to the reclaimed building elements that were located and validated

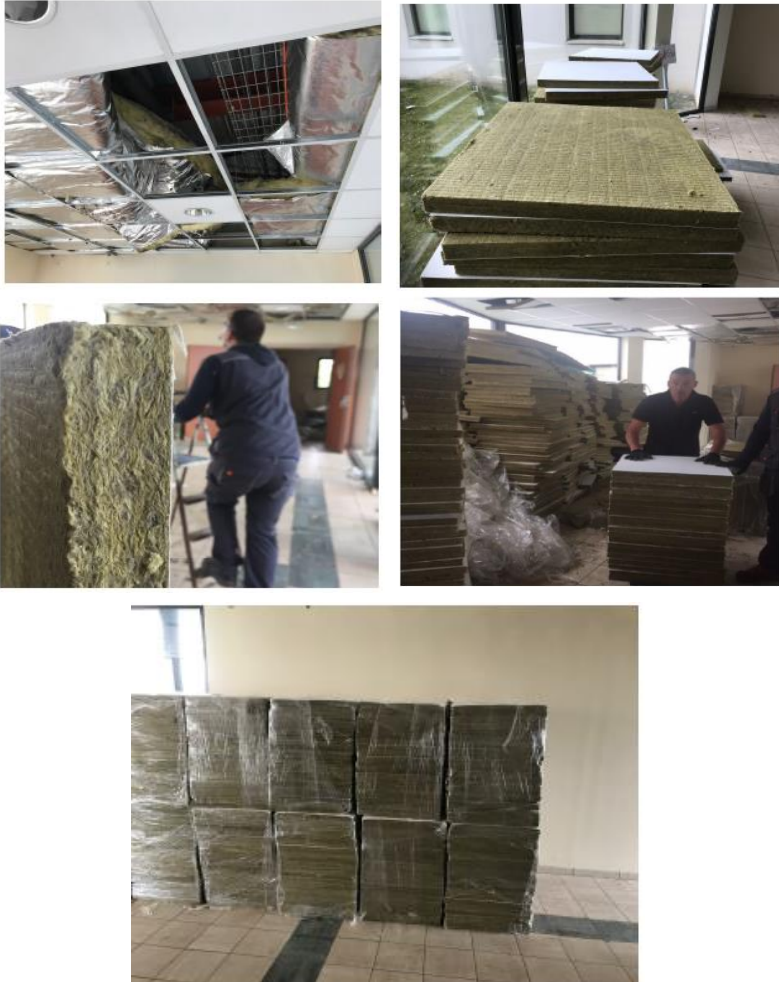
- The insulation materials originated from two recently constructed buildings that were going to be deconstructed following a problem of swelling pollutants that had weakened the structure.

- A material sheet characterising the reclaimed product was developed in order to ensure its traceability. It presents information related to its location in the original building, the quantity available on the site, the percentage reclaimed, its quality, the date of dismantling.

- After removal, the design office and the building technical controller gave a favourable opinion on the quality of the products
- Laboratory tests were conducted by ESITC (Ecole Supérieure d'Ingénieurs des Travaux de la Construction of Caen) using samples in order to demonstrate that neither the use of the insulation materials nor the selective dismantling had altered the qualities of the product. The aging tests covered the following values:

- 1) Sound absorption
  - 2) Thermal conductivity
  - 3) Resistance to humidity (sorption/desorption)
  - 4) Density and sizing.
- These elements satisfied the insurer who considered that the performance of the insulation materials was proved.

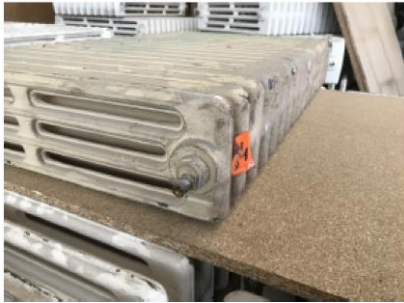
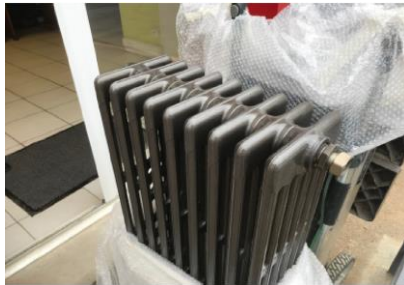
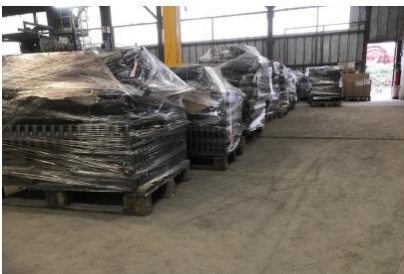
- The plumbing company cut out water circulations for two office buildings that were going to be deconstructed.
- The SSE (Social and Solidarity Economy company) did the removing, conditioned the radiators on pallets to transport them to the site of a local company specialised in reconditioning radiators.

- The reconditioning of the radiators followed a process in several steps: stripping by water-blasting, blowing the dust with high-pressure compressed air, application of a rustproofing primer coat, application of two finishing coats of paint, drying in the oven. To be protected during the transport to la Grande Halle and during storage, each radiator was wrapped.

- On the site of la Grande Halle, le WIP provided capping kit and the fastening brackets of the radiators.
- The construction company selected for the "Plumbing, biomass heating, ventilation" batch provided the thermostatic valves. It was also in charge of installing the radiators.

- As for the insulation materials, a material sheet of the product specifying the origin of the material, the dismantling and reconditioning procedures, was developed in order to prove to the insurers that the reconditioned material was still performant.
