Secure same-site reuse via a methodology for evaluating technical performance

Refurbishment of a CSTB office building

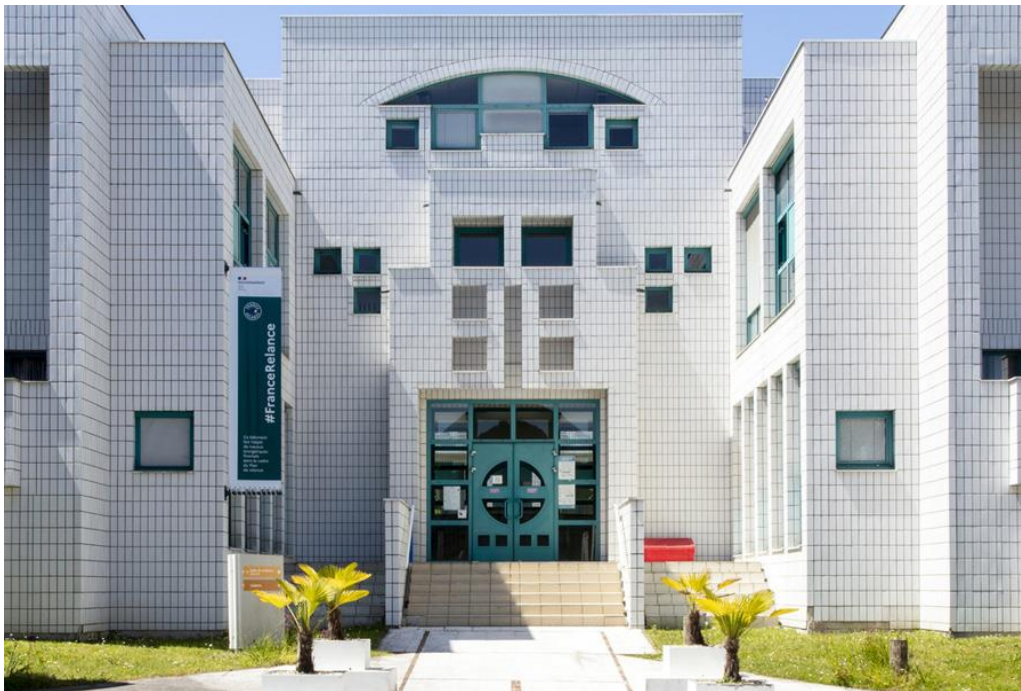
The project: the purpose of the project is the refurbishment, densification and extension of B38 building on CSTB's site in Champs-sur-Marne. As the building's thermal performance observed during its operation was mediocre, the main objective of this renovation is to improve its performance and to comply with the regulation. As the project benefits from the French government's Recovery Plan, the building is scheduled for completion by the end of 2023. The execution schedule was not tight but the repair phases were.

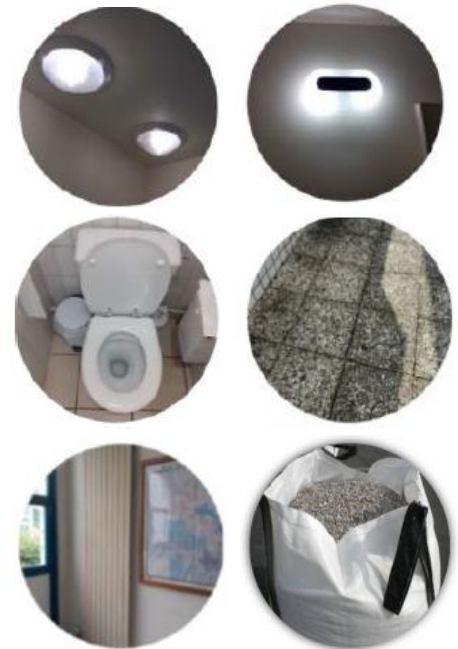
Source	Units removed	Packaging
Circular lights	20 units	Protection with a cardboard box
Lights	30 units	Protection with a cardboard box
Toilet	9 units	On pallets
Fine-gravel tiles	200 m ²	On pallets
Metal radiators	44 units	On pallets
Terrace roofing gravel	1100 m ²	In big bags

Extract of the final inventory forwarded by the site cleaning company "Re-use listing for Building B38 – 27/04/2022"

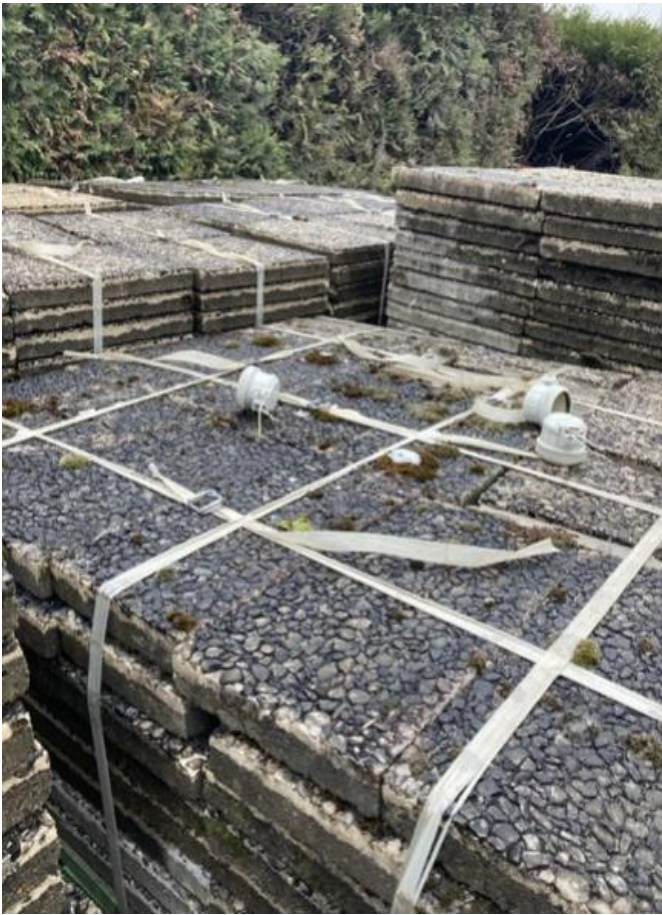
The sources identified for same-site reuse were stored in specific conditions: big bags for roofing gravel, filmed pallets for toilet bowls and strapped fine-gravel tiles, cardboard boxes for lights.

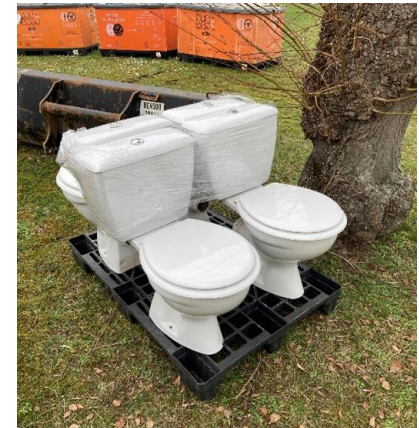
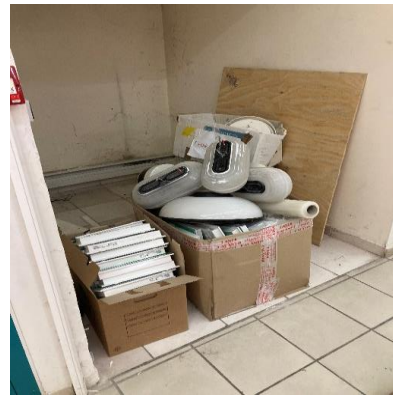
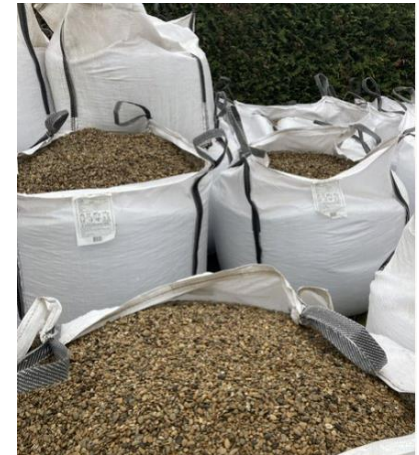
Examples of dismantled and reconditioned sources
Source: CSTB photographs
