Restoration of a conifer plantation to  
lowland raised bog at Cors-y-Sarnau

## REPORT

Richard Cutts, North Wales Wildlife Trust

October 2023

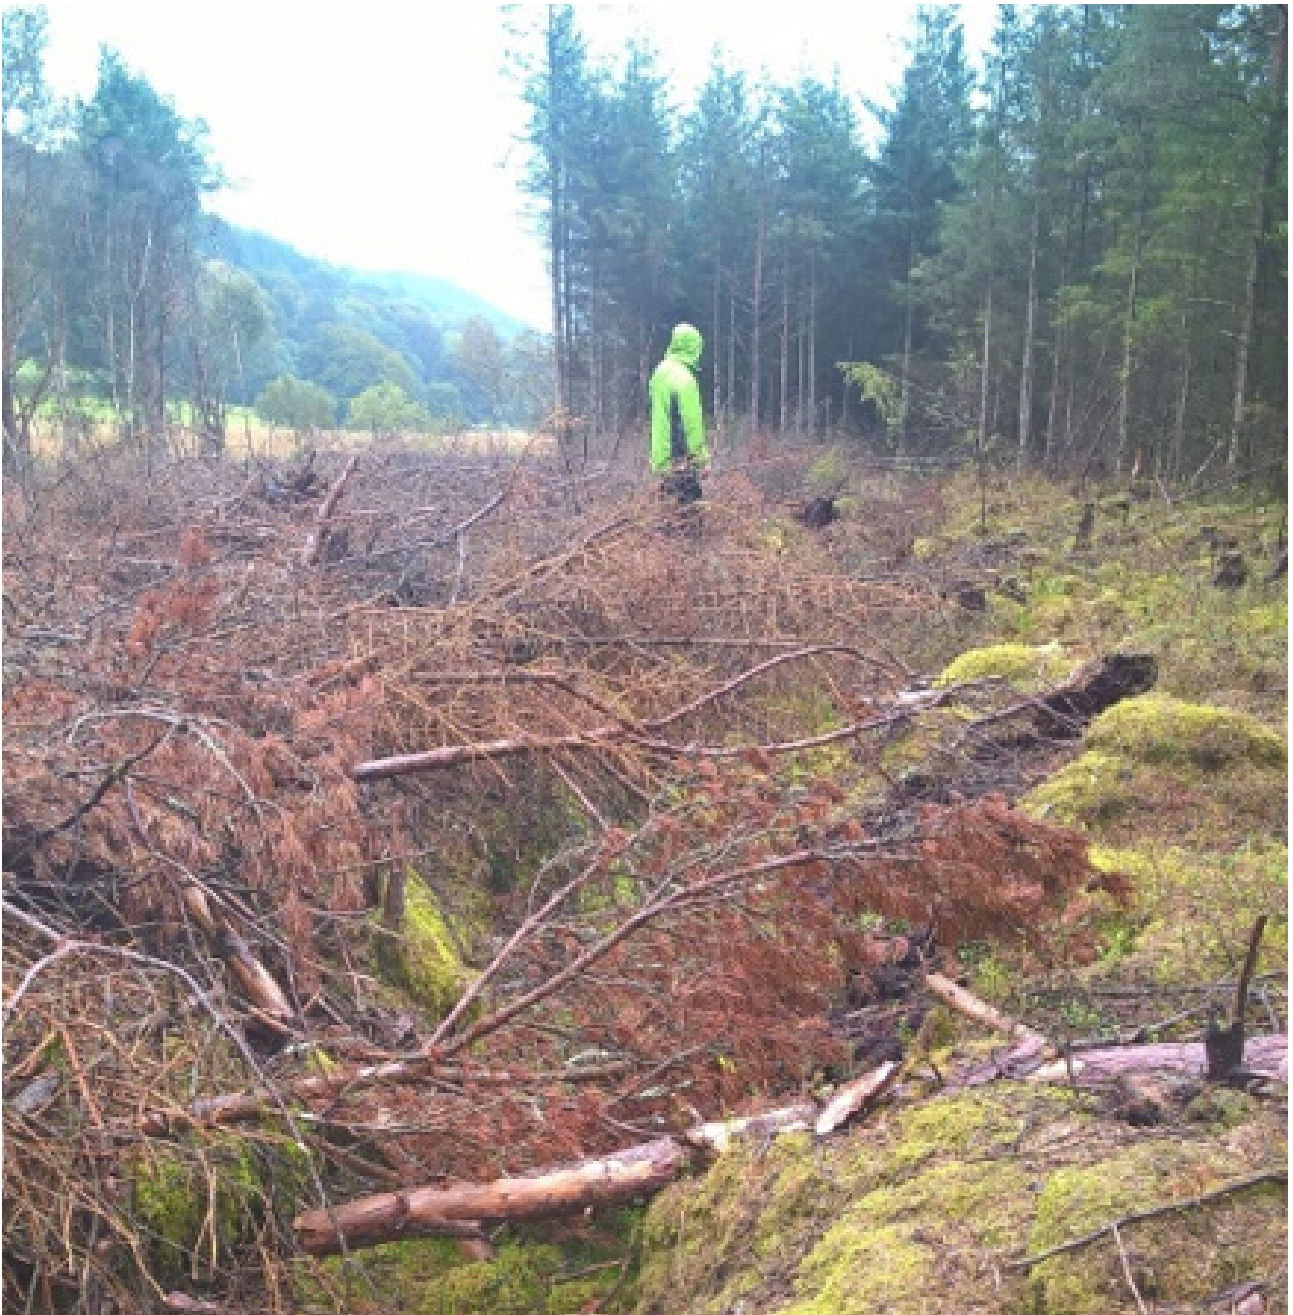
Figure 1.4: Coed Tŷ Uchaf restoration area during the clearance of conifers in 2016.

The conifer plantation at Coed Tŷ Uchaf was felled in 2016, and subsequently recolonised by a dense stand of young trees dominated by birch (*Betula sp.*). The deeper areas of peat have been damaged by a cross-cutting network of ditches, grips and forestry furrows, some of which were partially blocked with brash during the removal of the conifers. While no historic hydrological data was available, it was observed that the central areas of the peatland were dry and degraded.

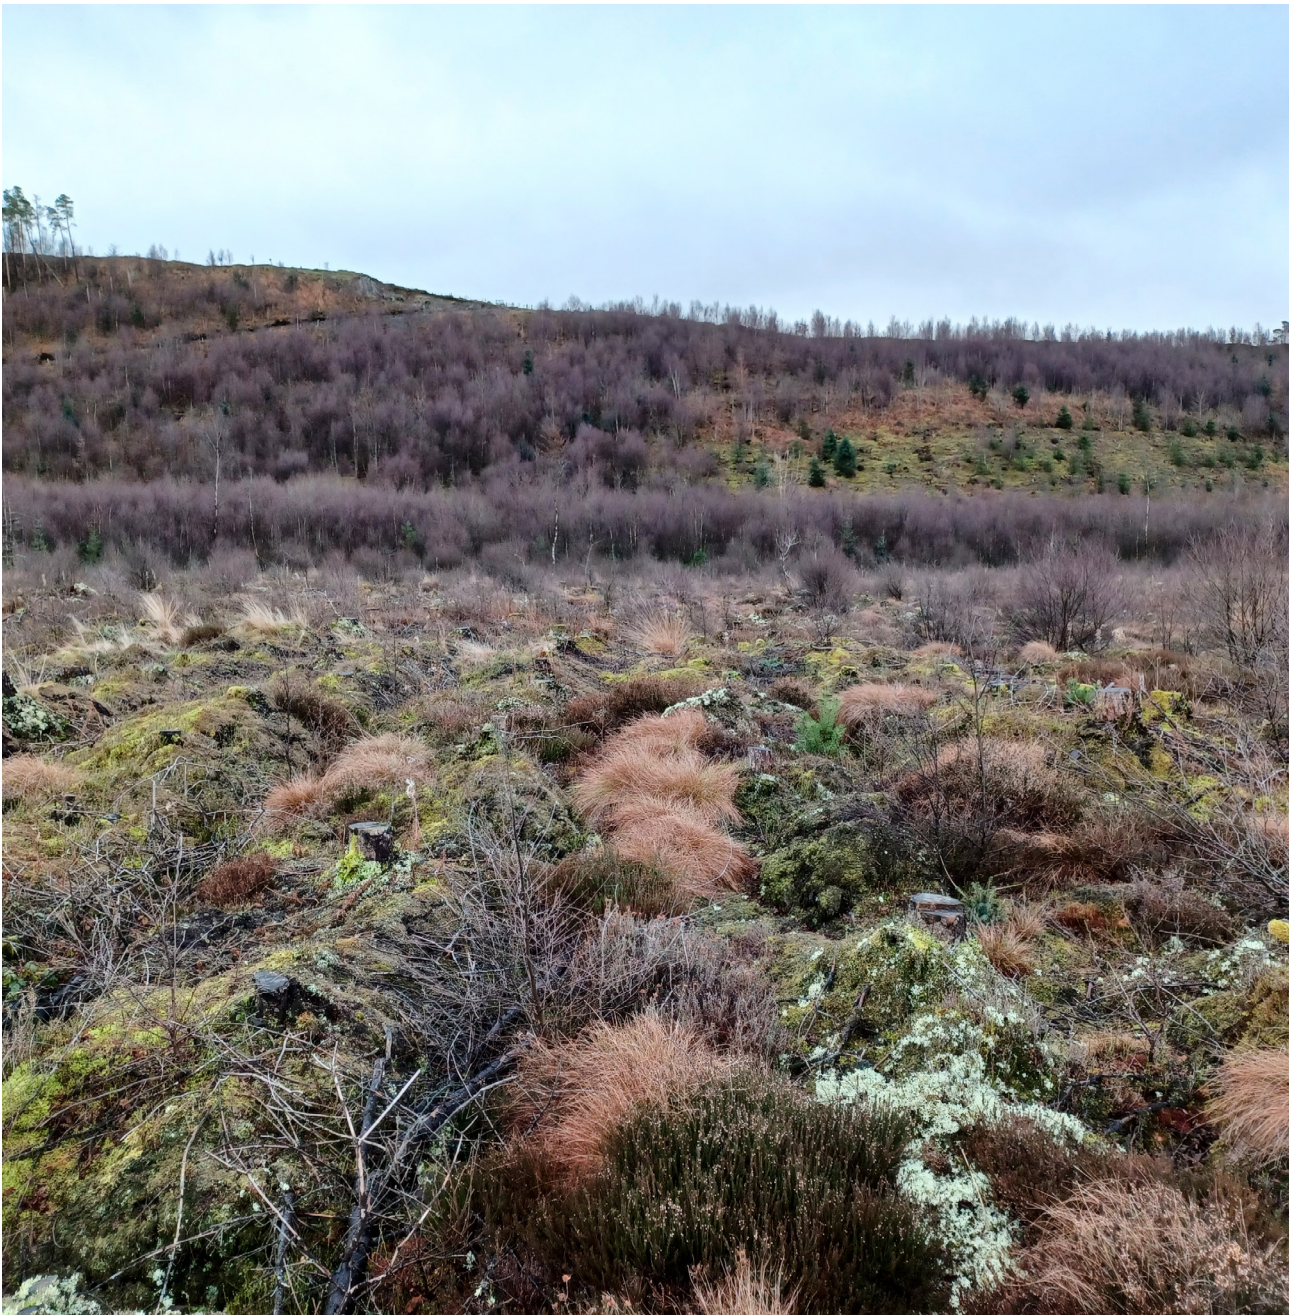
Figure 2.1: Birch scrub was cleared from the restoration area by hand in winter 2021/2022, with brash left behind for later removal.

The scrub was cleared by experienced contractors using a combination of chainsaws and brush cutters; clearance saws proved to be far more effective than regular brush cutter blades. The clearance works generated large volumes of brash which, in order to maximise the time available to the contractors, was left in situ to be dealt with at a later date by volunteers. While some brash was burnt on site, this should be seen as a last resort due to the associated carbon emissions. Instead, the majority of the brash was used to create dead hedges and brash piles along the edge of the peatland, with a small amount broken up further and used to partially block larger ditches.

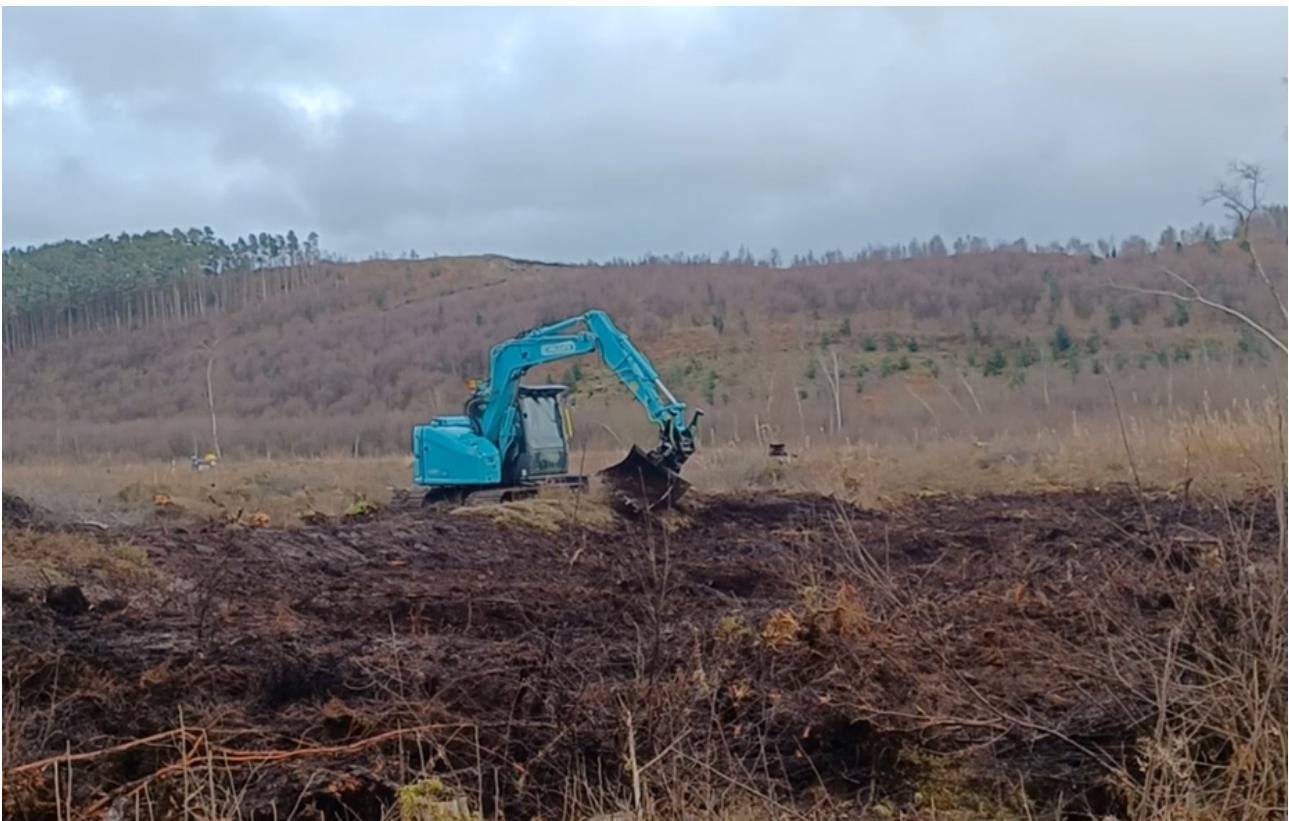
Figure 2.3: Excavator creating a section of bund, using a tilt-and-rotate coupler to increase the freedom of movement of the excavator bucket.

Both excavators were fitted with tilt-and-rotate couplers which allow 360° movement of the excavator bucket. These allow the operators to work more efficiently, with less repositioning of the machinery. A bunded fuel cube was also transported to site to allow refuelling close to the restoration area, saving time and additional potentially damaging movement across the site.

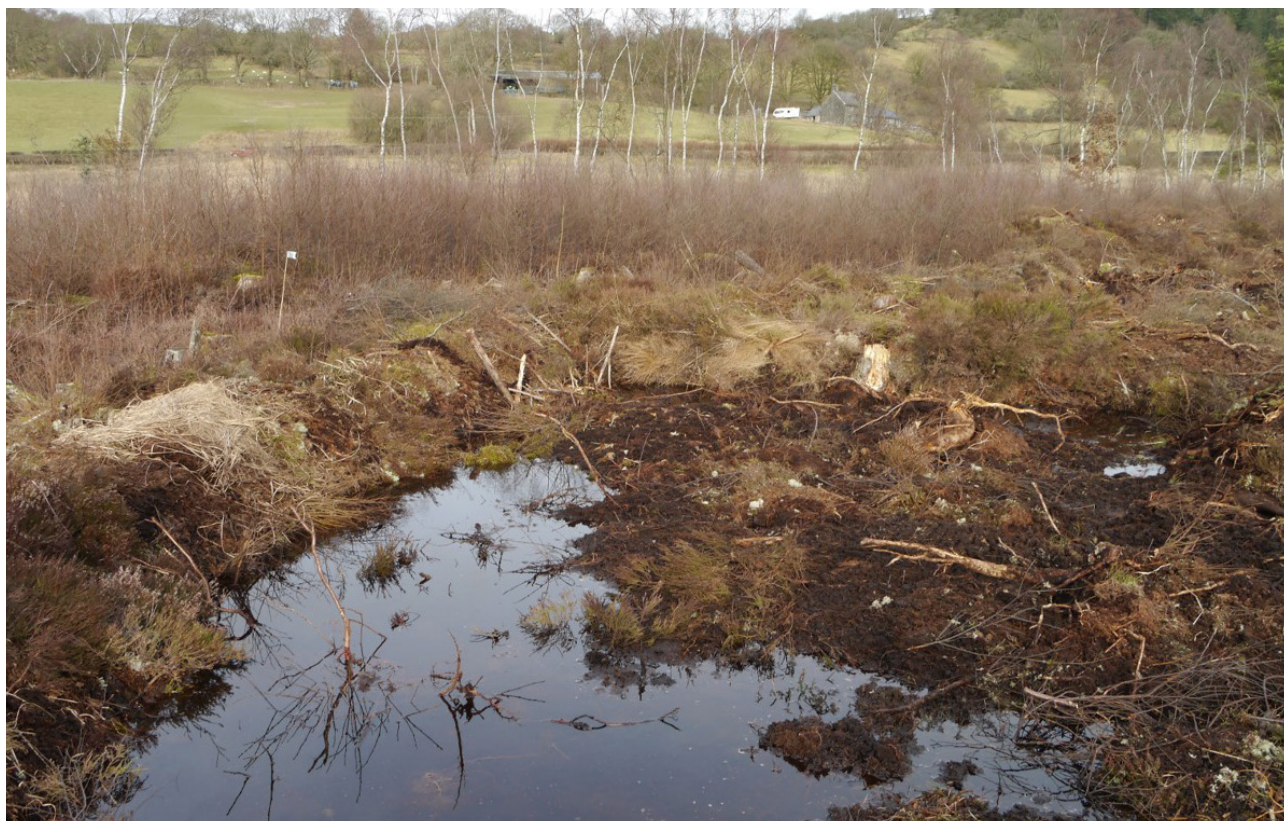
Figure 2.4: Newly completed bund, recovered with vegetation. The borrow pit created to source good quality peat for the bund is in the foreground, and has already started to fill with groundwater.

The bund is keyed into the peatland to ensure that water cannot pass through it, or flow underneath it through degraded peat or subsurface cracks. A trench is excavated to approximately 1m below the existing surface, going lower where it has to cross ditches or if peat cracks are found. The excavated peat is then mixed and relaid, and compacted to form the bund. Additional good quality peat is gained from borrow pits created on the upslope side of the bund.

The completed bund is approximately 0.8 m wide and raised to 0.25 m high relative to the bog surface. Vegetation is replaced on the top of the bund to help provide protection to the structure. Tree stumps along or adjacent to the bund position are dug out during the bund construction and placed upside down into the borrow pits.

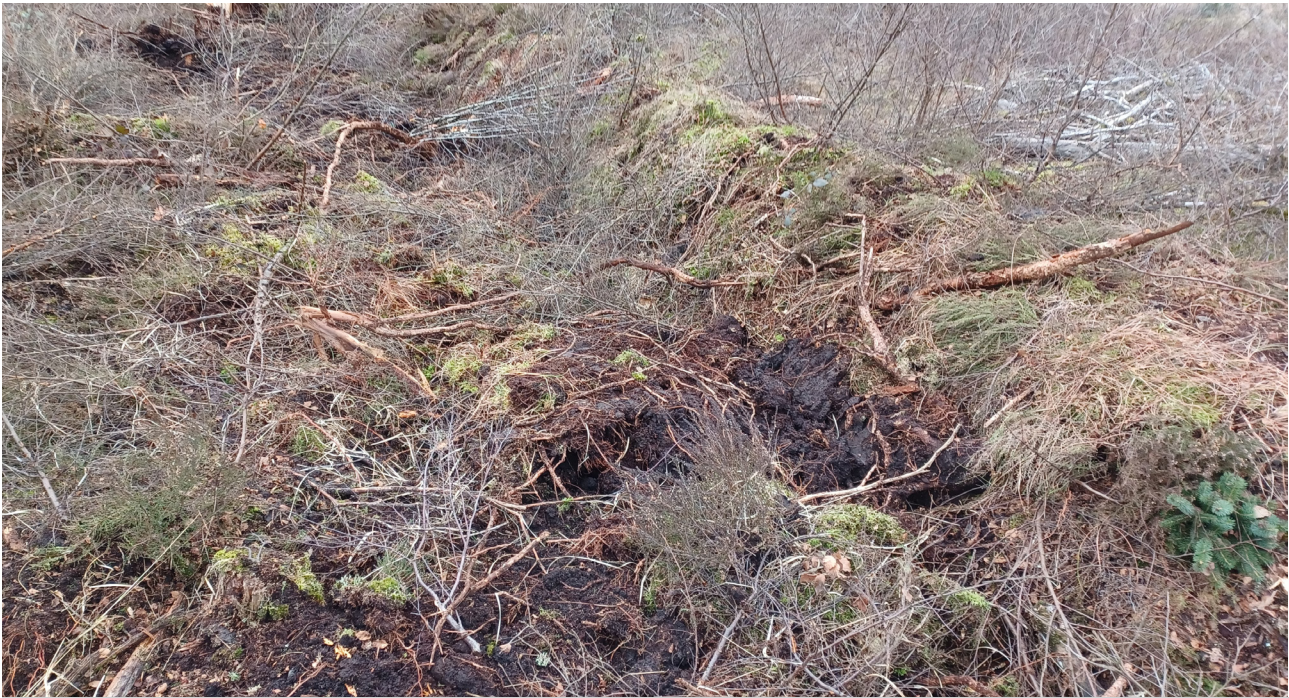
Figure 2.5: Detail of a completed section of bund, recovered with vegetation. The borrow pit is situated to the left of the bund and has been partially filled with brash and spare vegetation.

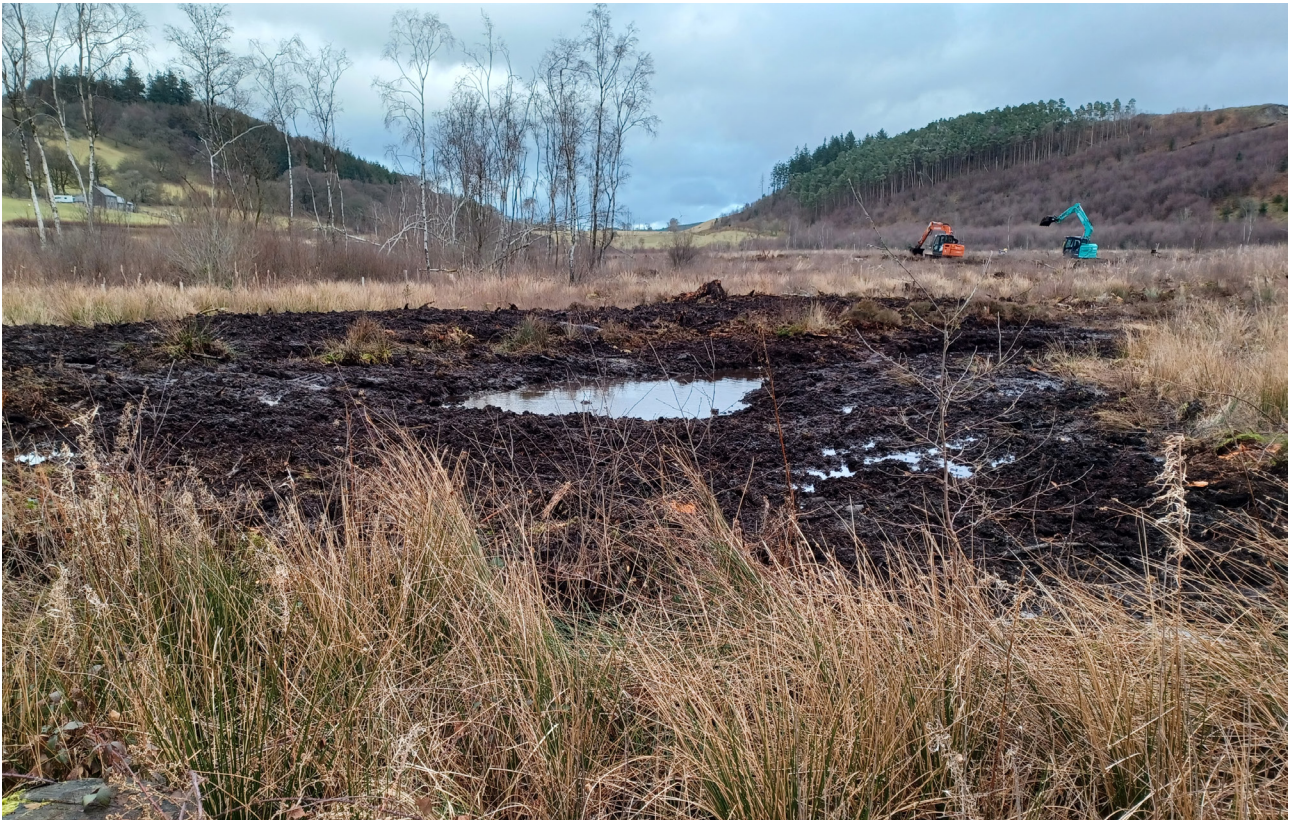
Figure 2.6: Newly completed pond, the deeper central section (partially filled with groundwater) is surrounded by a wide scrape.

Each of the ponds consists of a wide, flat scrape created by removing the vegetation and surface peat to create a flatter area slightly below the existing bog surface. At the centre of each scrape, a pond is excavated up to 1 m deep and left to fill from the water table. This design means that the deeper areas of the pond should retain water year-round, while the scrapes will become revegetated and will be seasonally inundated. Excavated material is used to block adjacent ditches or create shallow banks on the downslope side of each pond to help with water retention.

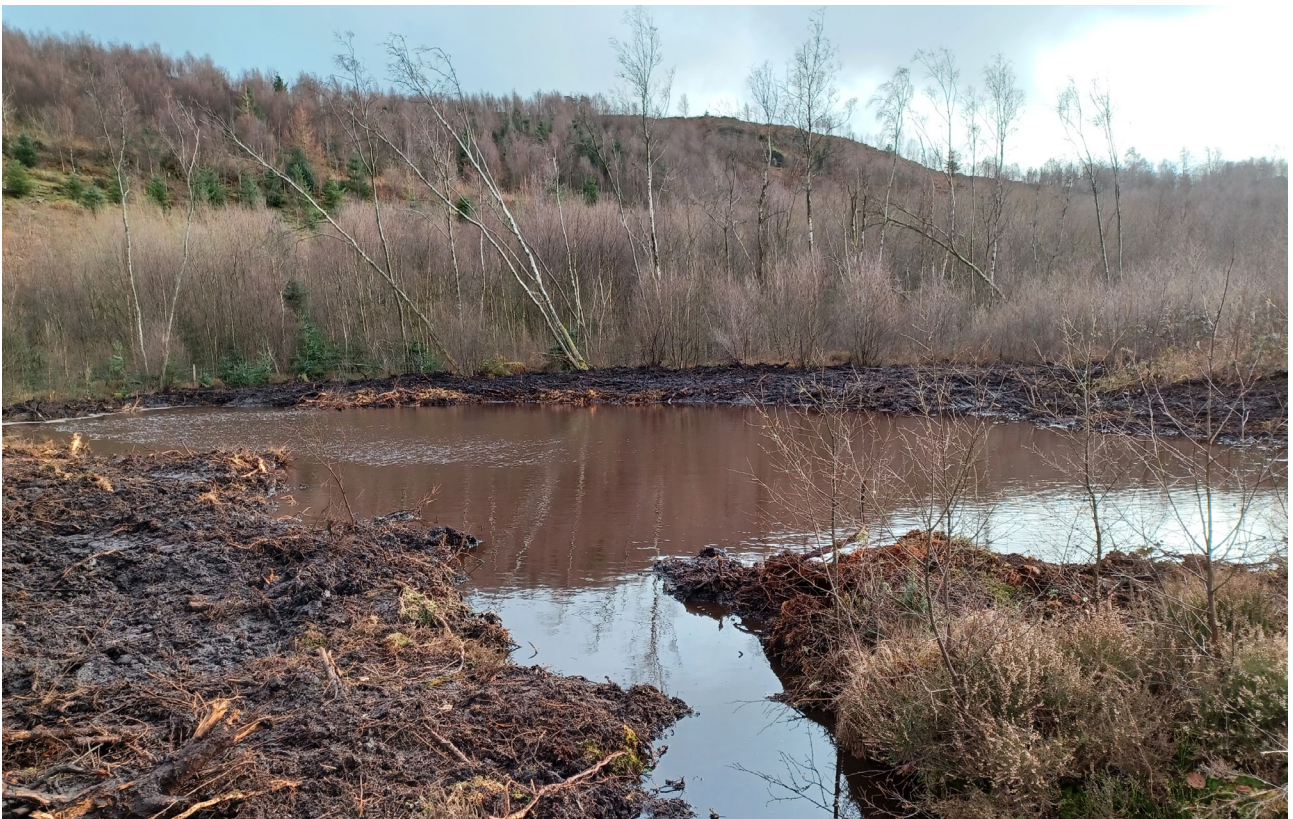
Figure 2.7: One of the ponds three days after creation, with water spreading onto the scrape and flooding back up an adjacent drainage ditch.

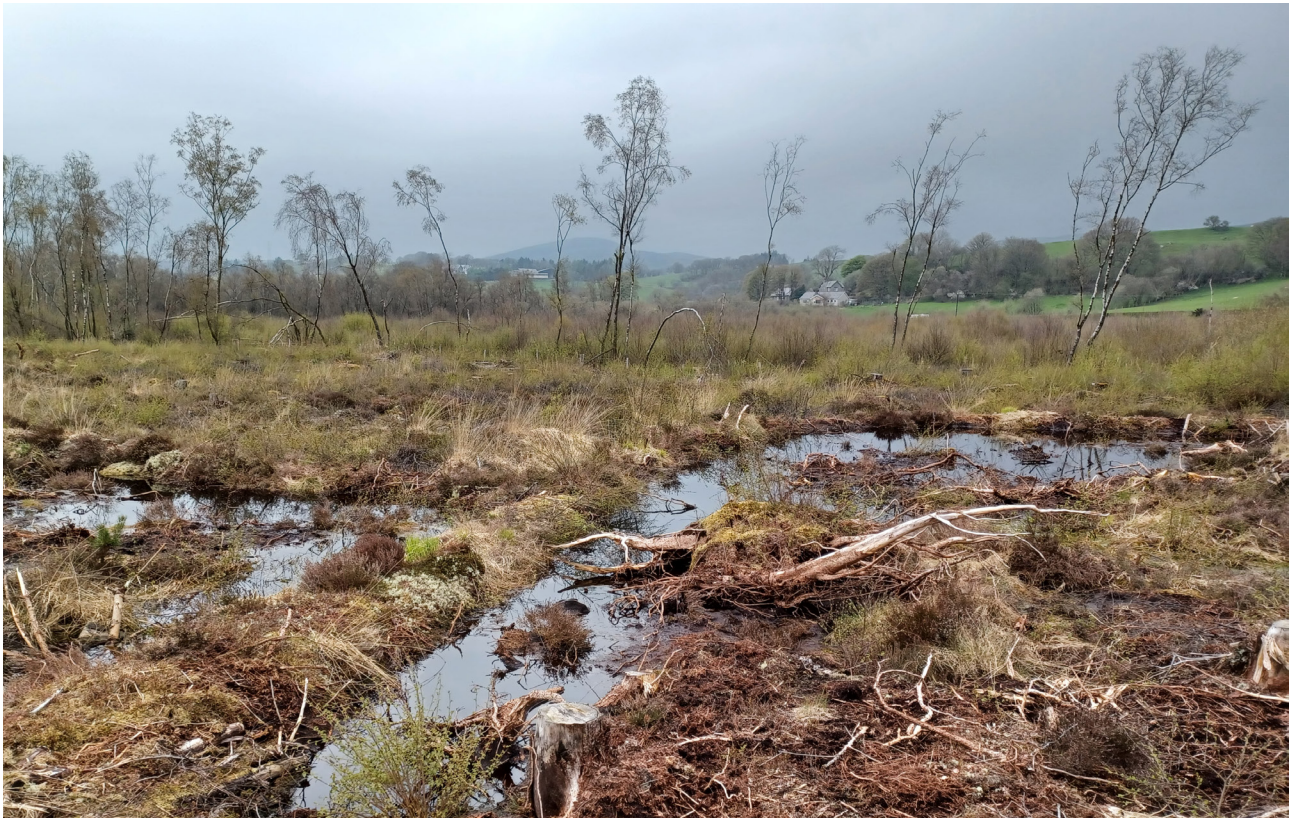
Figure 3.1: Water pooling behind the bund following heavy rain.

While no long-term patterns have yet emerged the general observation is that ground water levels within the central part of the restoration may have risen slightly and seem to be stabilising at a higher level compared to pre-intervention levels. The monitoring results also suggest some compartmentalisation of the ground water, with notable variations in the ground water levels between some adjacent dipwells. Direct observations of the bund have also shown that it is functioning well, with water pooling to the top of the bund in many places - 20 cm above the existing bog surface - following periods of heavy rainfall. Surface water has also been observed pooling back up the ditches and spreading onto low-lying areas of the bog, a further indication that the volume and duration of water retention has been improved through the installation of the bund.

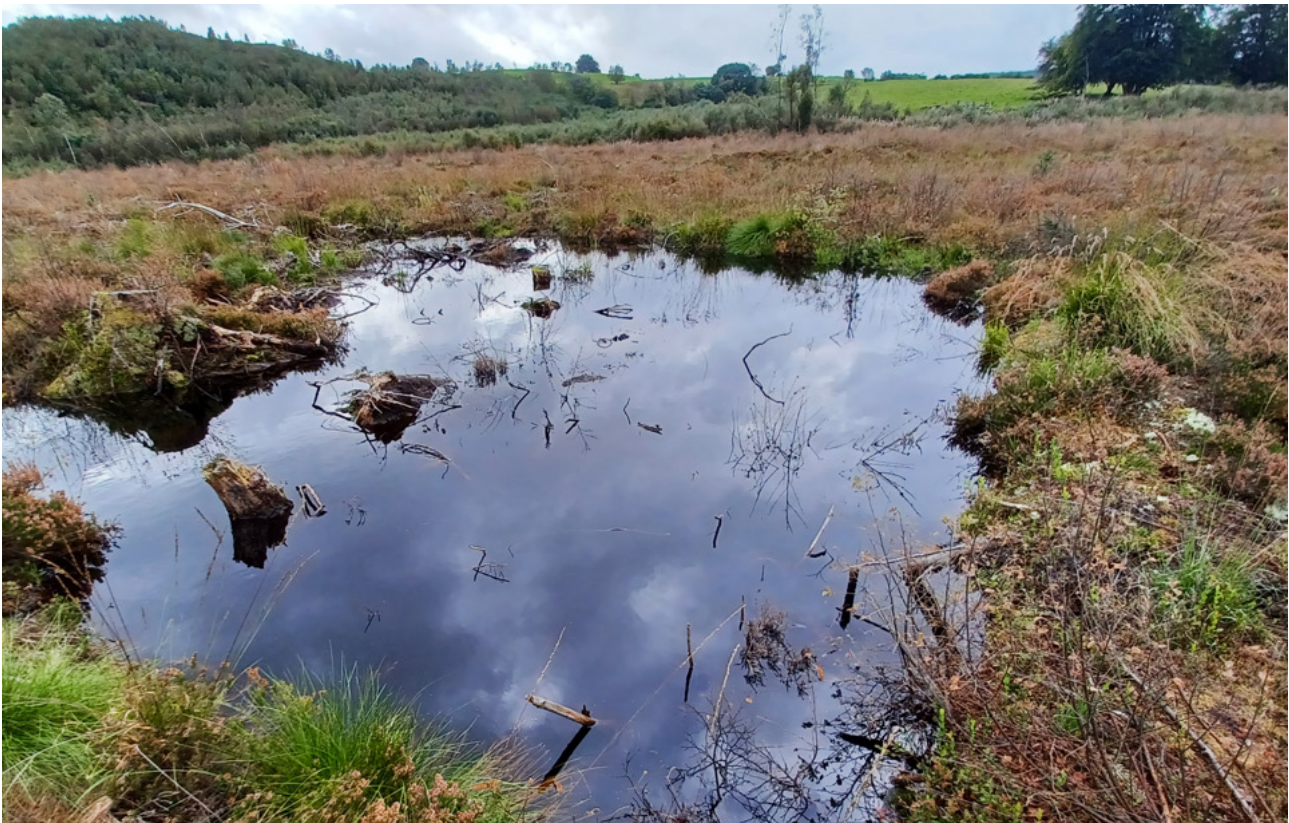
Figure 3.2: Completely flooded borrow pit, with the water approaching the top of the bund and flooding back up ditches and over the bog surface.

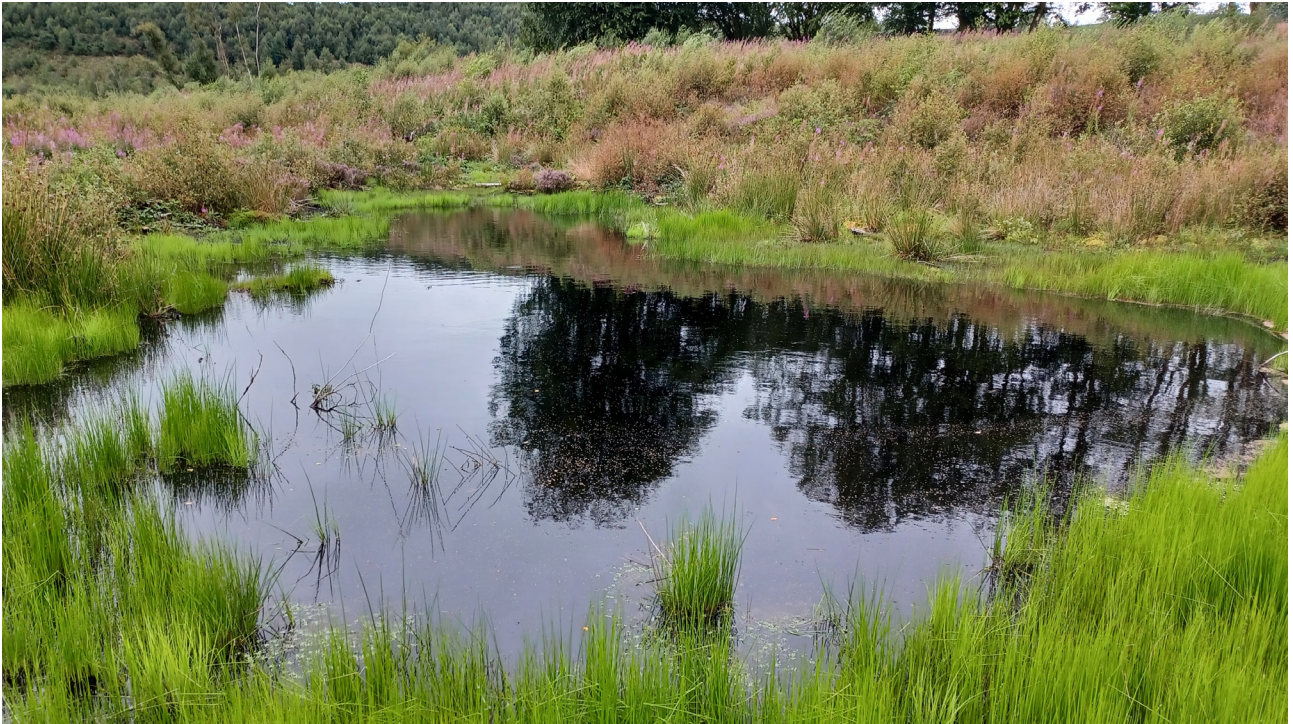
Figure 3.3: Partially-flooded scrape recolonised by soft rush (*Juncus effusus*) and bulbous rush (*Juncus bulbosus*).

One of the biggest immediate successes of the Care-Peat project at Cors-y-Sarnau has been the newly-created ponds. The scrapes have already been partially colonised by bulbous rush (*Juncus bulbosus*), a species that had not previously been recorded on the site. The ponds have also attracted a range of invertebrates, such as pond skaters (*Gerris lacustris*), whirligig beetles (*Gyrinus substriatus*), water boatmen and diving beetles. Common blue damselfly (*Enallagma cyathigerum*) and at least four species of dragonfly have also been observed around the ponds, with the latter seen laying eggs in the water.
