# INTERREG CARE-PEAT

The Care-Peat impact within  
De Wieden

## REPORT

June 2023

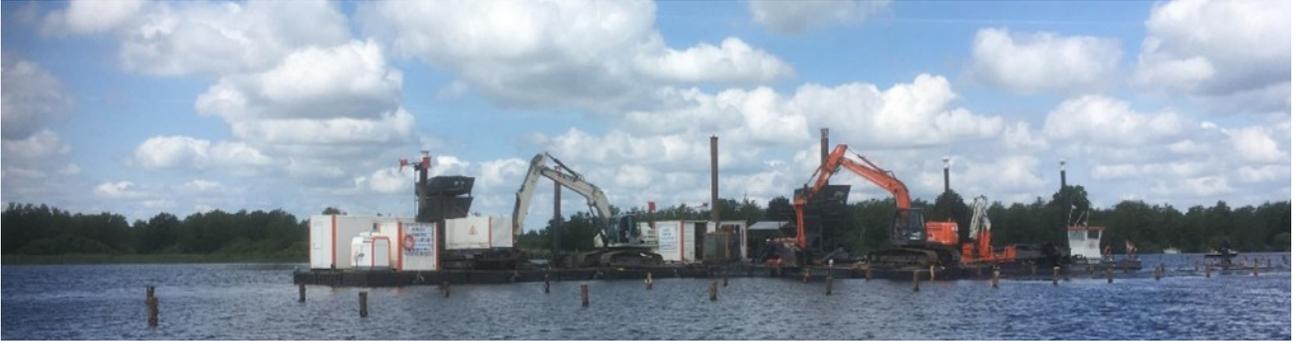
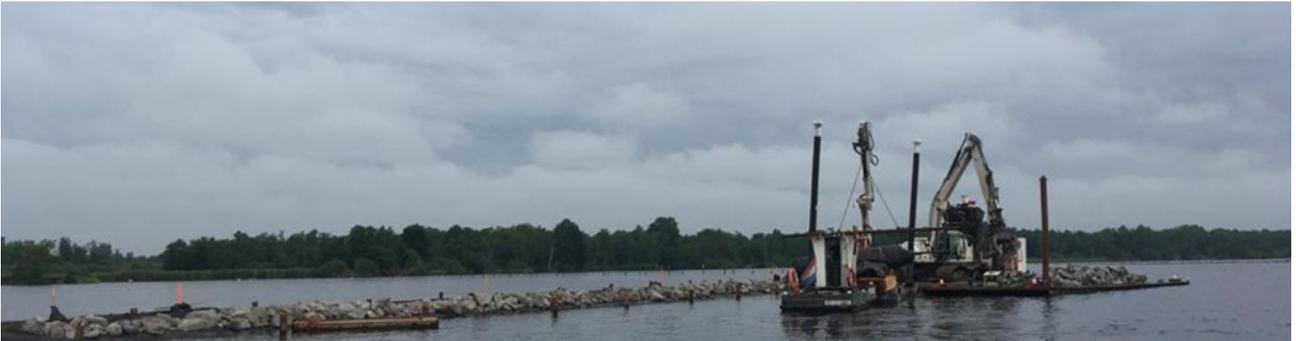
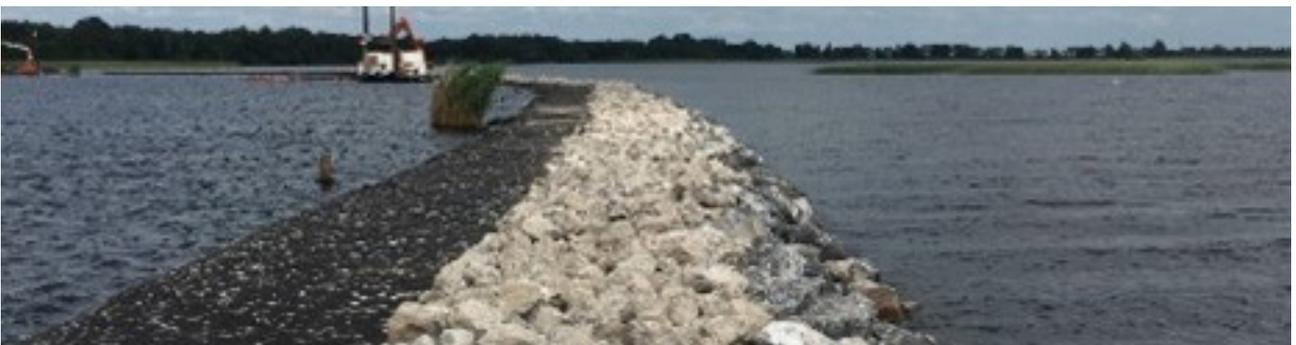
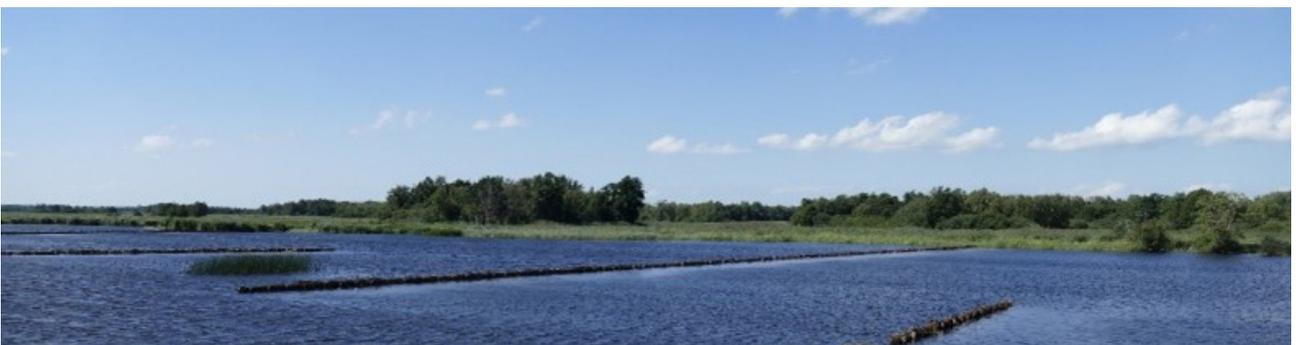
Figure 3: Construction of the Foreshore

Activities on site began in April 2020, and concluded in April 2021 (**Figure 3**). The first stage involved the construction of the foreshore. Here a demarcation was placed in the lake, by fixing a geotextile screen to poles positioned in the lake-bed along the foreshore line. Sand and sludge dug from around the foreshore was then pushed through the demarcation from the side of the lake. Additional sand was piled up against the inside of the screen to build up back pressure, and thus strengthen the base. The sand body was then covered with cloth canvas and then topped with stone chunks. The completed barrier was designated suitably robust to ensure peat deposited in the foreshore stays under water, and therefore does not shift into the surrounding lake.

The final stage of foreshore preparation involved the installation of willow screens (wiepen). These screens help to conduct water flow and thus prevent water turbidity caused by the discharging of process water in the lake. Local professional fishermen emptied the foreshore of fish prior to deposition of excavated peat. The foreshore was completed by August 2020, which enabled the start of work within the Peat Pits.

*Demarcation posts placed in lake-bed*

*Stone chunks placed upon sand body*

*Completed barrier*

*Willow screens in foreshore*

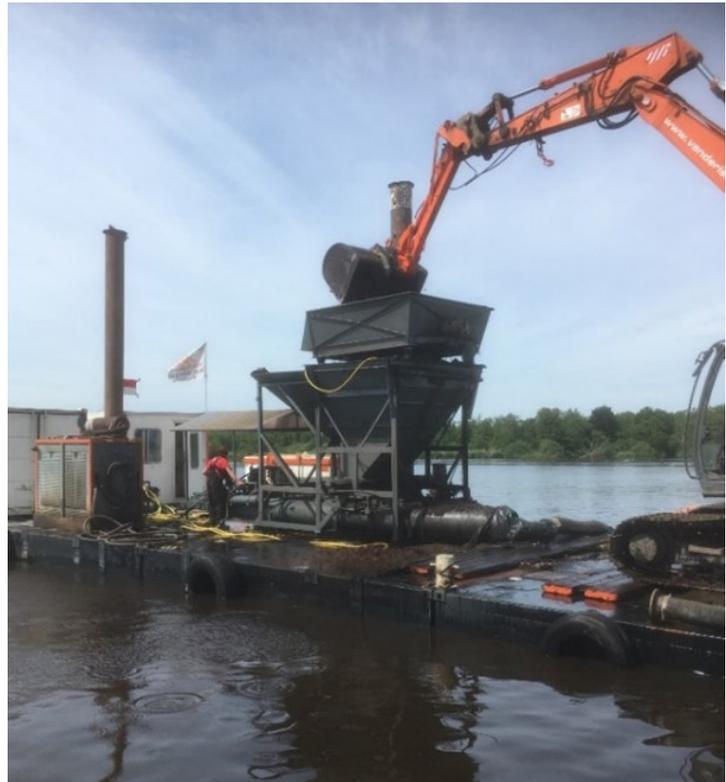
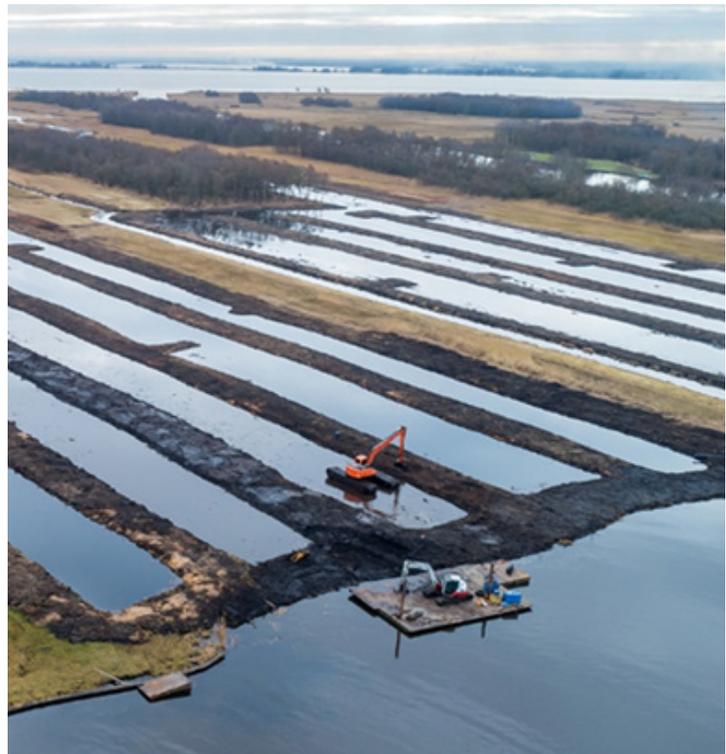
Figure 4: Construction of Peat pits

### *Loading of excavated peat into geo-tubes*

Turf ponds in the peat pits were excavated using mechanical diggers (**Figure 4**).

Care was however required to protect layers during excavation, and to maintain natural and associated cultural historic values. This was ultimately achieved via strict regulations on the size of each pond. The width of ponds was constructed to between 15 and 30 metres, while the length of ponds ranged between 30 and 100 metres. The target for pond depth below the water line varied from approximately 0.5 metres at the perimeter to 1 metre in depth below towards the centre.

Peat extracted from each pond was transported to the foreshore water via geo-tubes. The tubes provided an airtight environment, which limited soil carbon losses during the transportation process. The tubes also mitigated the need for heavy loading trucks, which could have damaged both restoration areas and surrounding habitats if they had been used. Peat material built up rapidly within the foreshore and should quickly develop into a bog over the coming years.

### *Digging of turf ponds and formation of pond banks*

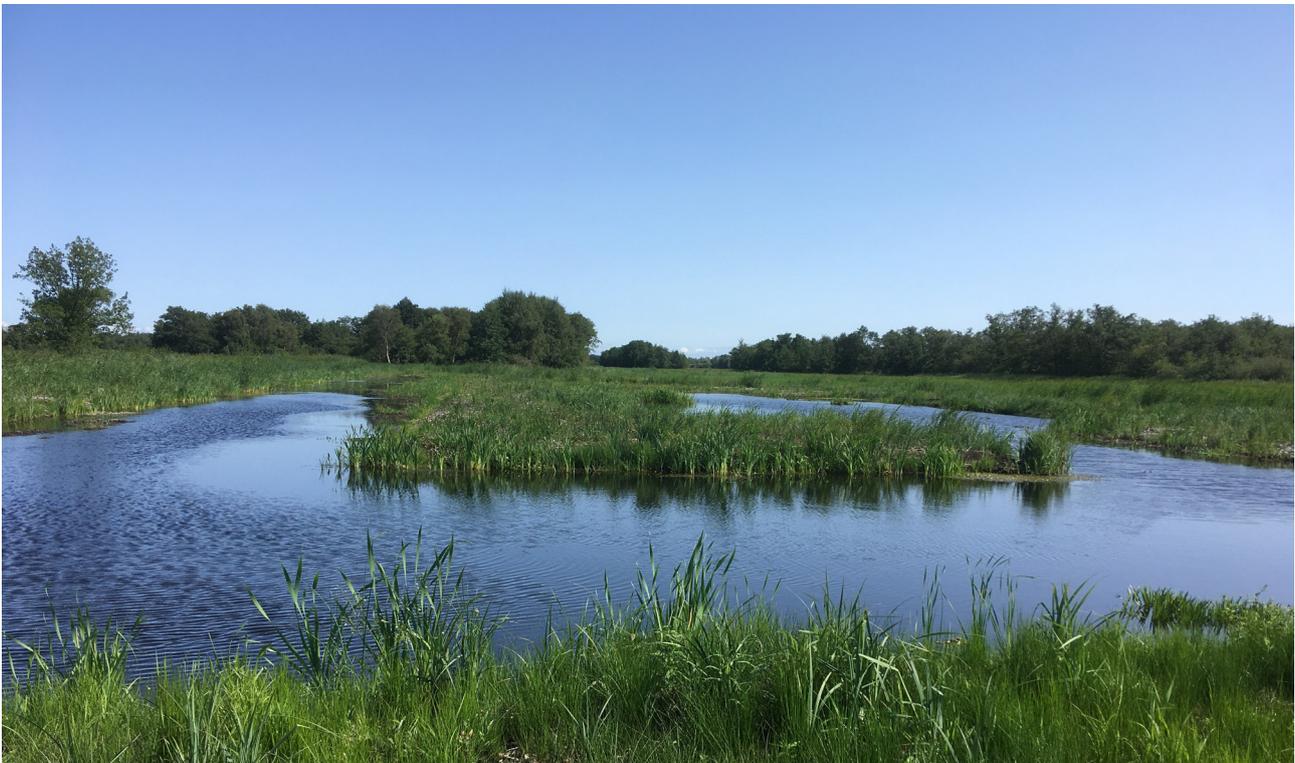
Figure 5: Post-restoration developments - *Juncus effusus* and reed development within Peat pits (August 2021)

Currently the pilot site is fully developed as planned, and while continued monitoring is required in the coming years to fully assess the benefits of restoration, initial on the ground developments indicate some success towards achieving the aims of the pilot site (**Figure 5-8**). Notably bare patches of soil have begun to develop vegetation with the occurrence of *Myrica gale* (Wild Gale), *Viola palustris* (Marsh Violet), *Dactylorhiza praetermissa* (Marsh Orchid) etcetera. The emergence of species associated with an early-terrestrialisation phase – e.g. *Stratiotes*, *Potamogeton*, *Hydrocharis*, *Typha* – and the expansion of reed in the peat pits is a promising development.

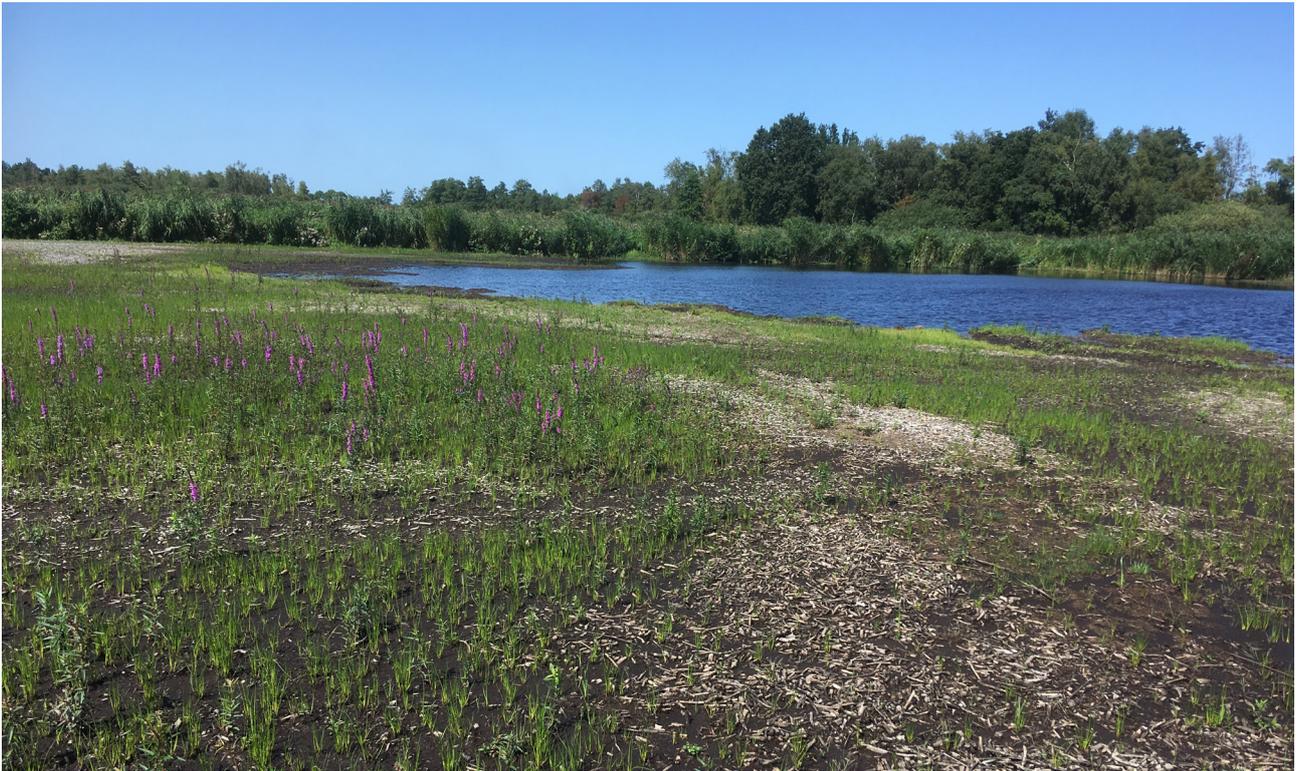
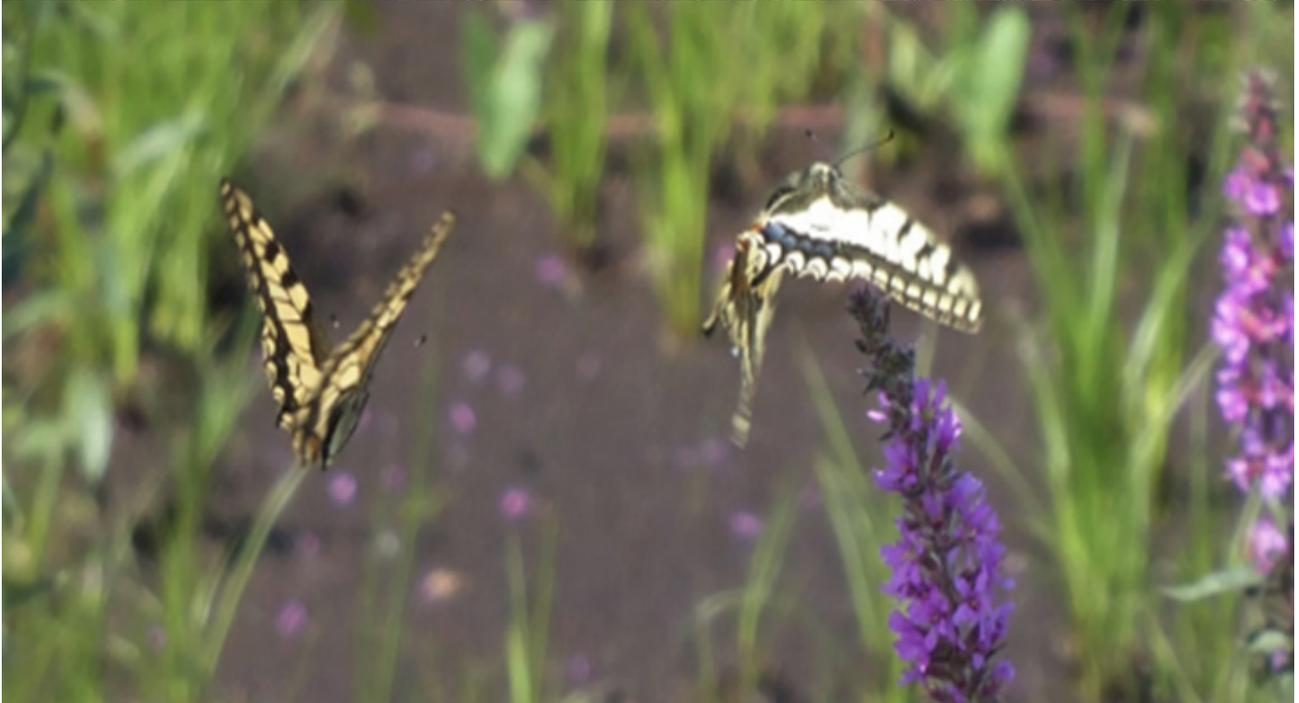
Figure 8: Post-restoration developments - Flora and fauna behind foreshore barrier

Water quality is also improving and is projected to continue to do so in the upcoming years. This is indicated by the positive development of reeds on-site, owing to suitable provision of space and growing conditions. In parts of the foreshore the initial vegetation development has already led to the formation of a rootzone with some carrying capacity. This indicates a development towards a more stable substrate for further succession. In other parts the foreshore soil is still soft without a tied rootzone, although vegetation development has started here.

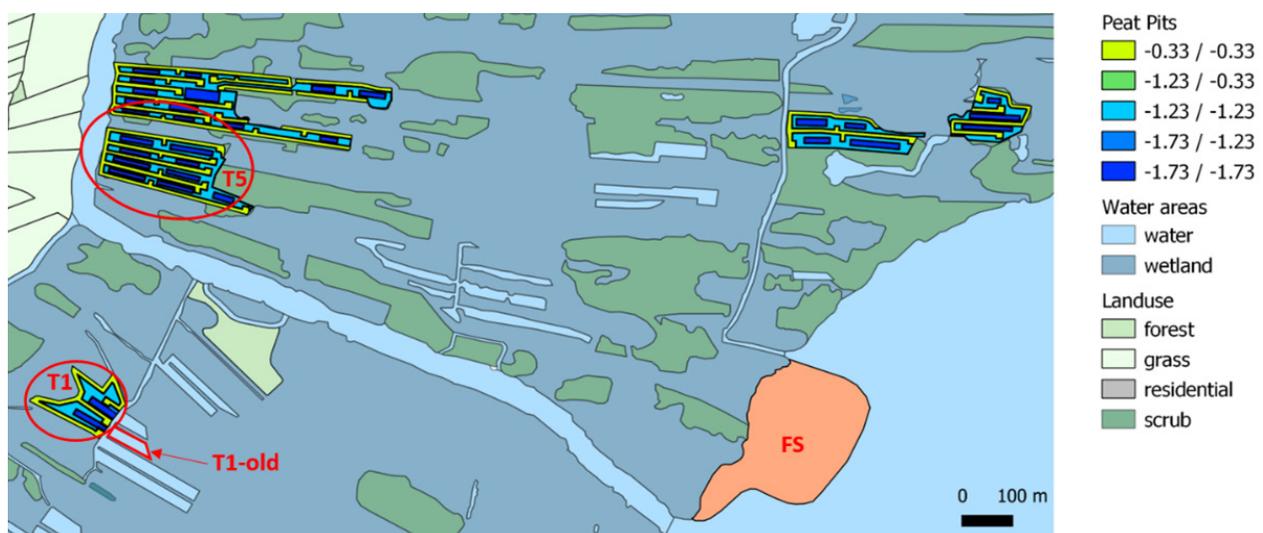
Figure 9: Monitoring areas within the De Wieden pilot site.

In situ monitoring began in August 2021 and was carried out over the course of six field campaigns, centred around the months of August and November in the years 2021 and 2022 respectively, along with February and April in 2023. All restoration works in the pilot area were completed by April 2021, therefore the monitoring exercise indicates changes in GHG emissions during the initial post-restoration period. In total, three monitoring areas were designated, to examine the effect of different restoration works (**Figure 9**). The first area was located within the Foreshore (FS), with measurements undertaken on water and peat areas to contrast the current habitat areas created by restoration. Unfortunately, during the monitoring period the peat in general was unsafe to walk on. Therefore, sampling plots were designated within safe-to-access areas, that included an area next to the foreshore, and an area of floating peat accessible by boat.

The second and third areas, labelled T1 and T5 respectively, were located within the Peat pits, where peat had been previously extracted to form the foreshore. Again, measurements were undertaken to compare different restoration habitats, and included areas of water created through peat extraction, and dikes composed of crushed tree and peat residues. An additional measurement area within T1 was centred on an area adjacent to restoration works, where soil had been stripped out prior to the Care-Peat project. Measurements here, conducted on water only, provided a proxy control area to examine the future evolution of local GHG emissions after the end of the project. All measurement areas are visualised in **Figure 9**.

As collars could not be installed on the soil due to low compaction, measurement points were located on areas of vegetation. The foreshore (FS) area is mainly composed of *Juncus effusus* and some *Carex* species. Vegetation in the T1 and T5 areas are disturbed through mowing activities, and therefore change during the year. The main vegetation species found here include *Juncus spp.*, reeds and *Carex spp.* Due to continuing vegetation development within sample areas, small adjustments in the location of collars was required to obtain reliable measurements.
