DI1.1.2 Deliverable- Remote imaging report

I1.1.2 Remote imaging report (Based on the operating plan of OVAM)

The Meerhout landfill site is located in the province of Antwerp, Flanders Region, Belgium. The site is triangular shaped. The W-E extension is 380 m and the N-S extension is 360 m. The site area is 7.5 Ha and the total perimeter is 1250 m long. This include the container park facility, partially located on the older dumping zone.

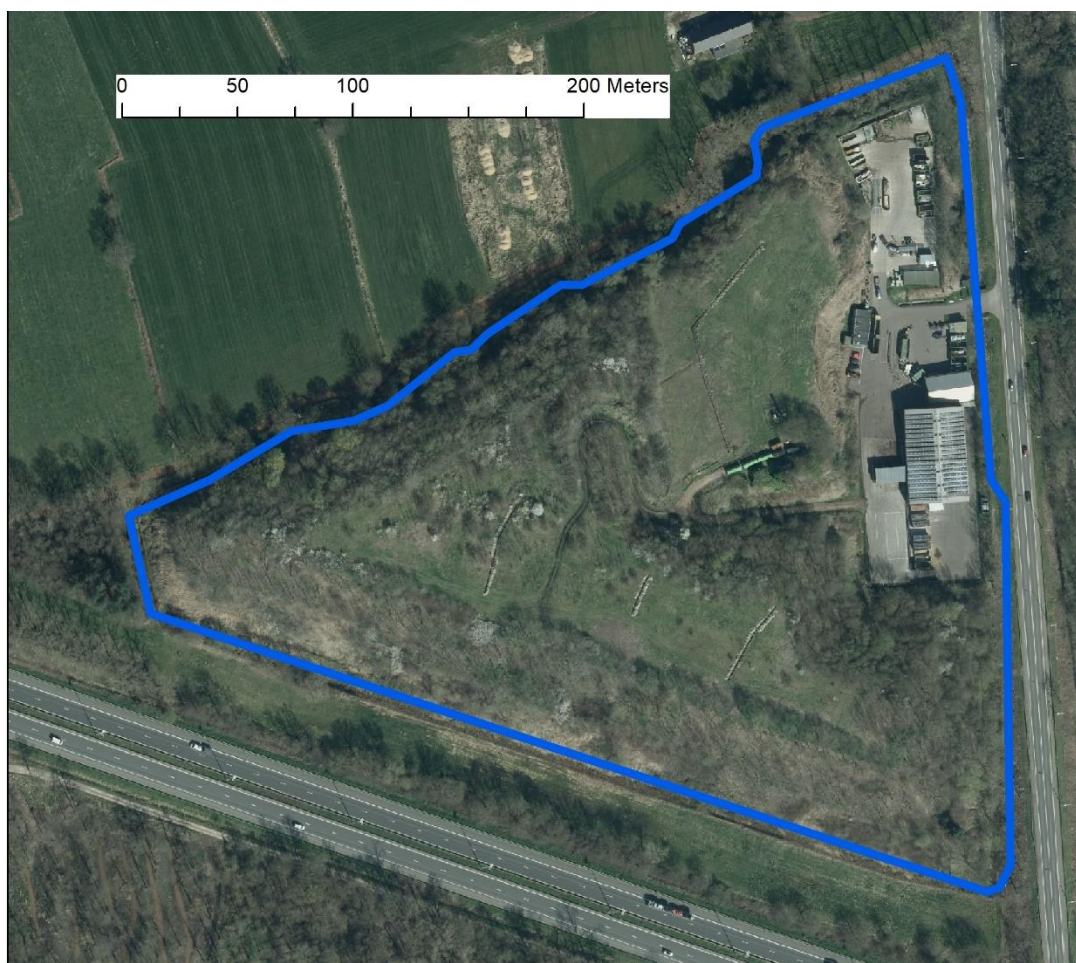
Figure 1: The Meerhout landfill site: aerial view of February 2017

The more recent aerial view of the site is presented at Figure 1. This photograph has been acquired in wintertime, in February 2017. No major changes occurred on the site between this last view and our visit of the site on October 13th, 2017.

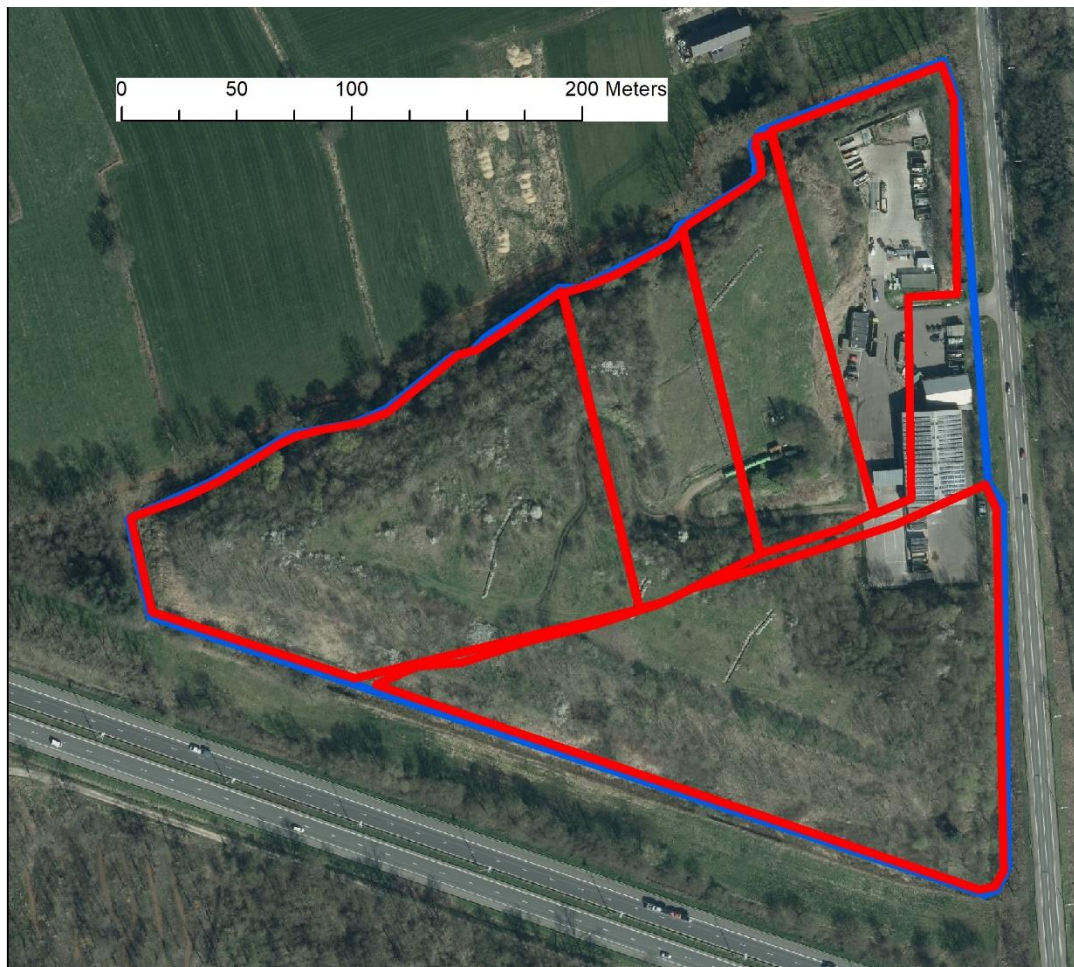
Figure 2: Extension of the site from 1962 to 1999

The site is subdivided in different zones that correspond to the historical successive extensions of the site (see deliverable I1.1.1) (Figure 2). The waste disposal activity started in 1962 in the most N-W zone of the site. Then, the site successively extended westward (1982, 1983 and 1986). In 1989, the landfill extended southward. Then, the storage capacity was increased by increasing the thickness of the disposal facility. The total thickness of waste is 4-5 m in the older zone (1962-1982), 10 m in the 1982-1983 zones and 20 m at other places, so that the original division of the site and successive extensions zones are still recognizable today.

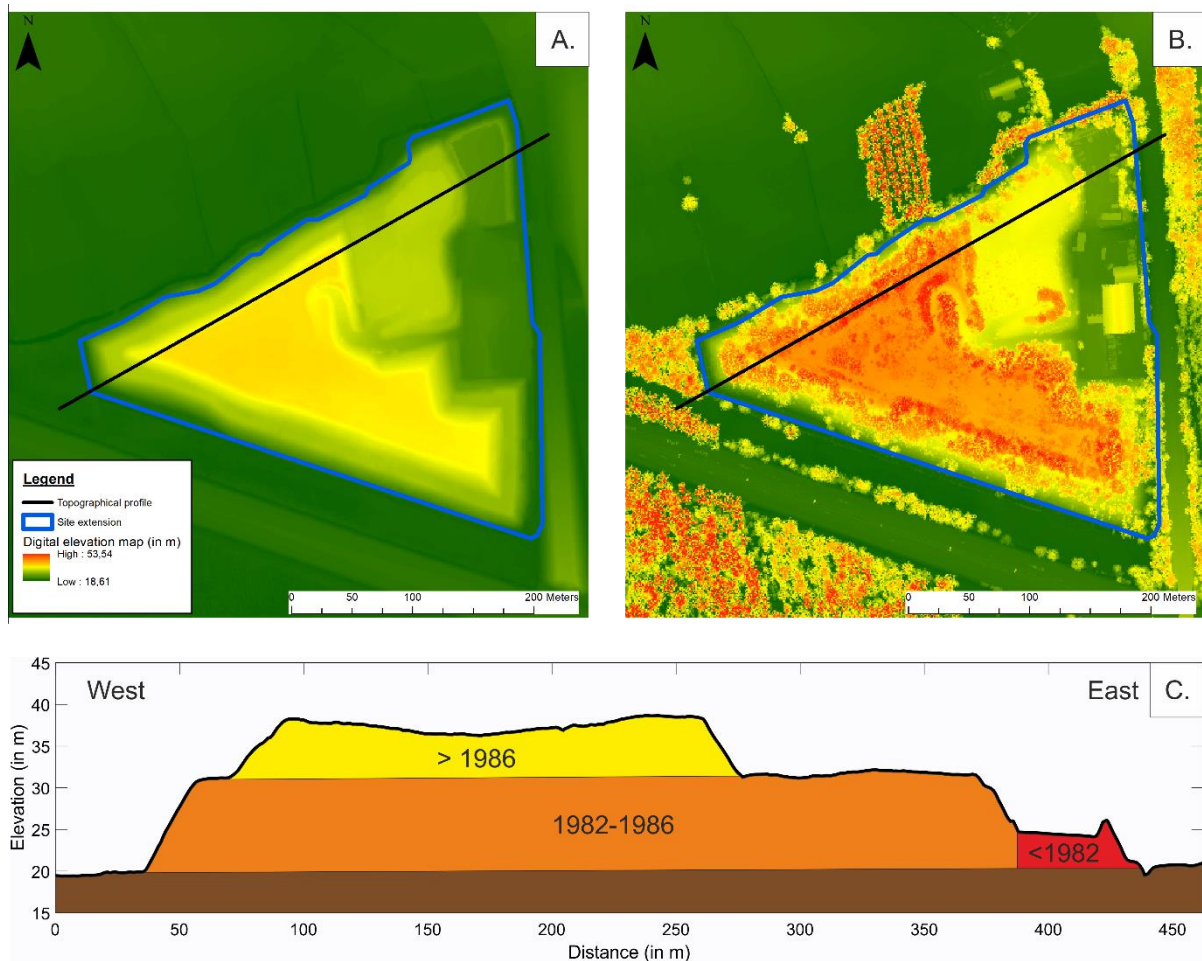
Figure 4: The Meerhout landfill present topography: a. DEM soil elevation; b. DEM top of vegetation; c. cross-section

The elevation of the site is now 20 m above the initial topographic level, except in the oldest areas (the area without membrane and the area with the thin agricultural plastic film).

- 4m of waste in the older zone (no membrane)
- 10m of waste in the 1983 zone (thin membrane)
- 20m of waste in the newer zones (>1986; thick membrane)

The digital elevation model is presented at Figure 4a, and a cross-section at figure 4c.

The site vegetation can be visualized at Figure 4b. Photos were also taken during the site visit on October 13th, 2017 (Figure 5).
