Tree House

Secure reuse via a maintenance and servicing contract

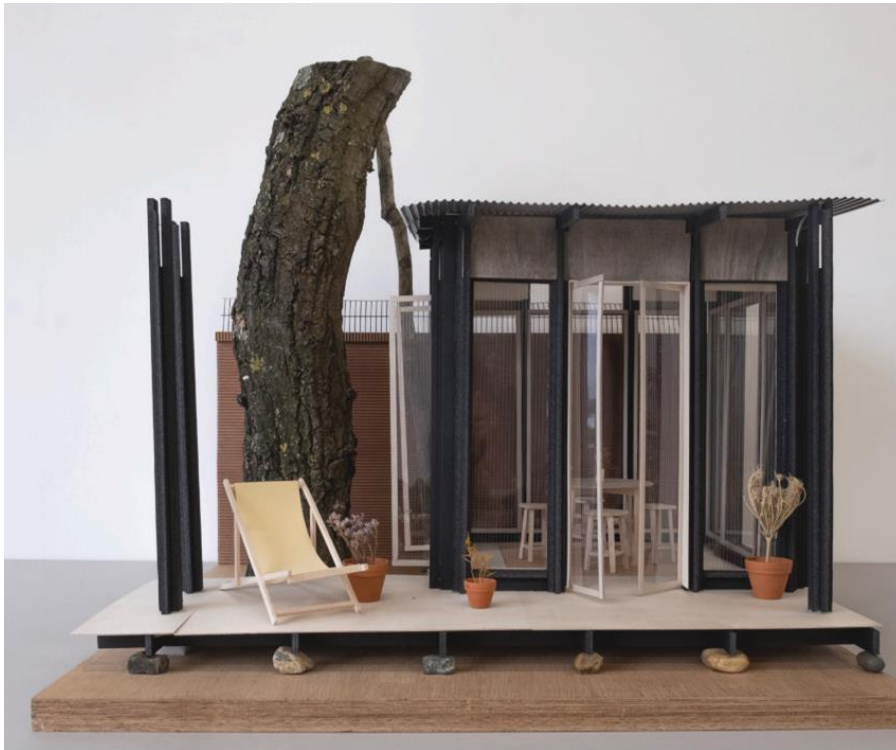
Image source: Studio Acte

- The building's design was adapted to the available materials. The structure was conceived as a dry assembly using bolting, screwing and interlocking which allowed for great flexibility and favored the interchangeability of elements. This approach also eased the constraint linked to the availability of resources.

- The building is composed of a beam-floor framing resting on natural stone and small pavings. All the materials except for the zinc roof come from prior deconstructions. The structure and the wooden floor (Basralocus) come from the old mooring piles of the port of Rotterdam (at the origin, this wood came from the forests of Surinam and Guyana). The acrylate panels come from deconstructed trusses. The wooden formwork panels and the plywood respectively come from the old floor of a nightclub and from non-downgraded stocks.
